Samamish-Juanita Transmission Line Project

Puget Sound Energy Sammamish-Juanita Transmission Line Project Wetland and Stream Delineation Report Preliminary Draft

**Puget Sound Energy
Samamish-Juanita Transmission Line Wetland Delineation**

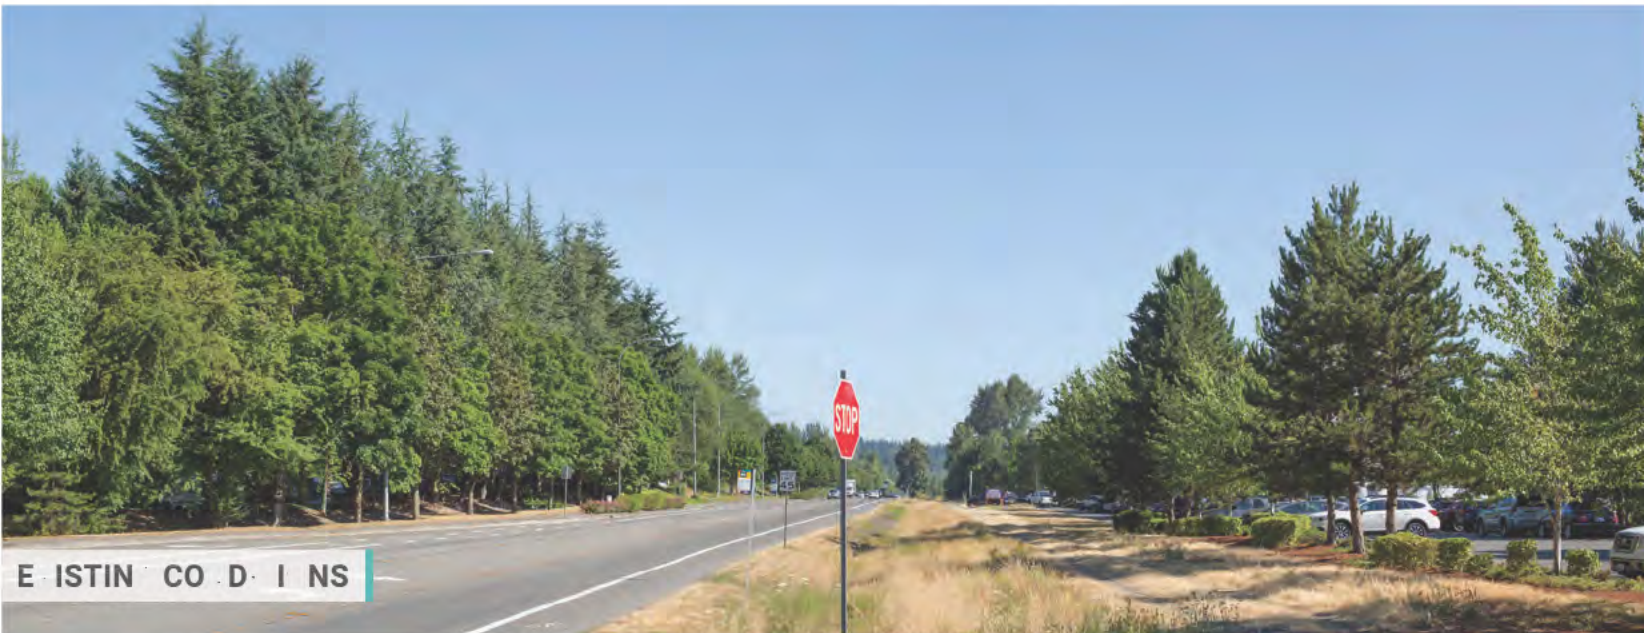
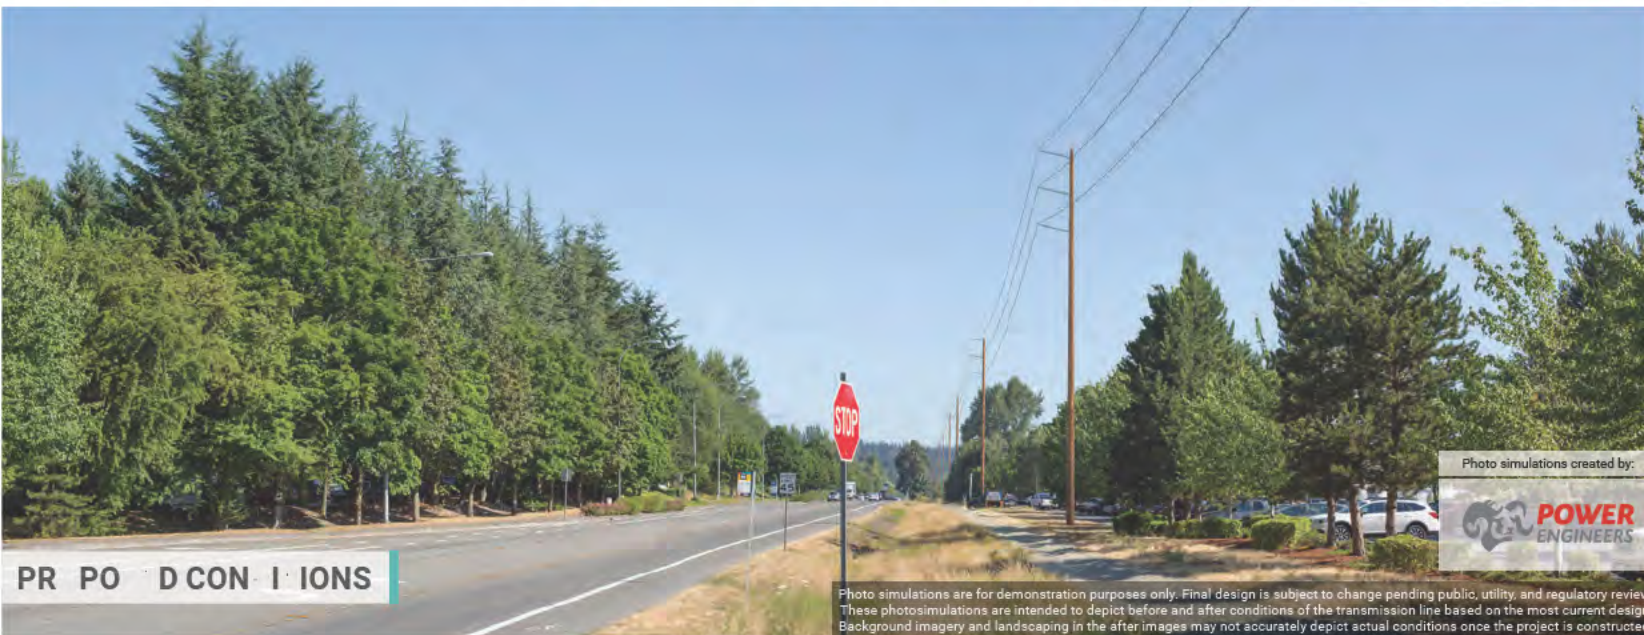
E ISTIN CO D I NS

PR PO D CON I IONS

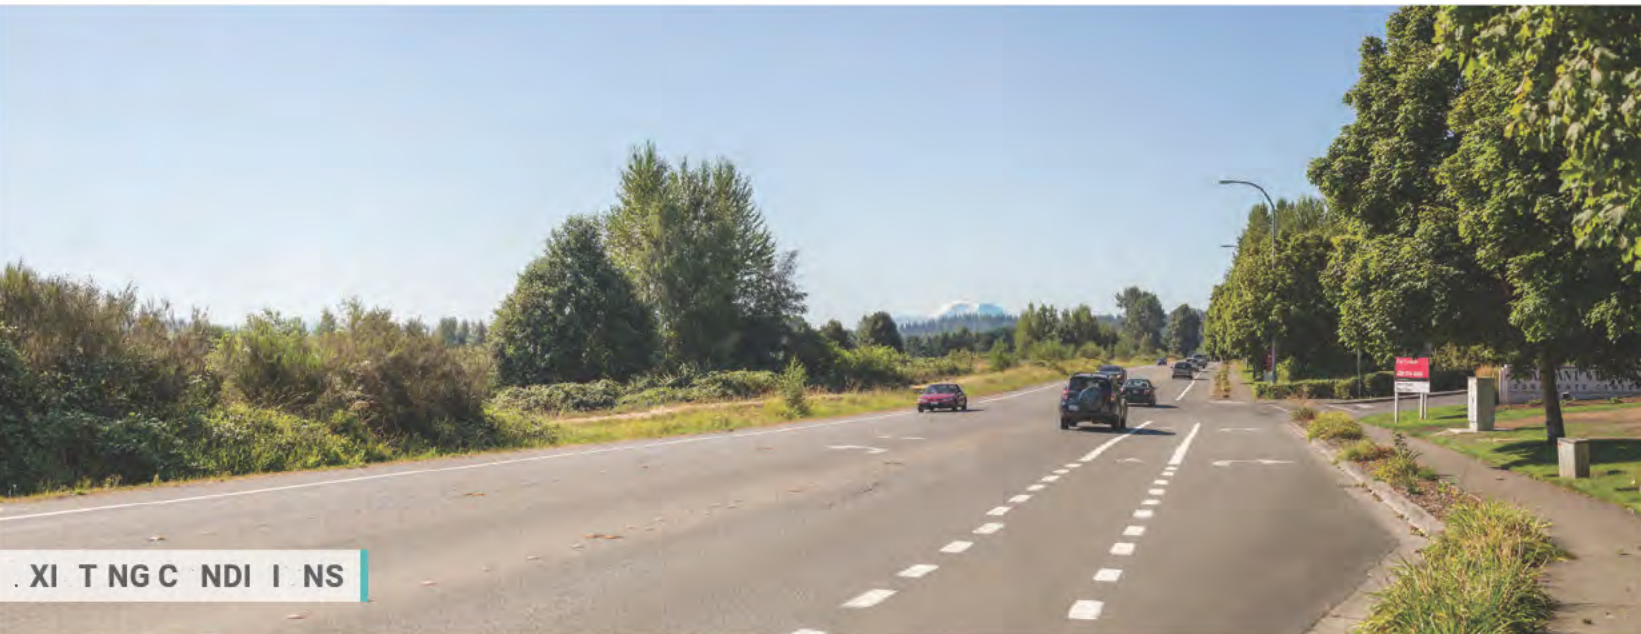
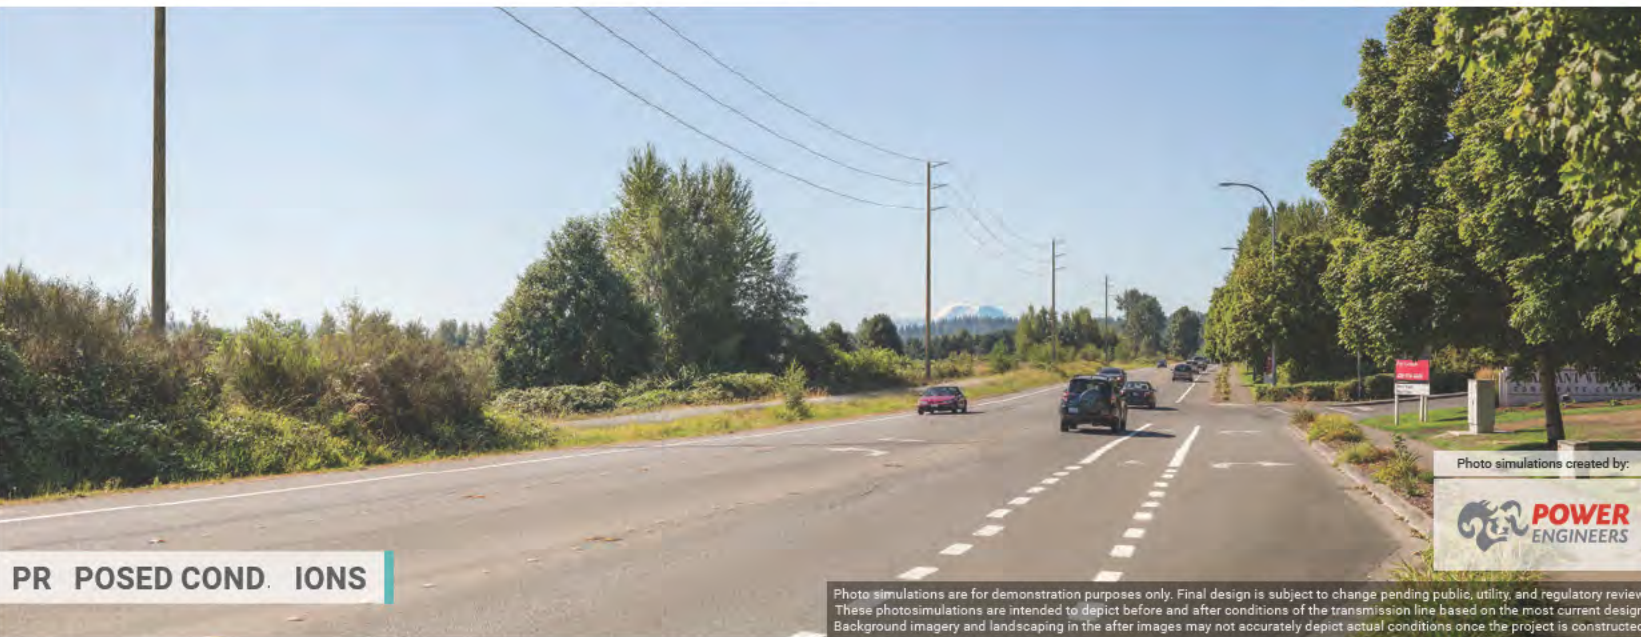
CURRENT CONDITIONS

PROPOSED CONDITIONS

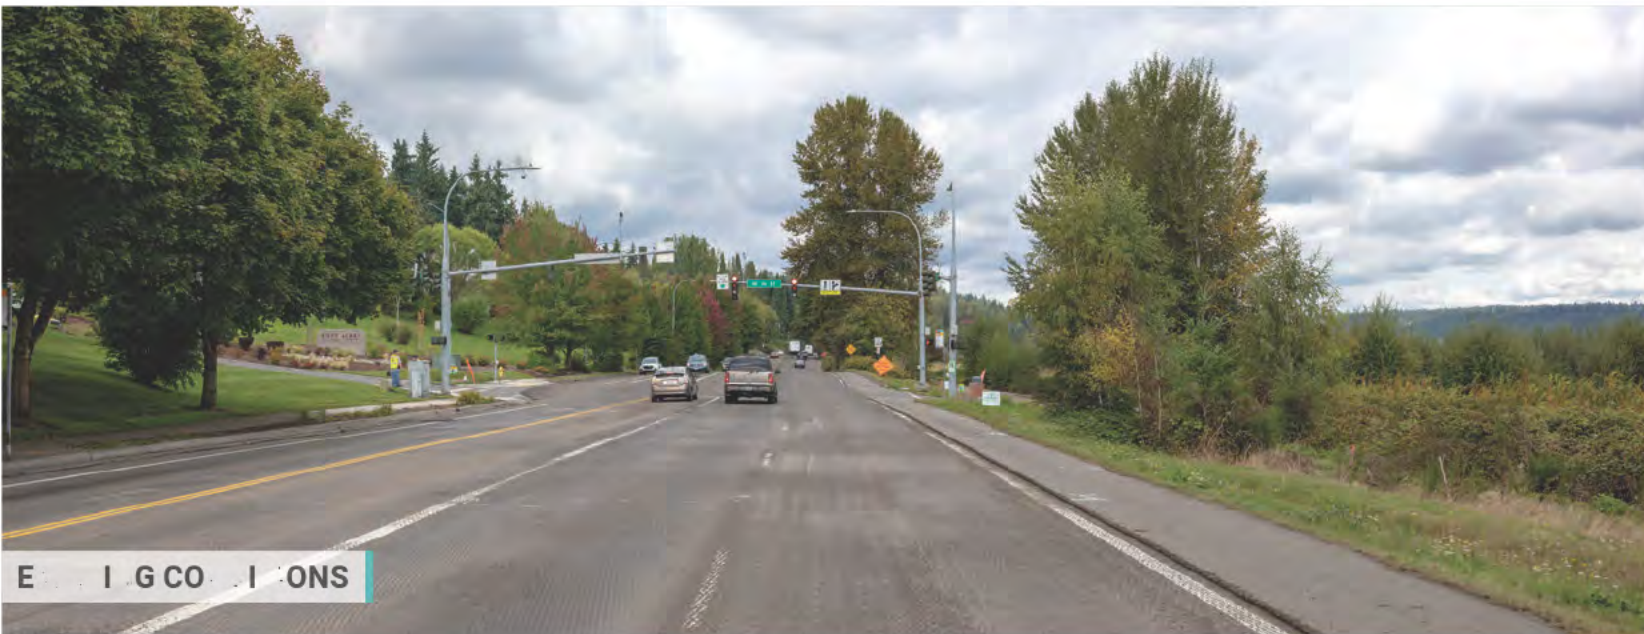
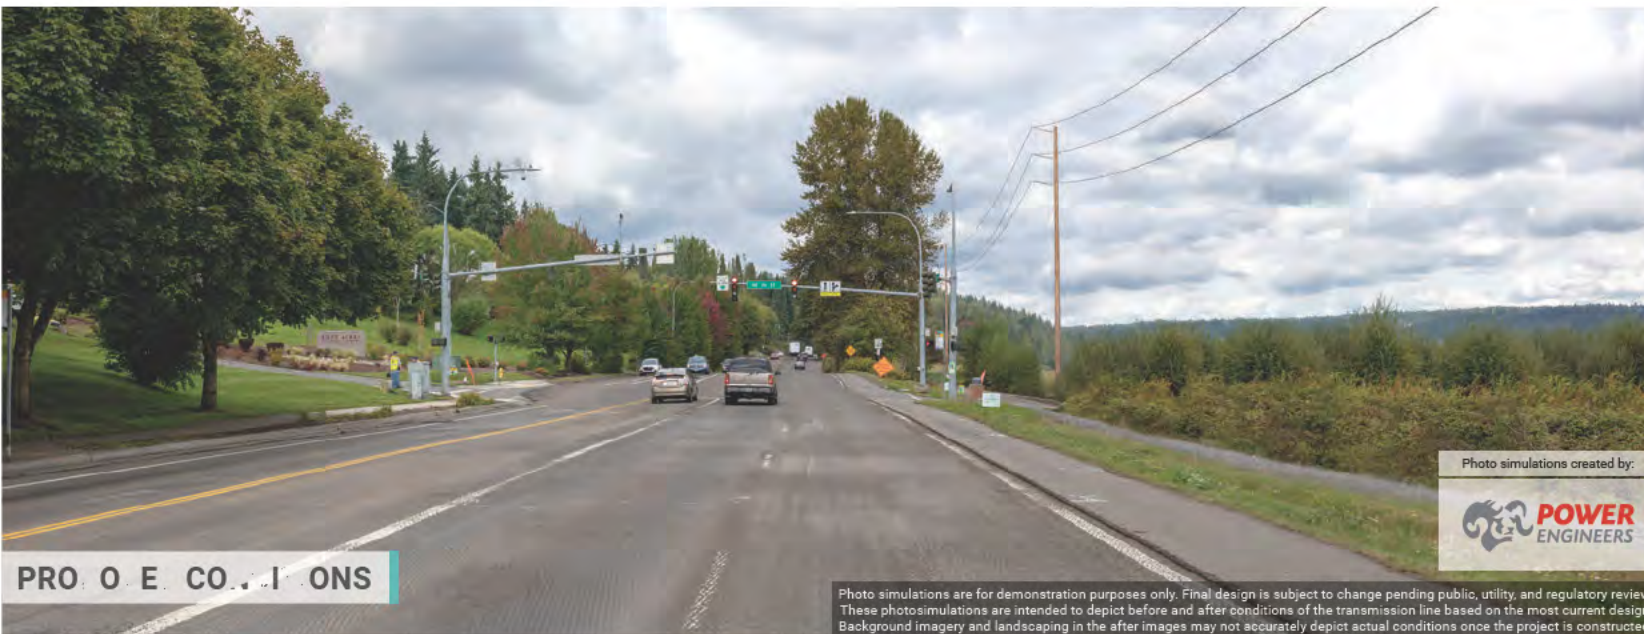
EXISTING CONDITIONS

PROPOSED CONDITIONS

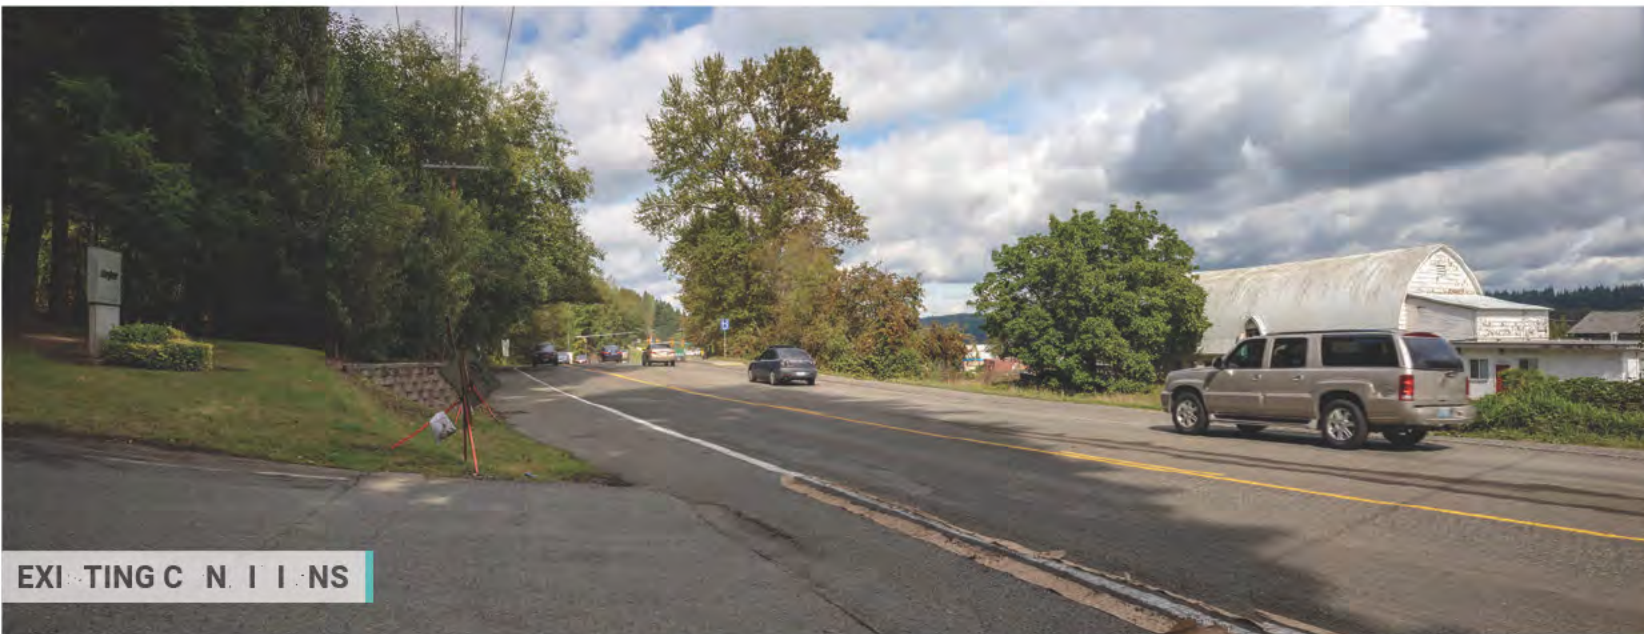
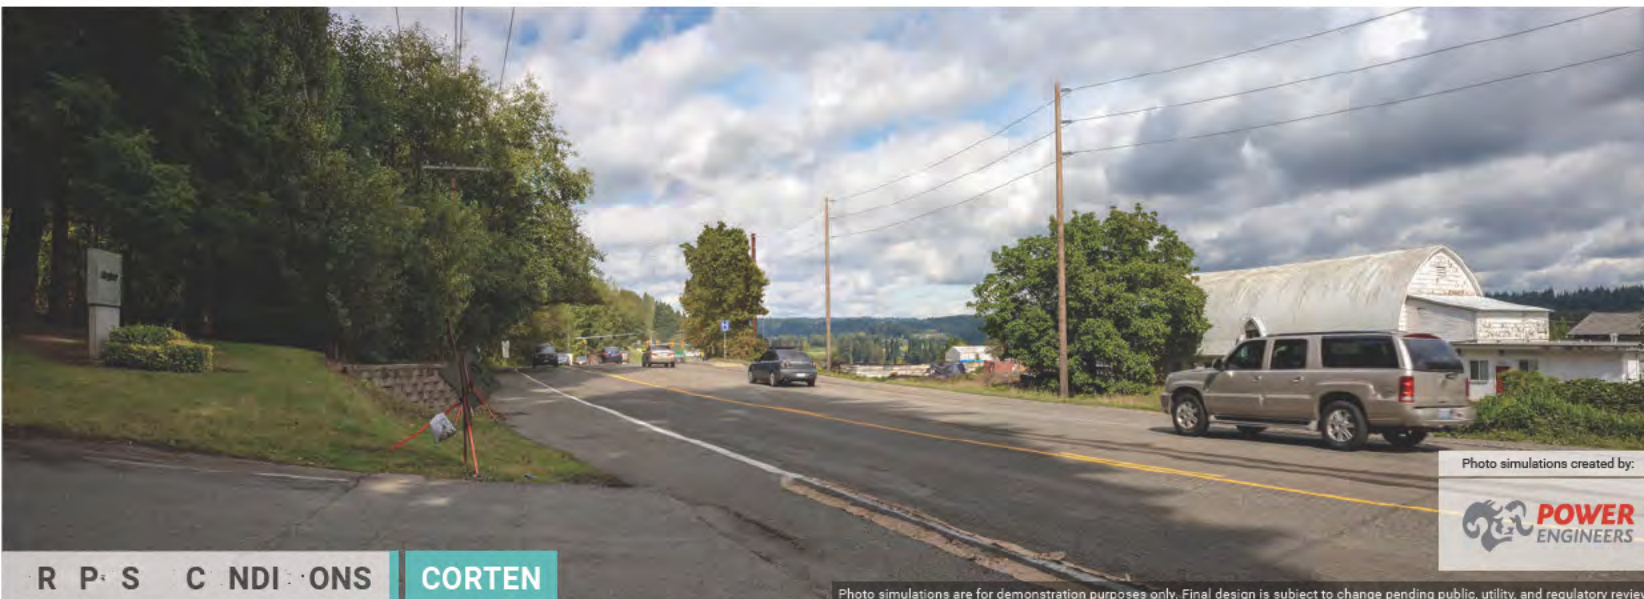
EXISTING CONDITIONS

PROPOSED CONDITIONS

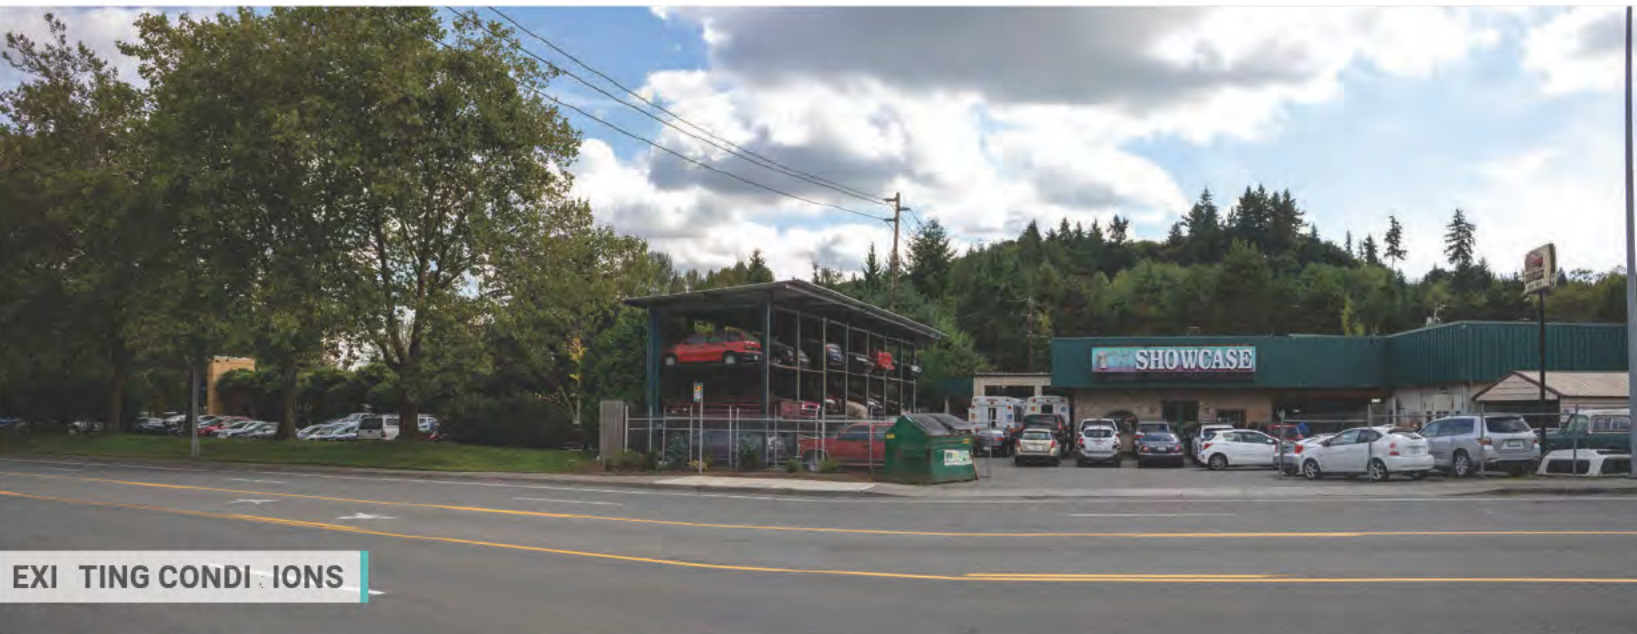
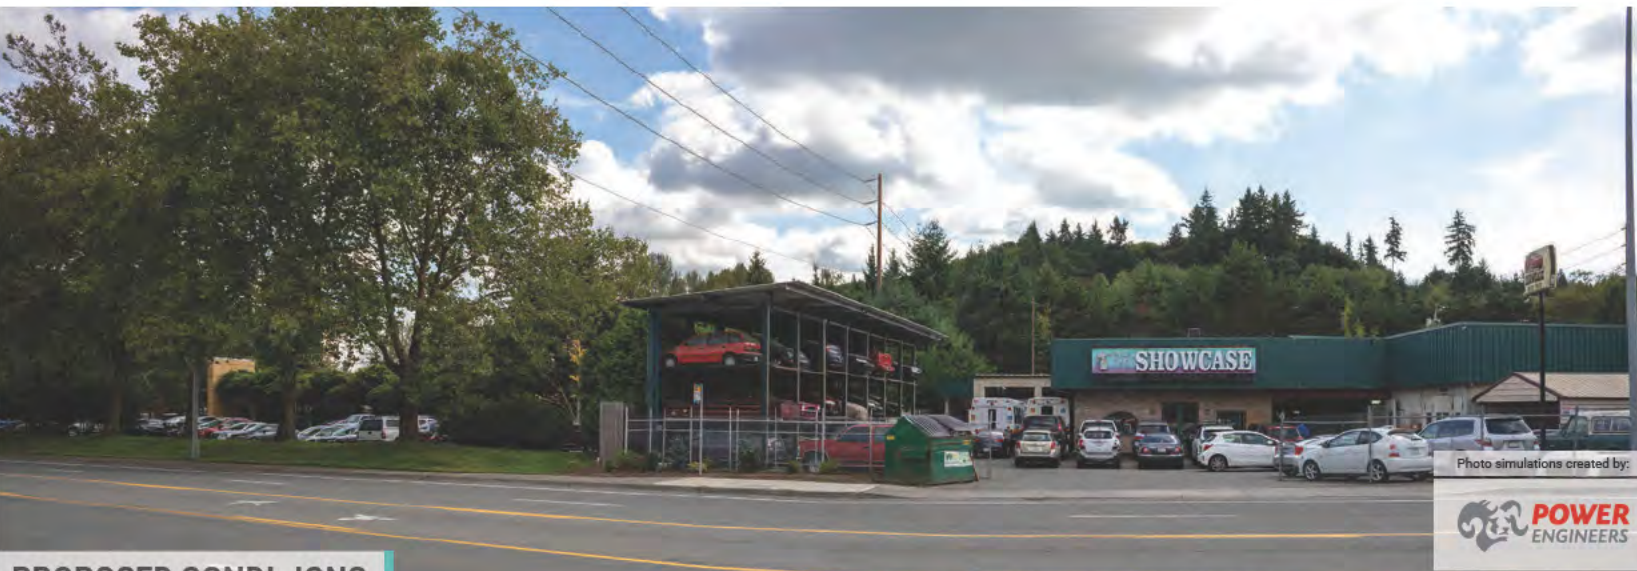
EXISTING CONDITIONS

PROPOSED CONDITIONS

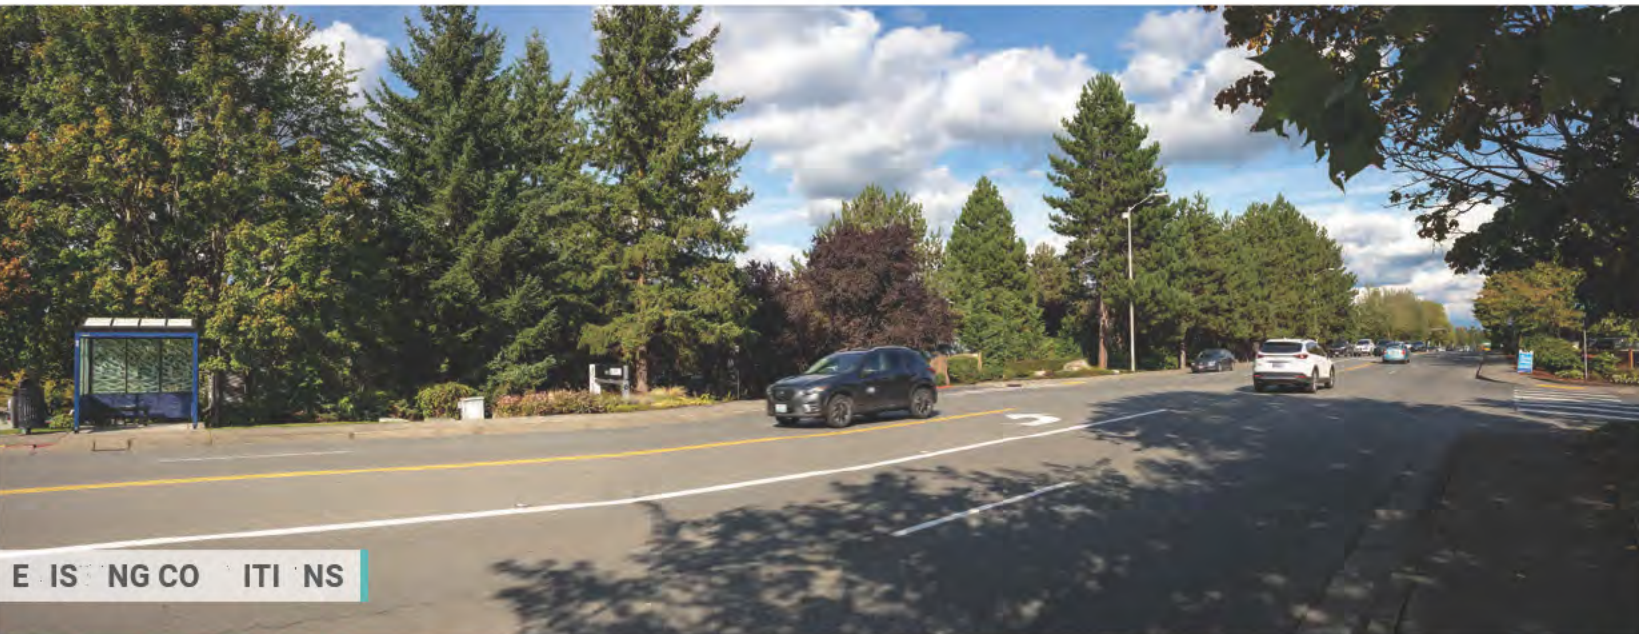
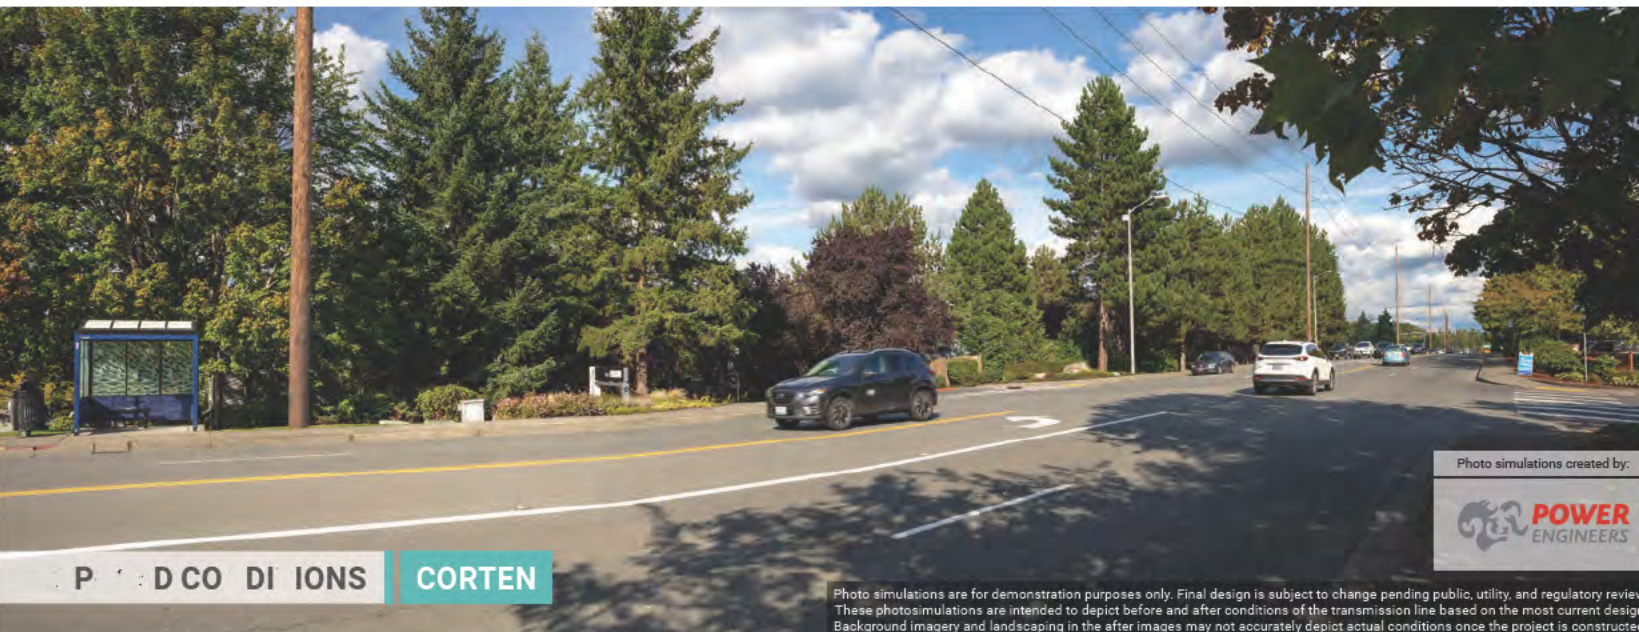
EXISTING CONDITIONS

PROPOSED CONDITIONS CORTEN

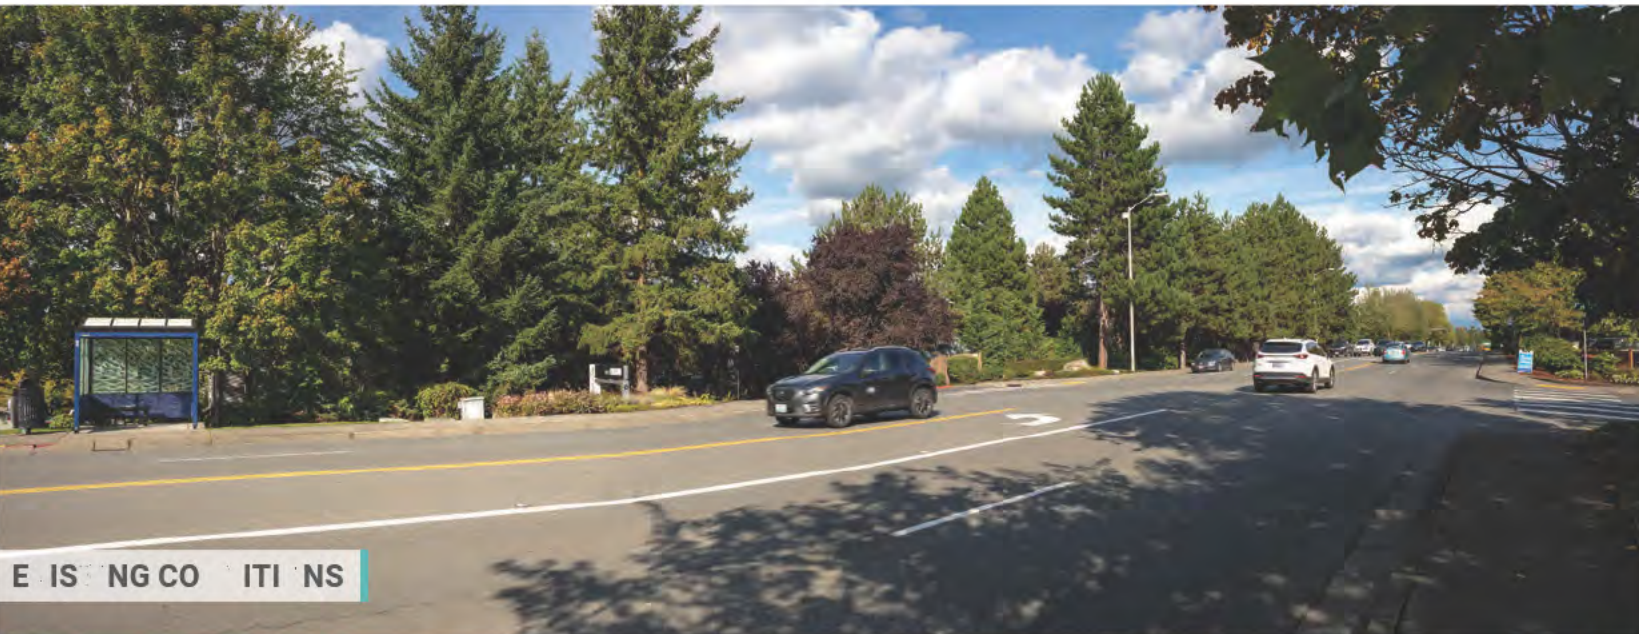
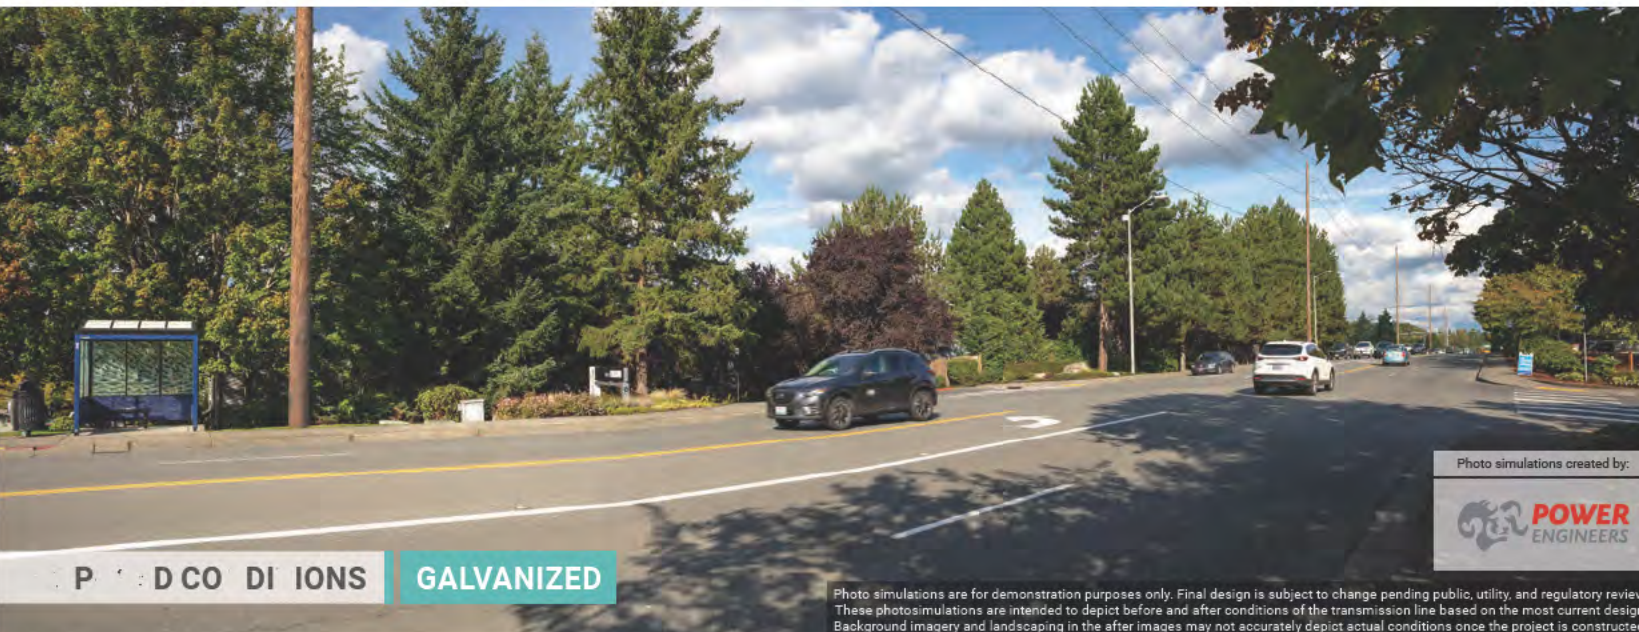
EXISTING CONDITIONS

PROPOSED CONDITIONS GALVANIZED

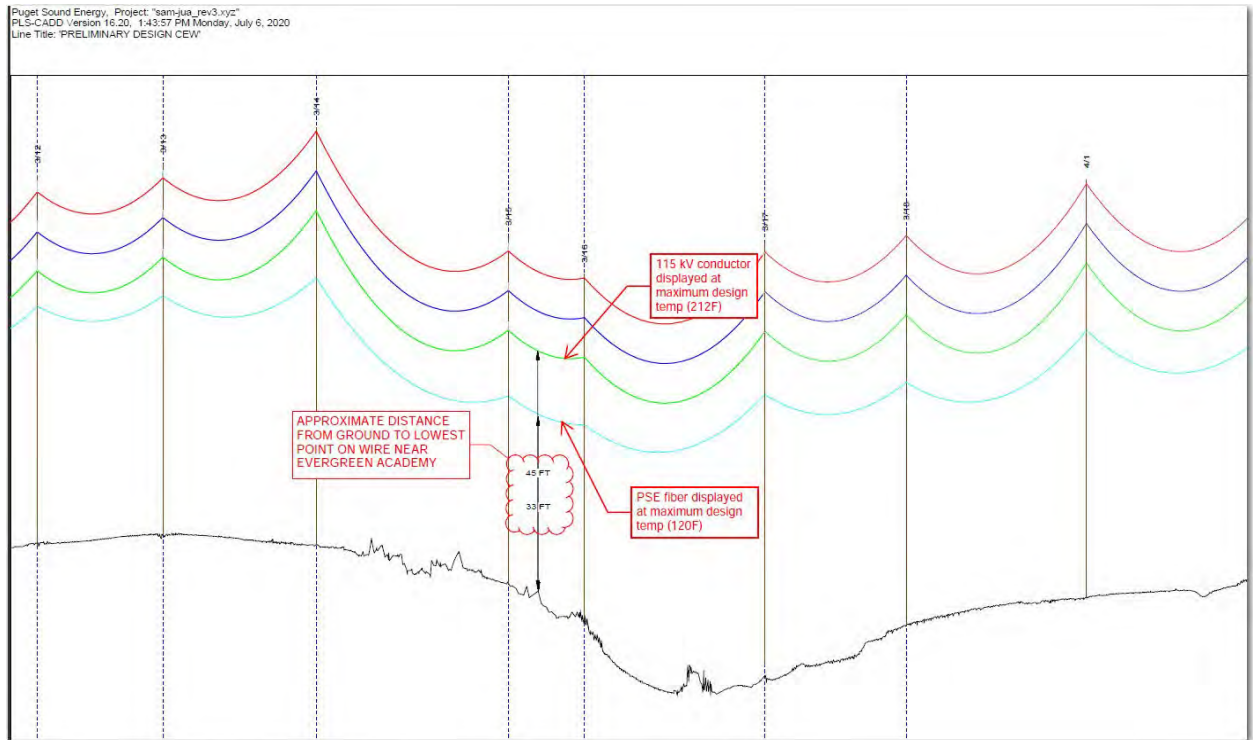
Sammamish Juanita Proposed 115kV Line near Evergreen Academy Normal summer current Loading

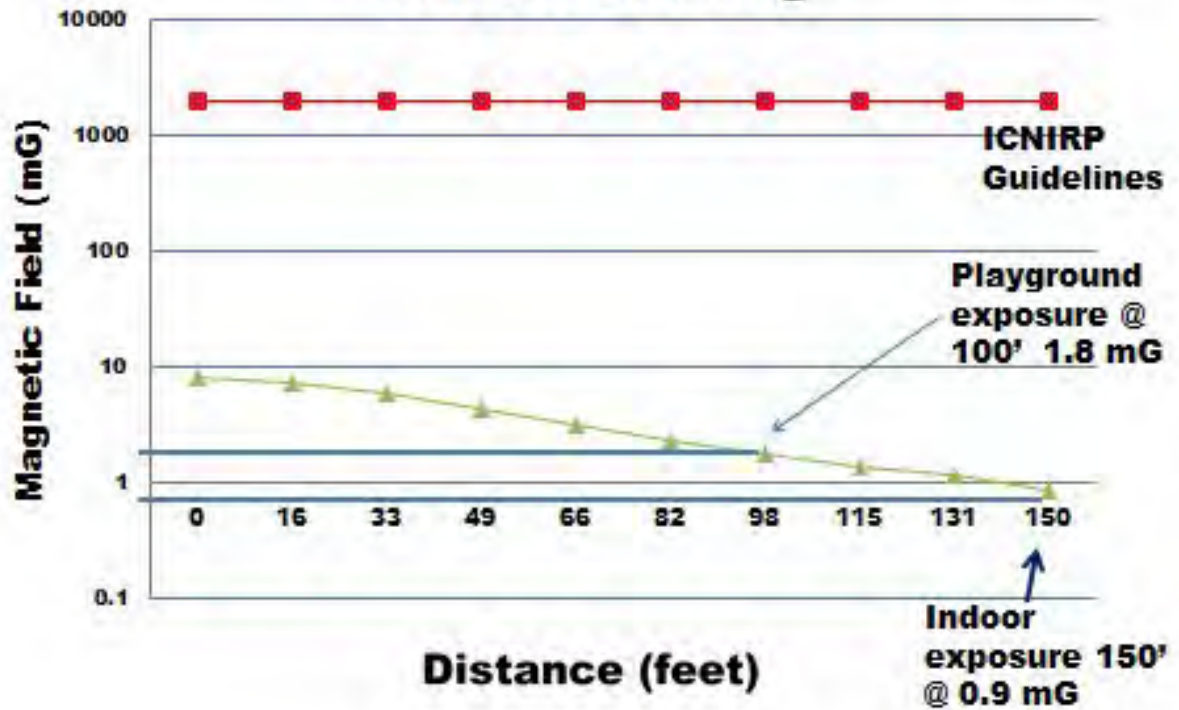
Sammamish Juanita Proposed 115kV Line near Evergreen Academy Normal Winter Loading

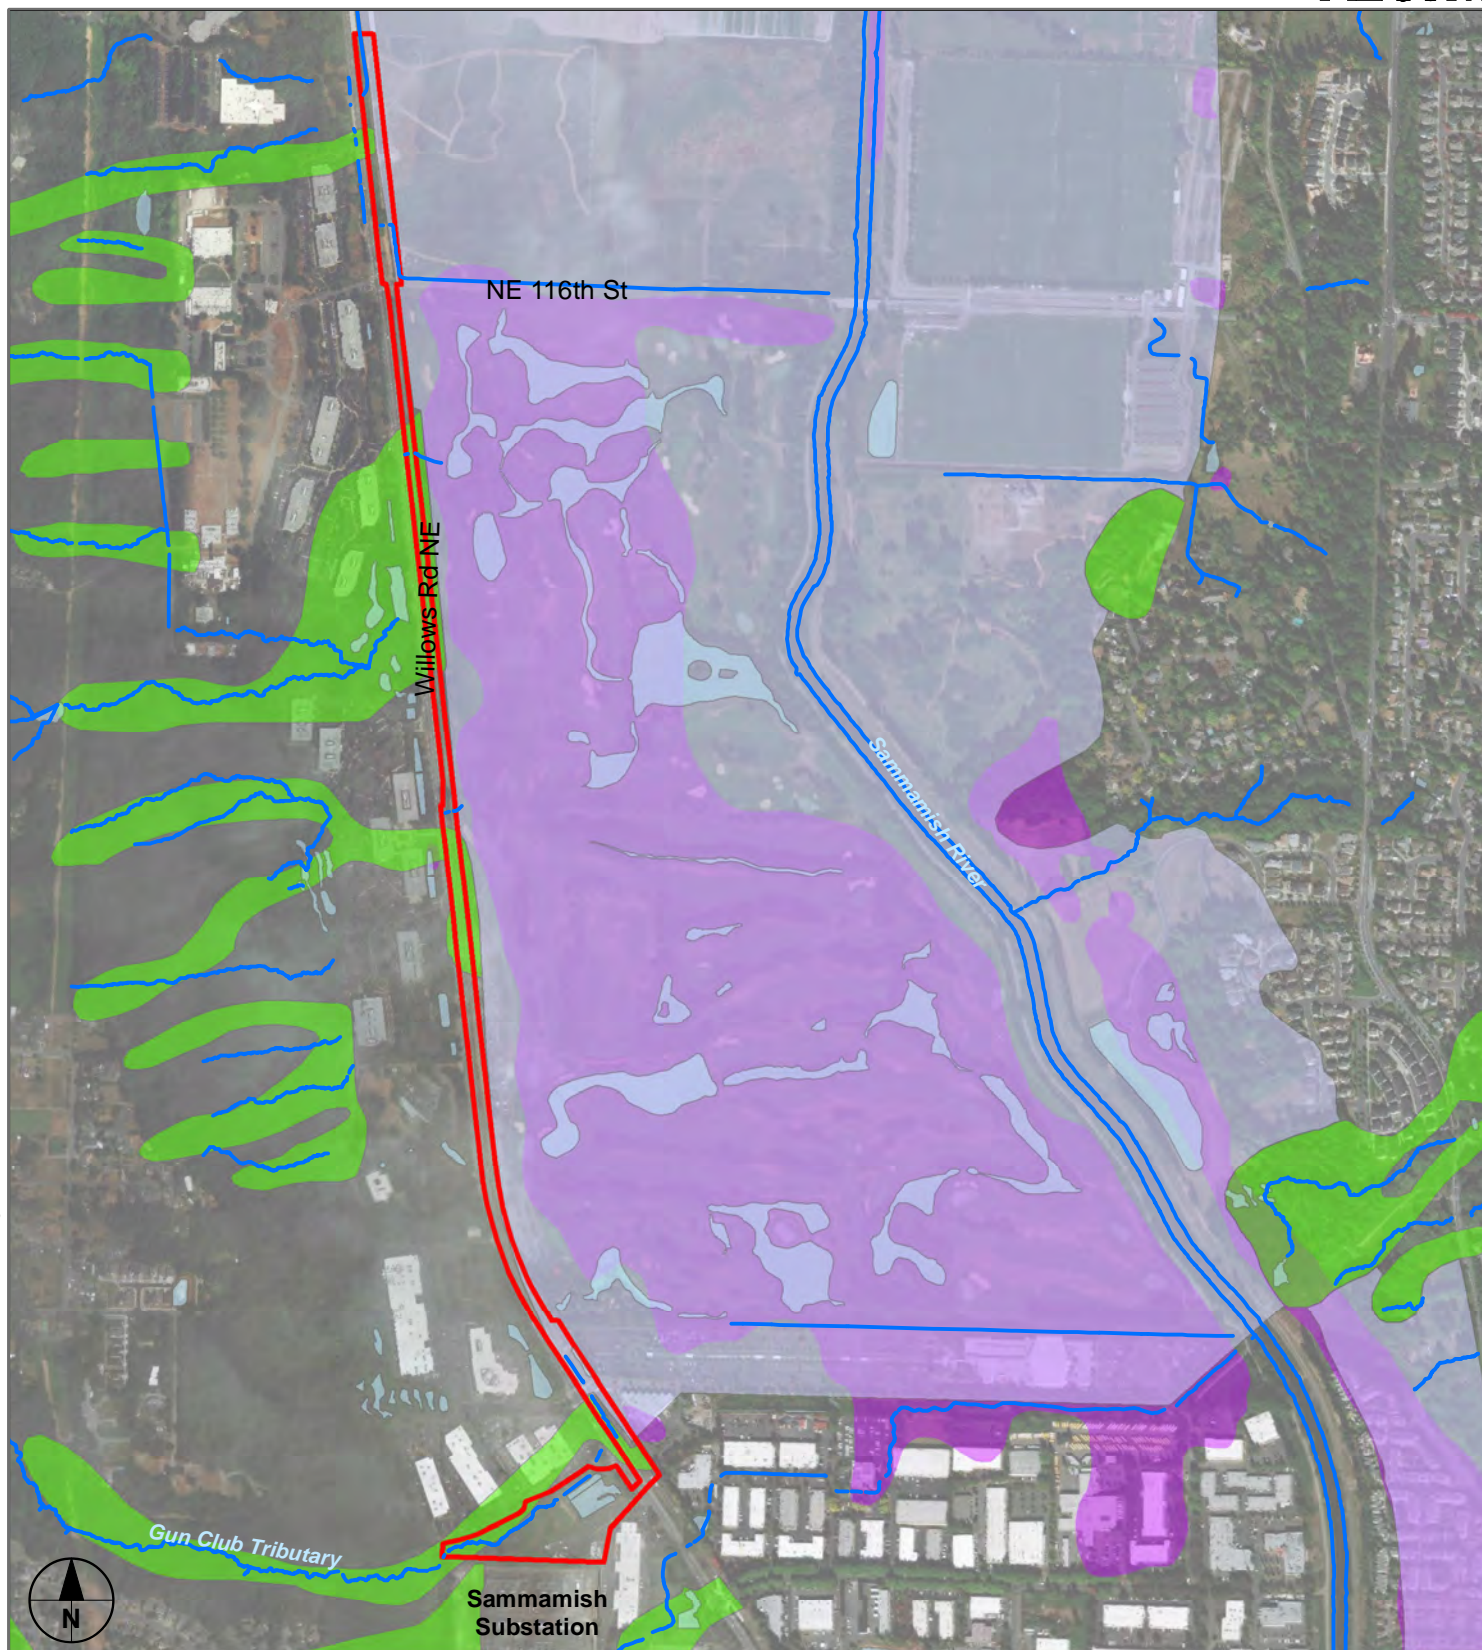
Figure 4-1
**City of Redmond
Wetland and Stream Mapping**

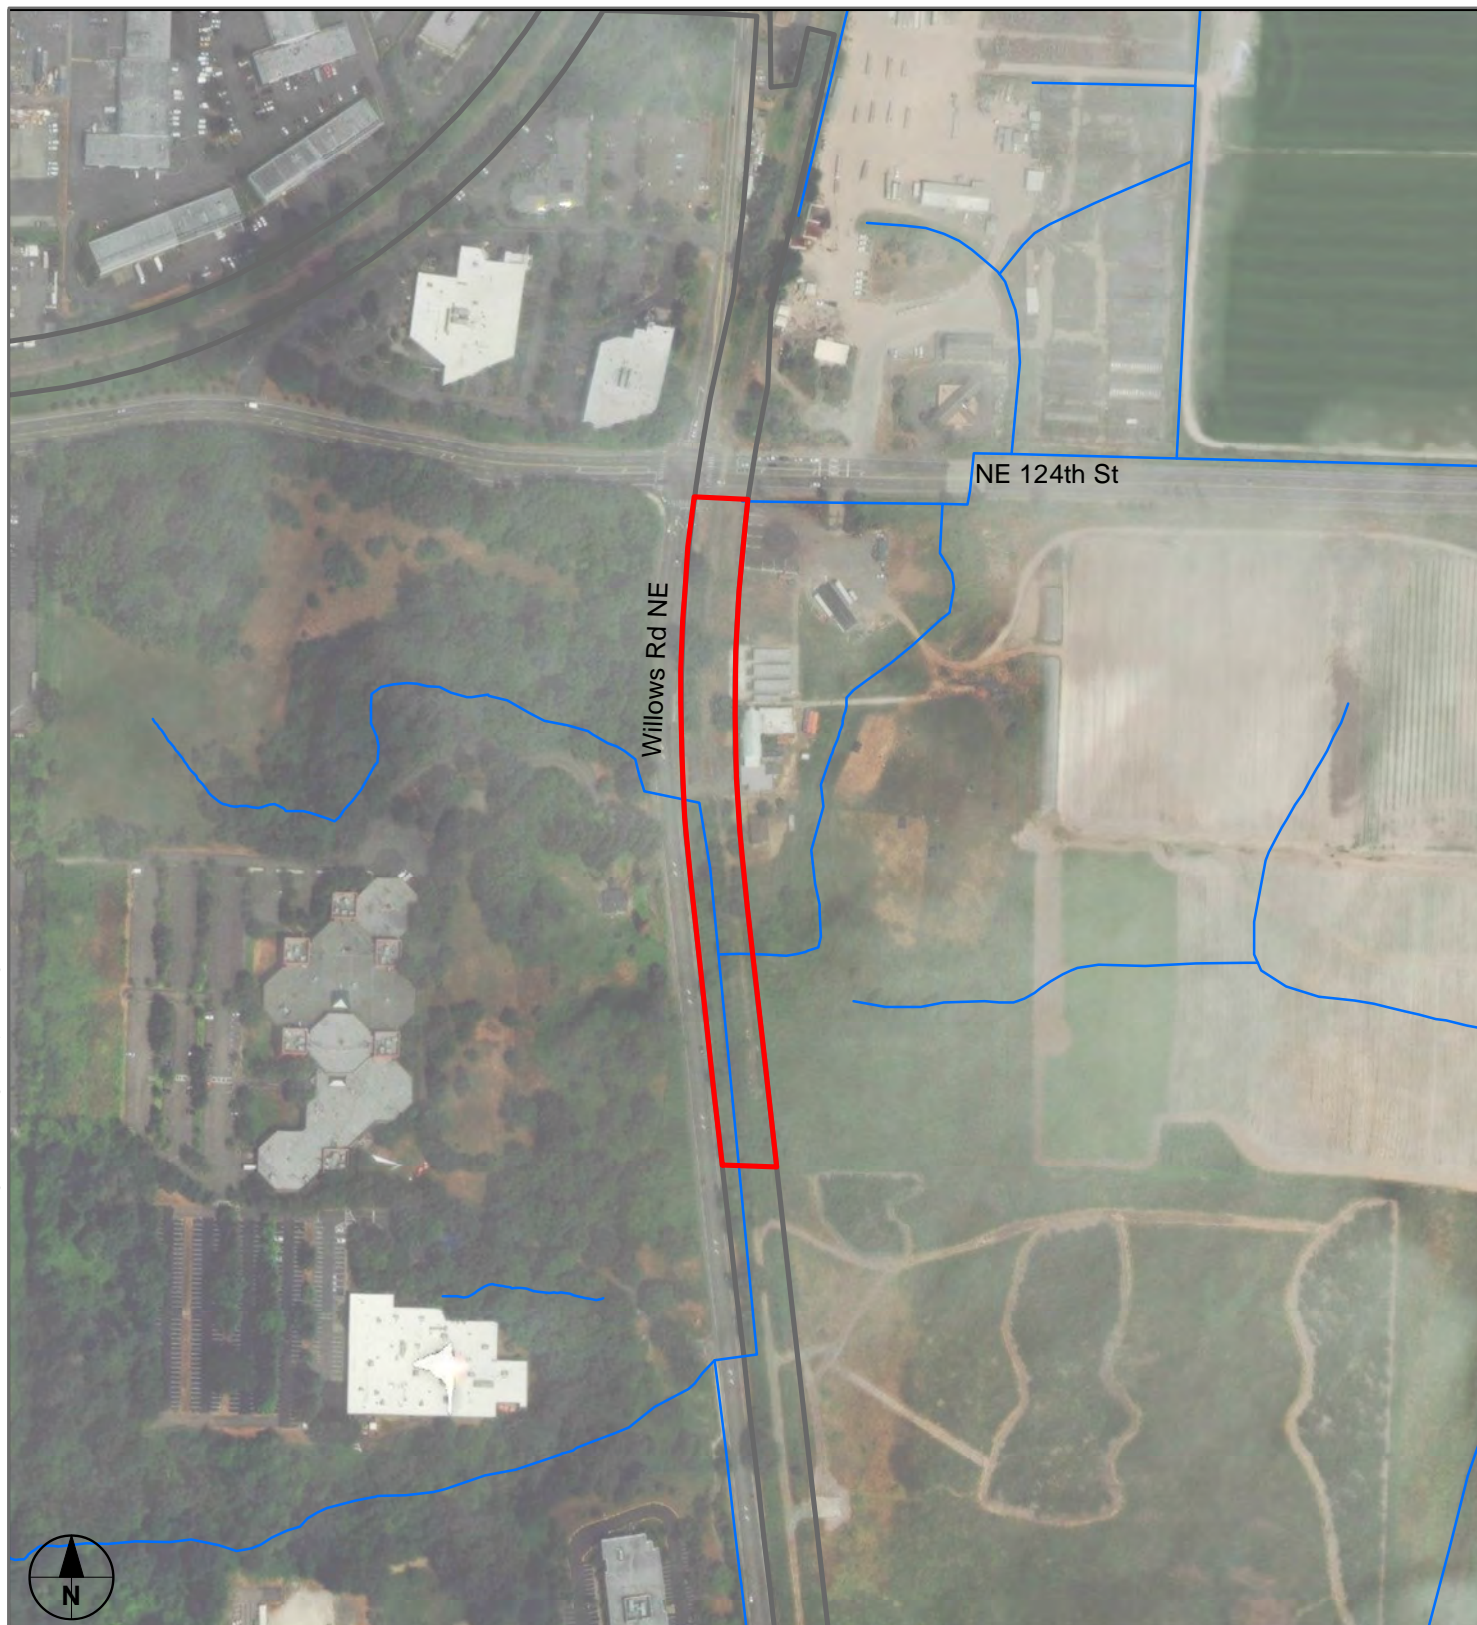
Figure 4-2
**King County
Wetland and Stream Mapping**
