Samamish-Juanita Transmission Line Project

Puget Sound Energy Sammamish-Juanita Transmission Line Project Wetland and Stream Delineation Report Preliminary Draft

**Puget Sound Energy
Samamish-Juanita Transmission Line Wetland Delineation**

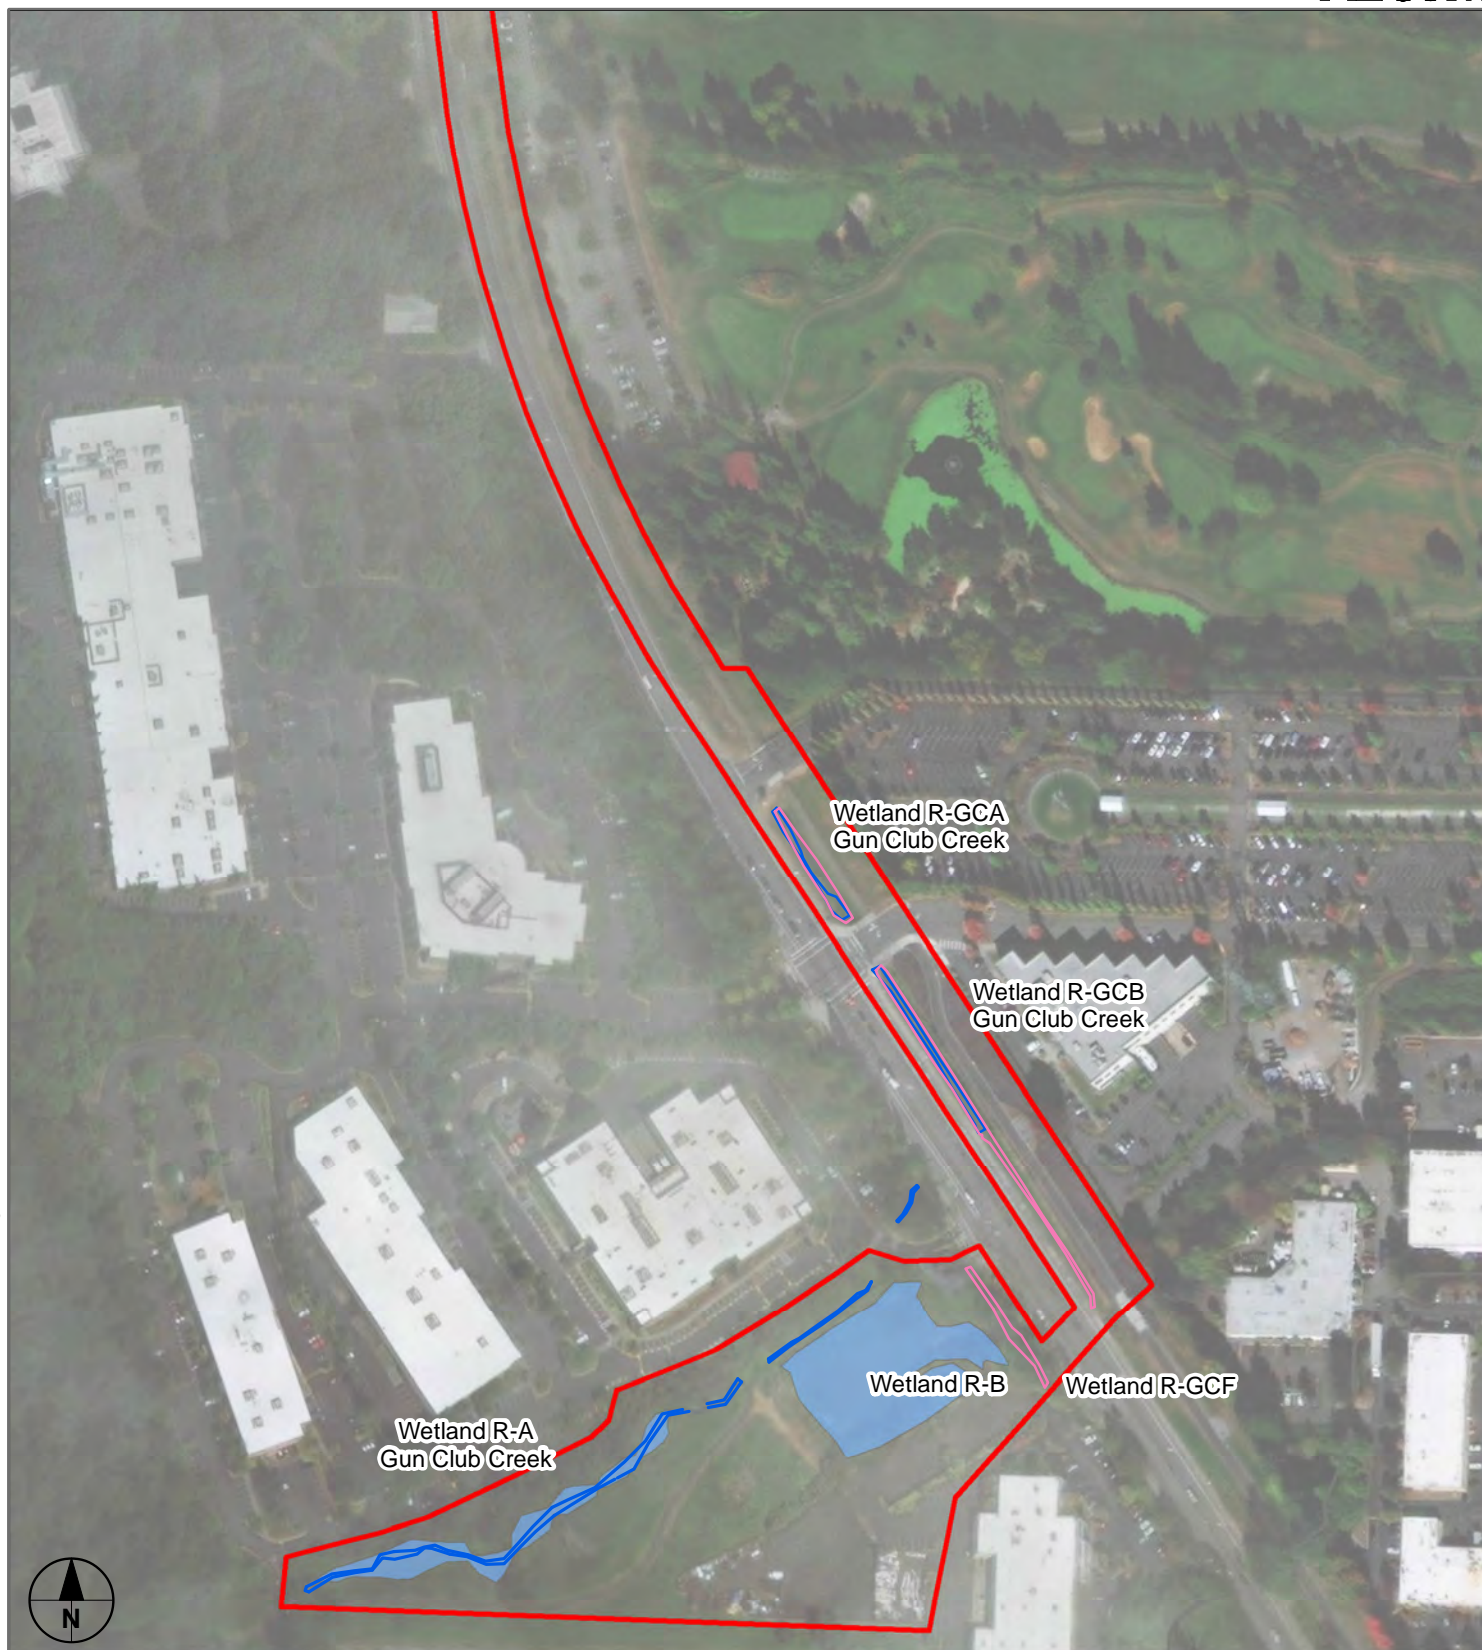
Figure 5-1
**City of Redmond
Overview of Delineated
Wetlands and Streams**
Figure 1 of 2

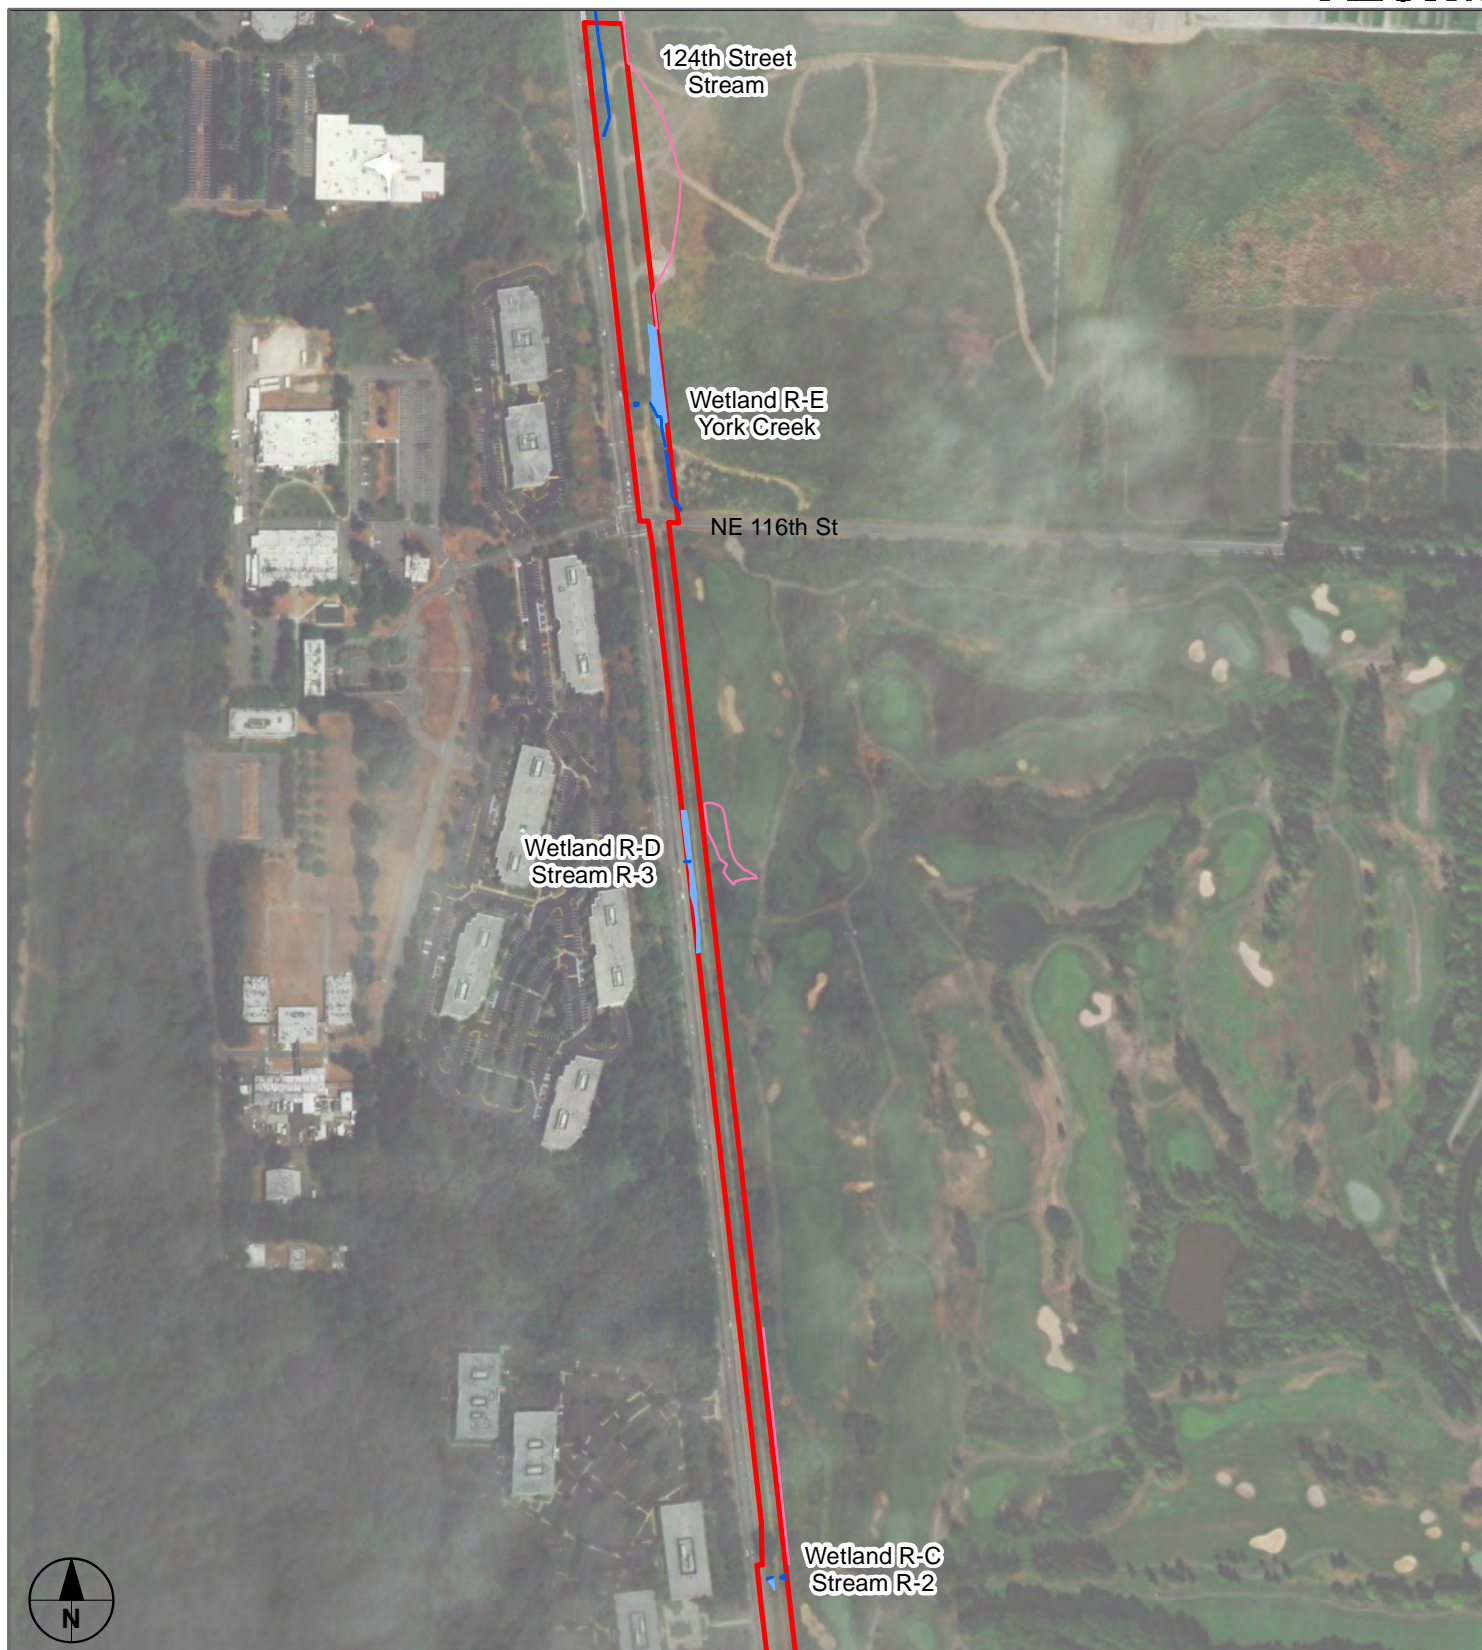
Figure 5-2
**City of Redmond
Overview of Delineated
Wetlands and Streams**
Figure 2 of 2

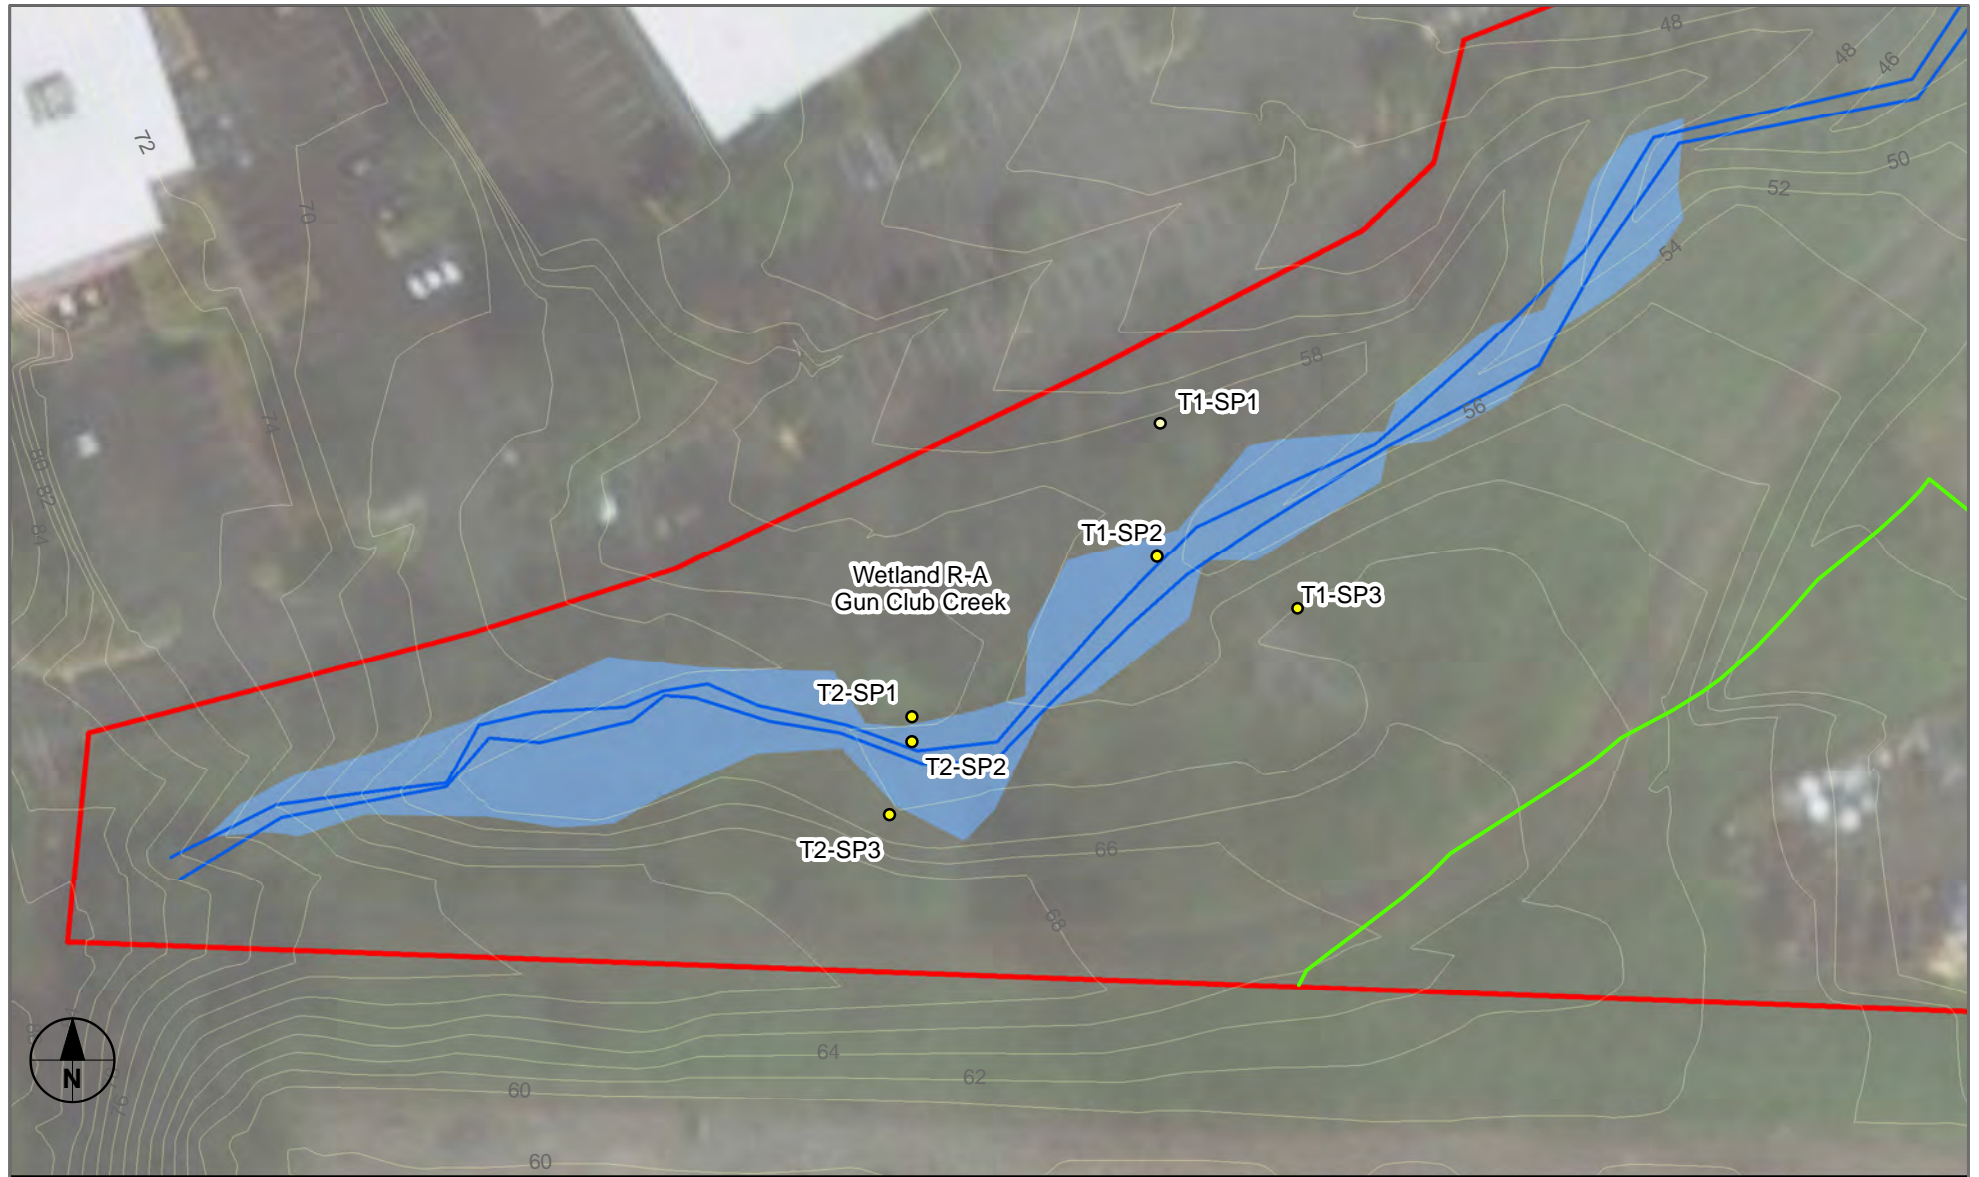
**Figure 5-3
Wetland R-A and
Gun Club Creek**
