**Puget Sound Energy
Samamish-Juanita
Transmission Line
Wetland Delineation**

Kirkland, Washington
Project No.: 60608044

Puget Sound Energy Sammamish-Juanita Transmission Line Project Wetland and Stream Delineation Report Revised Final (February 2021)

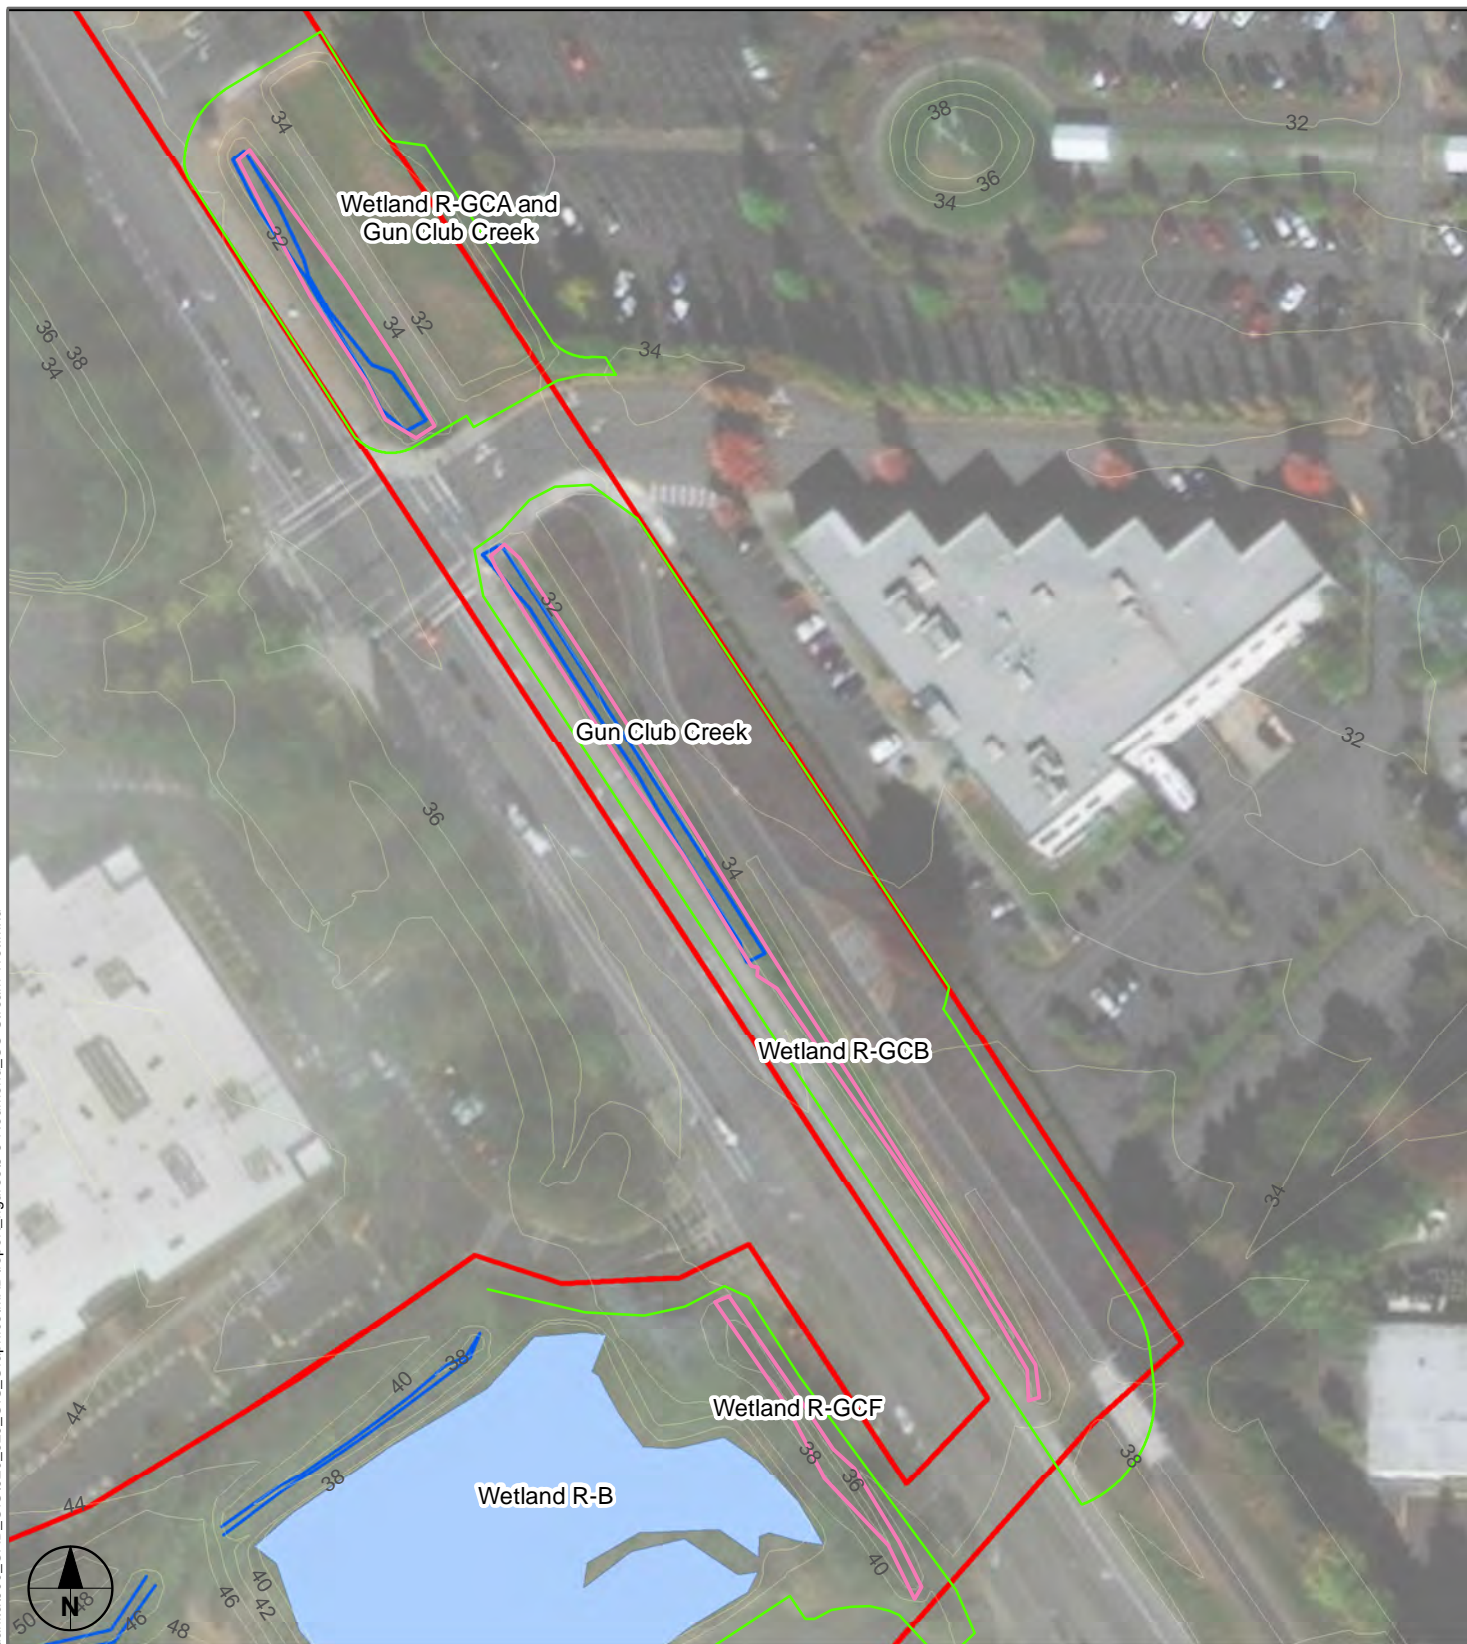
Figure 5-5

**Wetlands R-GCA,
R-GCB, R-GCF
Gun Club Creek**

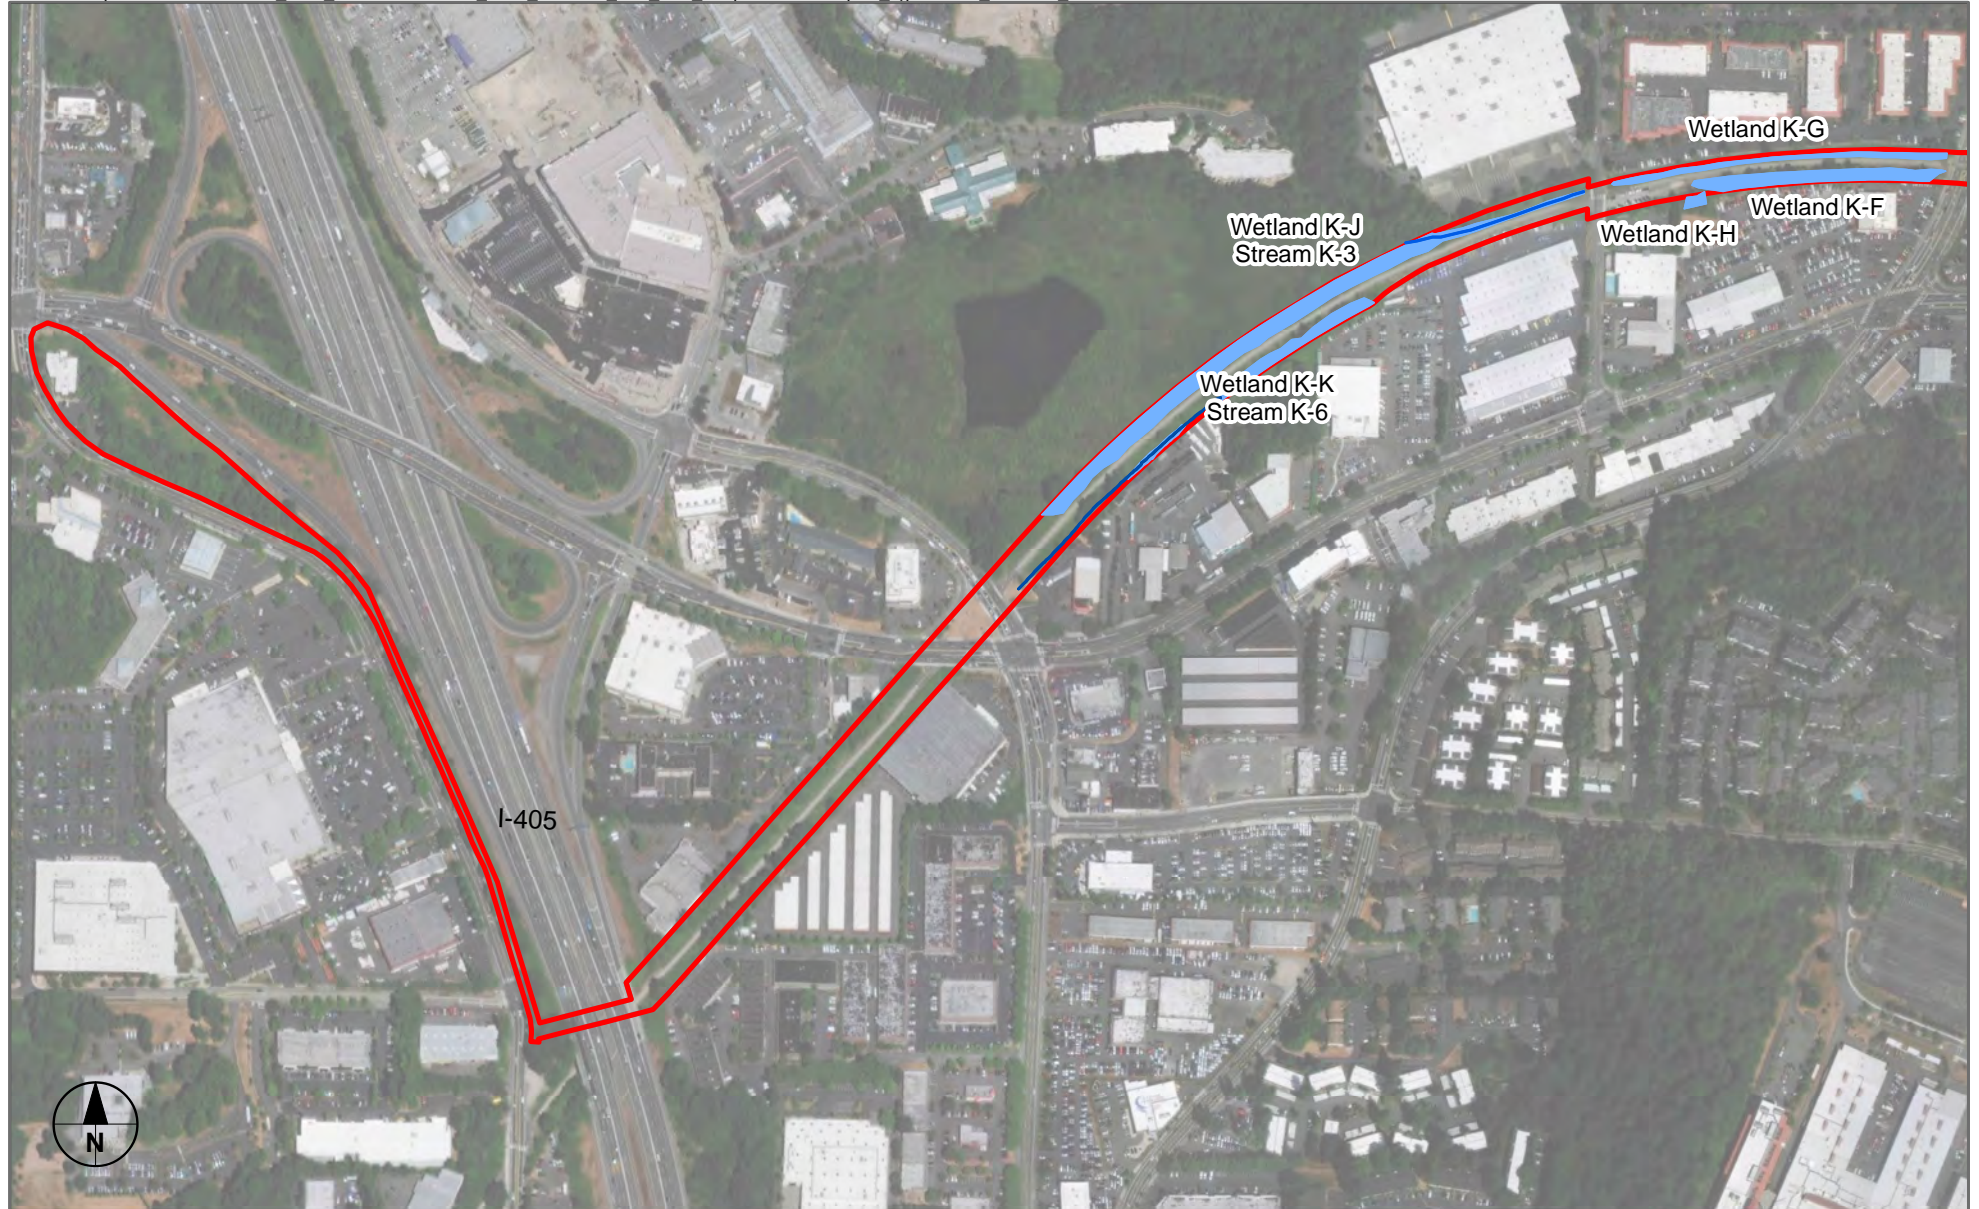
Figure 7-2
City of Kirkland
Overview of Delineated
Wetlands and Streams
2 of 3 957

Ditch K-9 occurs between 120th Avenue NE and the I-405 on-ramp (Figure 7-2). The ditch receives runoff from a culvert from the parking lot and developed areas on the west side of 120th Avenue NE. Water flows down the slope and along the on-ramp. Flow is ephemeral. Scour is present on the slope but there is no OHWM. This ditch is not a relocated tributary or excavated in a tributary.

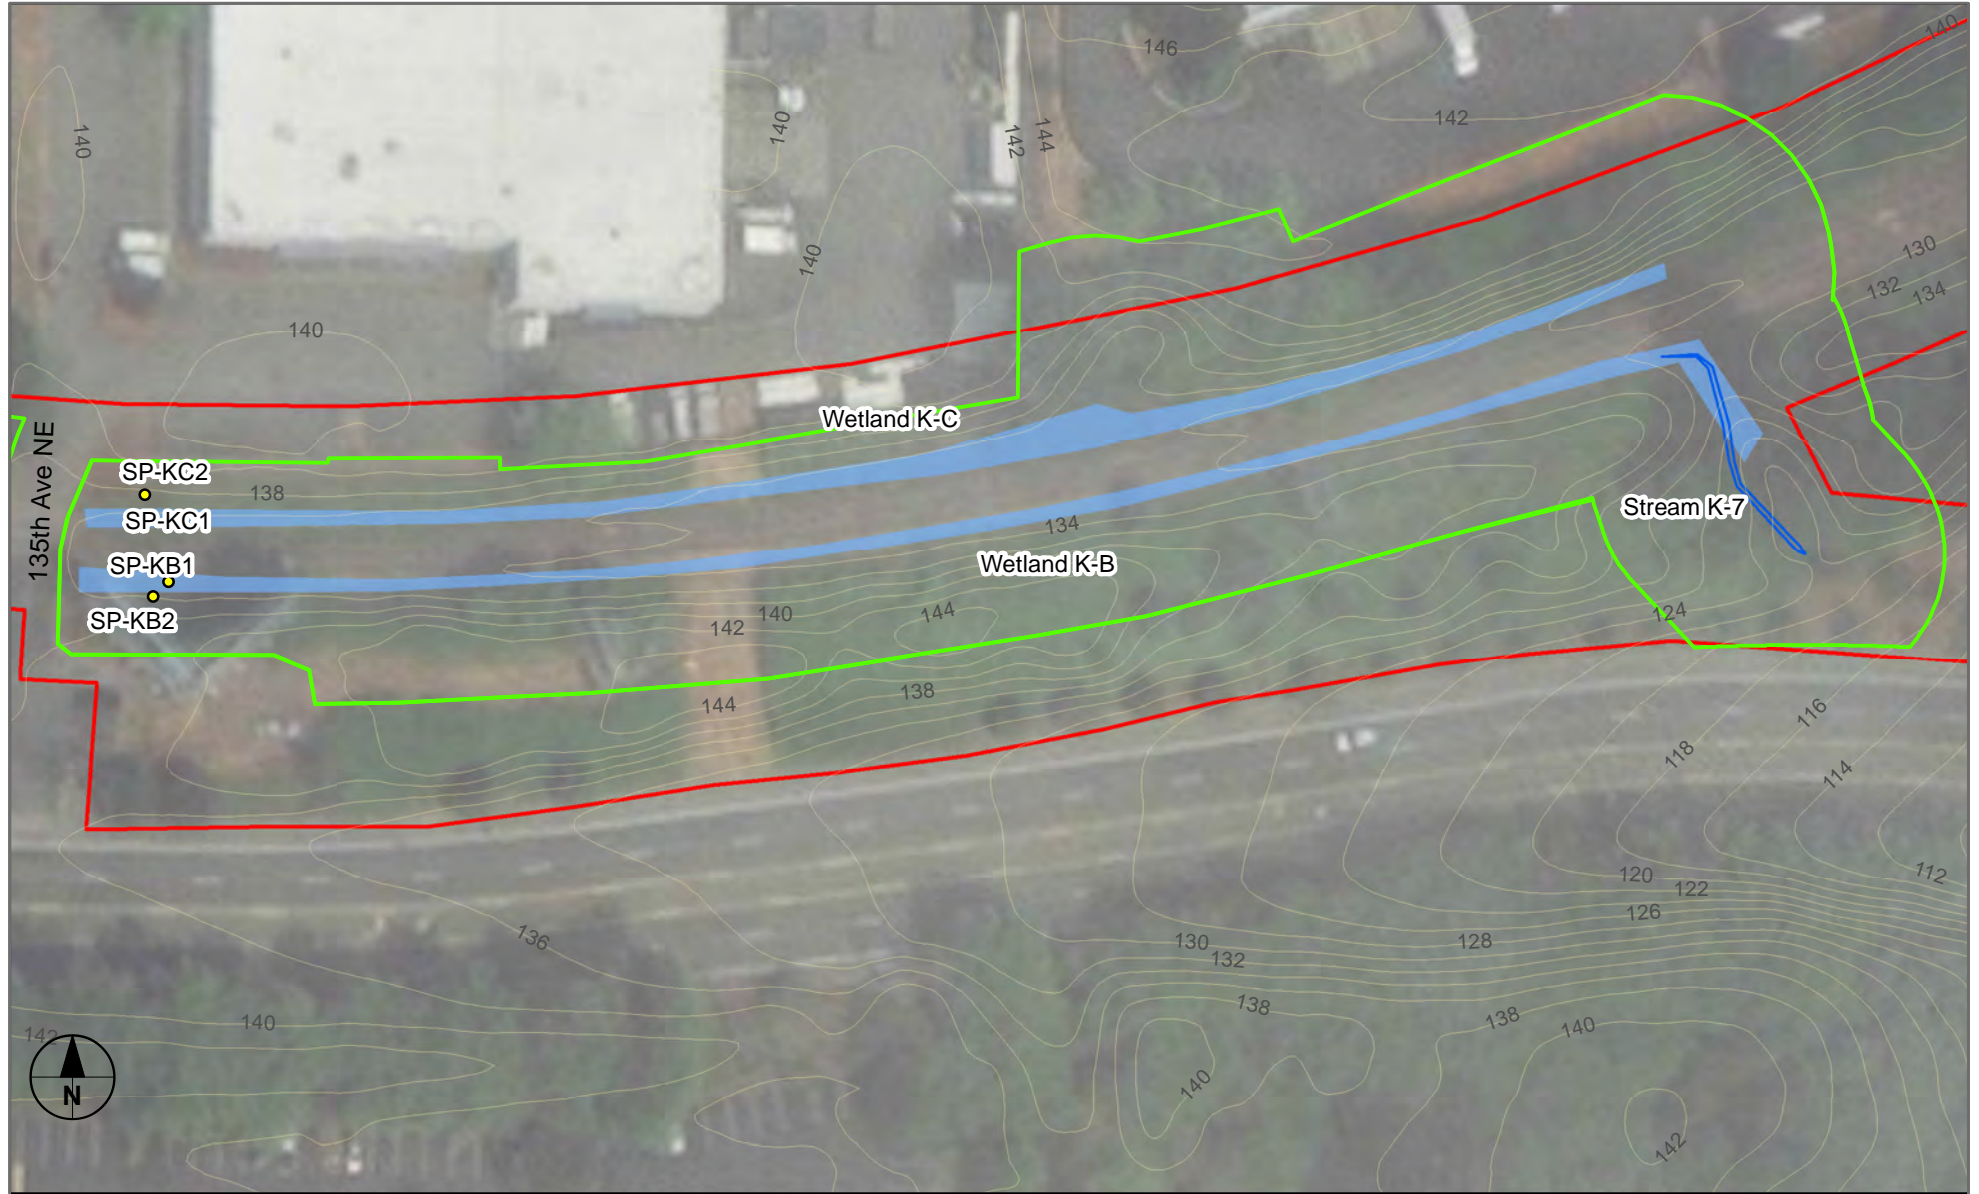
**Figure 7-7
Wetlands K-B
and K-C
and Stream K-7**
962

Soils. The wetland is underlain by railroad rock embankment, primarily cobble more than 4 inches in diameter. For this reason, a soil pit could not be dug to describe soils. A thin layer of silt/sediment covers the rock that has likely been deposited by stormwater runoff. Because of the altered conditions in this wetland, hydric soils were assumed based on standing/ponded water, landform, and vegetation.

Hydrology. During field visits, areas of standing/ponded water were observed, but there was no active flow of water within the ditch. At Sample Plot SP-KB1, 4 inches of standing water were present, and soils were saturated to the surface. Therefore, this wetland meets wetland hydrology indicators Surface Water (A1), High Water Table (A2), and Saturation (A3).

Soils. Similar to Wetland K-B, wetland K-C is underlain by rock from the railroad embankment, primarily cobble more than 4 inches or more in diameter. For this reason, a soil pit could not be dug to describe soils. A layer of silt/sediment covers the rock that has likely been deposited by stormwater runoff from adjacent steep slopes. Because of the altered conditions in this wetland, hydric soils were assumed based on standing/ponded water, landform, and vegetation.

Hydrology. Standing water was observed within the ditch during the site visit. At wetland Sample Plot SP-KC1, 4 inches of standing water were present, and soils were saturated to the surface. Therefore, this wetland meets wetland hydrology indicators Surface Water (A1), High Water Table (A2), and Saturation (A3).

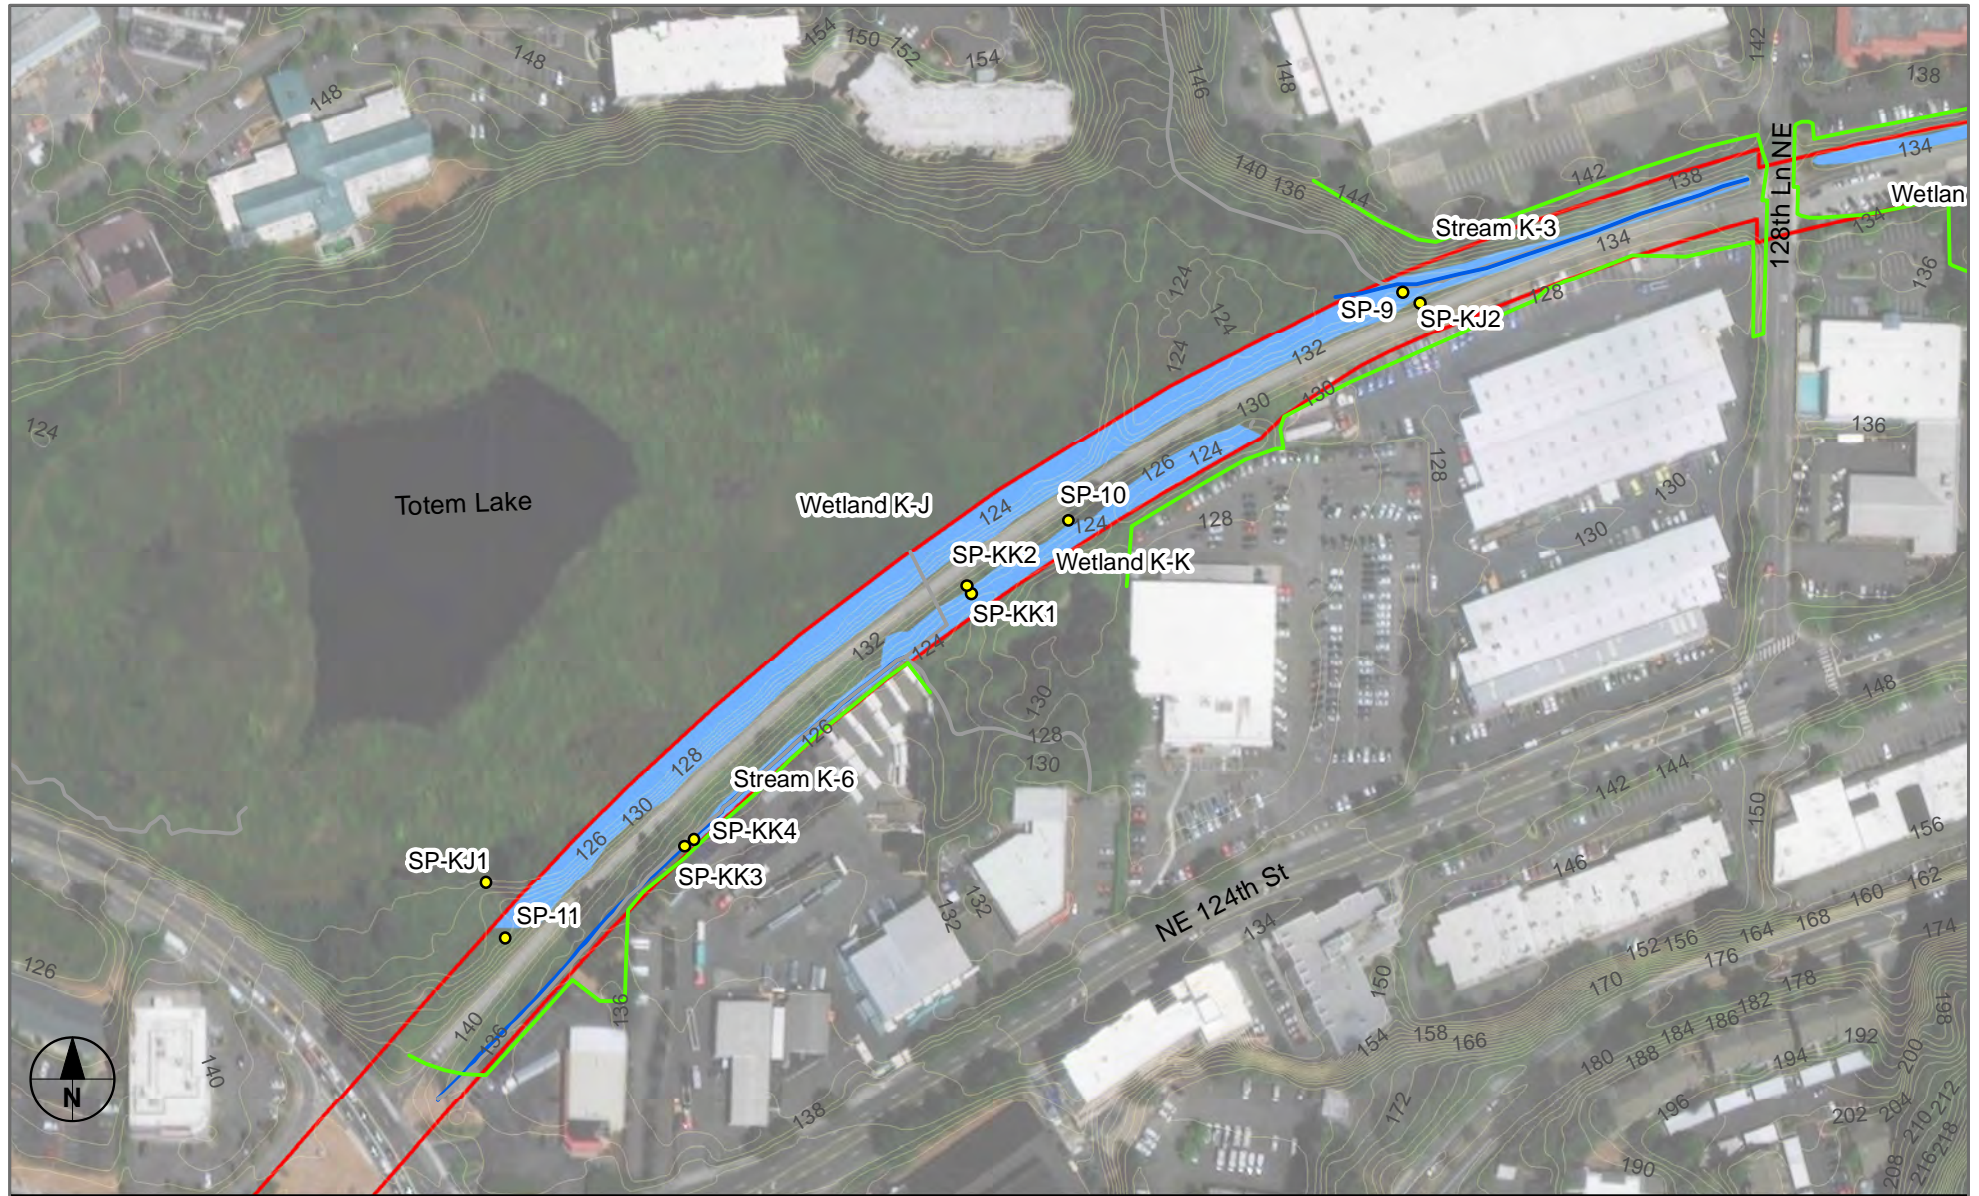
Figure 7-9

**Wetlands K-F,
K-G, and K-H**

Wetland K-F is a linear, 0.4-acre PEM/PFO depressional wetland located south of the trail, just east of 132nd Place NE (Figure 7-9). It receives stormwater runoff from adjacent developed areas, and functions as a ditch, similar to other wetlands in the area. Based on the rating form, it is a Category III wetland (scoring 17 points). It provides moderate levels of water quality and hydrologic functions, and low levels of habitat functions. It has high structural diversity because of the multi-layer forested component, but low interspersions between classes. It also has few habitat features and no surrounding buffer.
