CERTIFICATE CONCERNING DESIGN AND CONSTRUCTION OF ELECTRONIC SPEED MEASURING DEVICES

Speed Validation Report

Client: Kirkland, WA

PREVENTIVE MAINTENANCE CHECKLIST

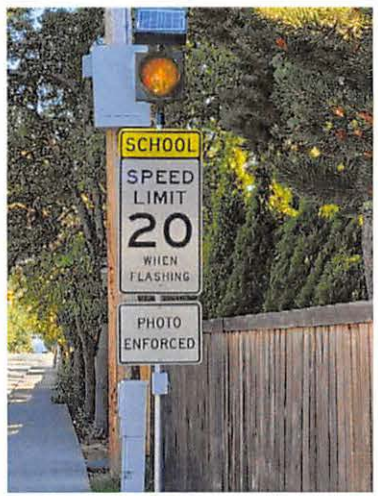
5.1. Enclosure:

5. Take (and attach) photo of enclosure, pole, and photo enforcement sign(s) for presence and damage.
