CERTIFICATE CONCERNING DESIGN AND CONSTRUCTION OF ELECTRONIC SPEED MEASURING DEVICES

Speed Validation Report
Client: Kirkland, WA

Preventive Maintenance Checklist

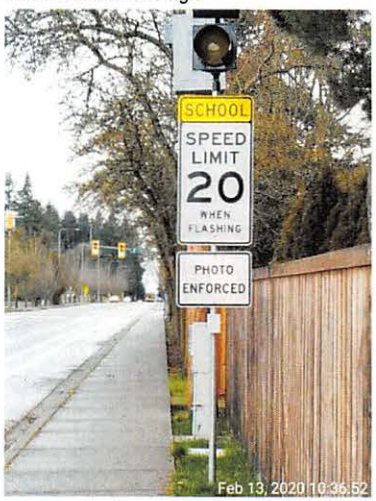
Clean enclosure

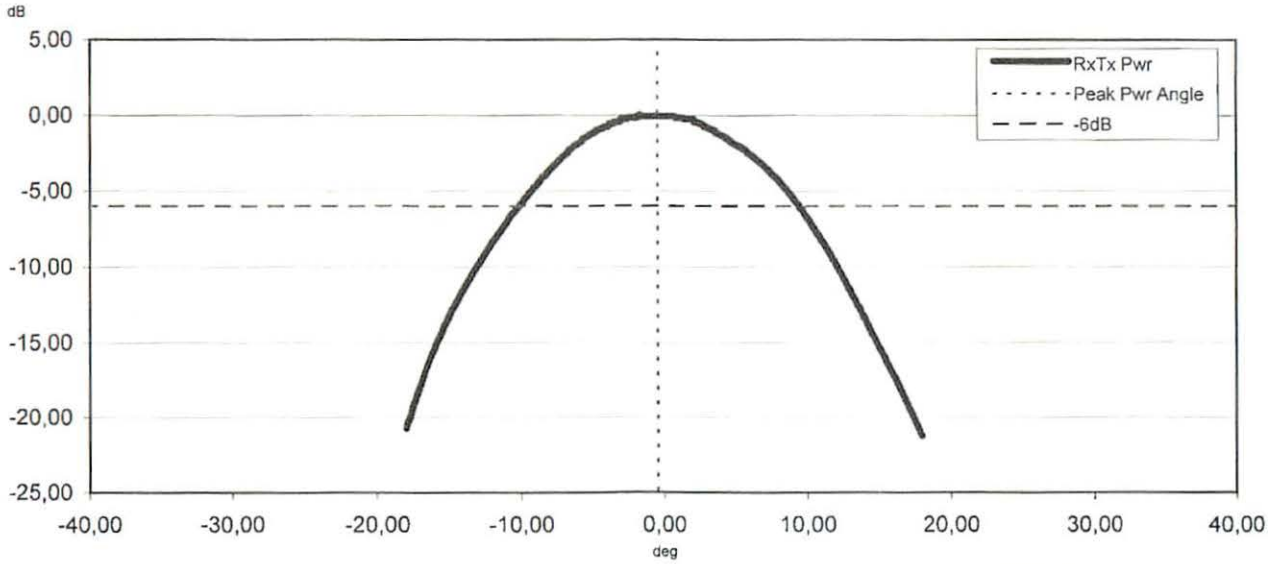
Beam Characteristics: OK

required		measured	
RxTx Pwr:	-38,00	dB	-35,54	dB
Peak Pwr Angle:	0,00	deg	-0,43	deg
Beam Width:	20,00	deg	19,86	deg

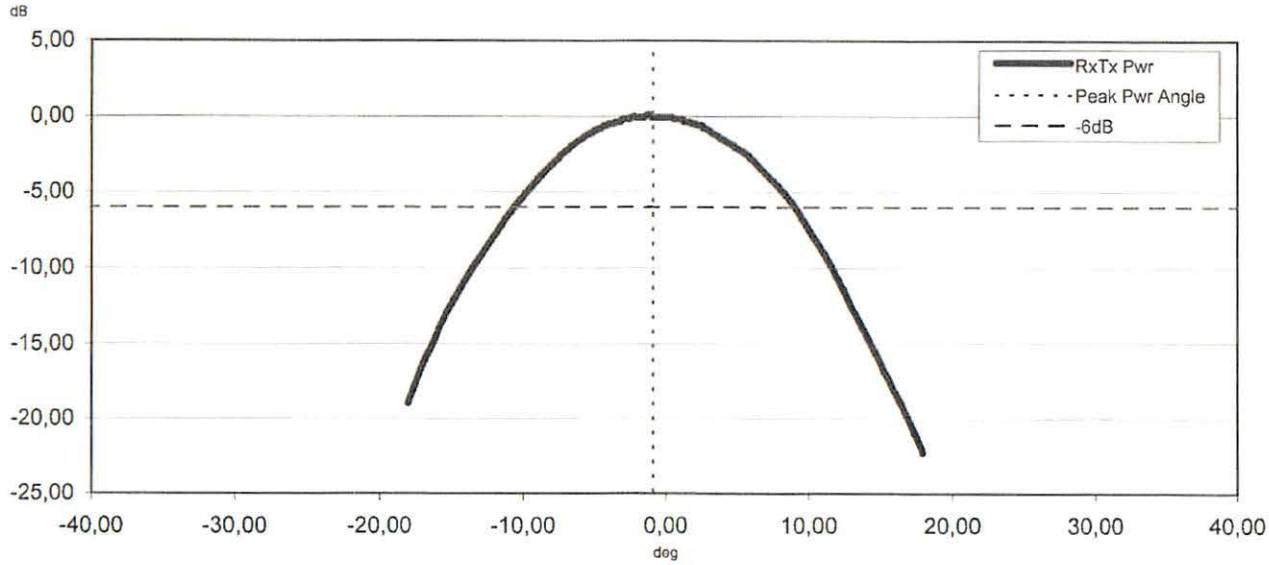
Beam Characteristics: OK

required	measured
RxTx Pwr:	-38,00 dB	-35,22 dB
Peak Pwr Angle:	0,00 deg	-0,86 deg
Beam Width:	20,00 deg	19,86 deg
