CERTIFICATE CONCERNING DESIGN AND CONSTRUCTION OF ELECTRONIC SPEED MEASURING DEVICES

Speed Validation Report
Client: Kirkland, WA

Preventive Maintenance Checklist

Calibration Report

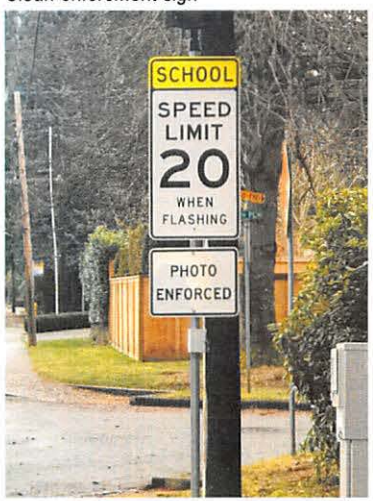
Pole at a distance

Pole close up

Clean enclosure

Clean enforcment sign

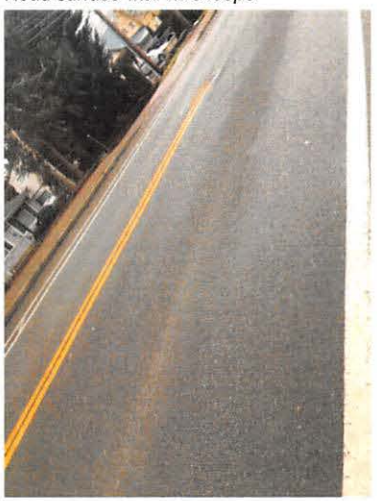
Road surface with wire loops

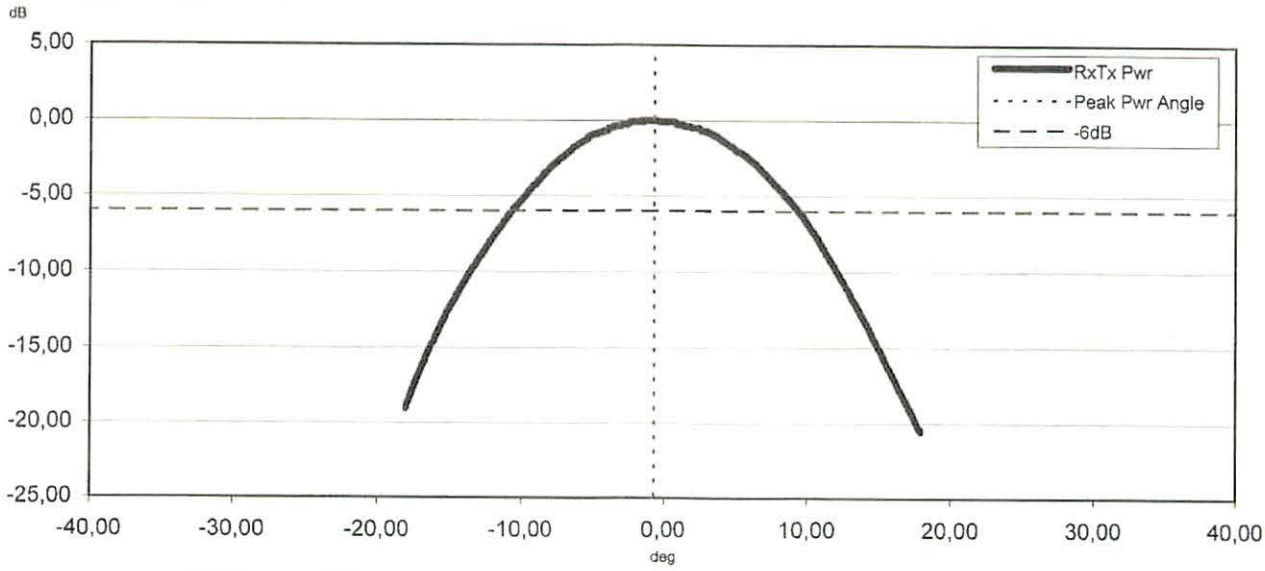
Beam Characteristics: OK

required	measured
RxTx Pwr:	-38,00 dB	-36,01 dB
Peak Pwr Angle:	0,00 deg	-0,65 deg
Beam Width:	20,00 deg	20,24 deg

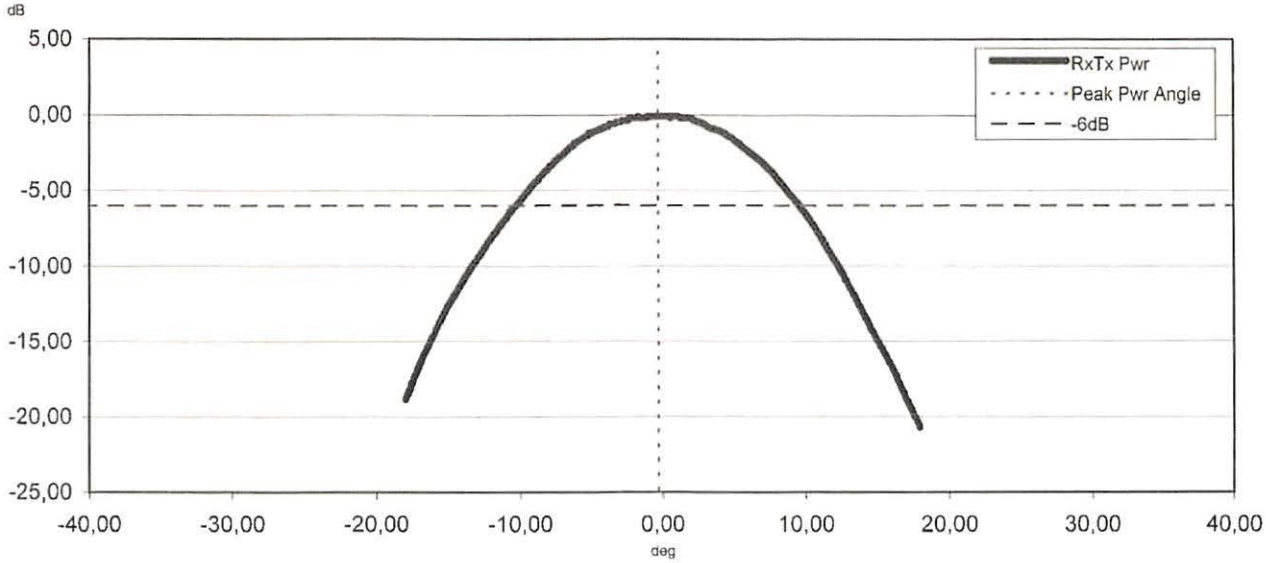
Beam Characteristics: OK

required		measured	
RxTx Pwr:	-38,00	dB	-35,93	dB
Peak Pwr Angle:	0,00	deg	-0,28	deg
Beam Width:	20,00	deg	20,28	deg
