**CEDARBROOK
TREE PLAN**

**9900 – 124TH AVE NE
KIRKLAND, WA**

February 28th, 2013

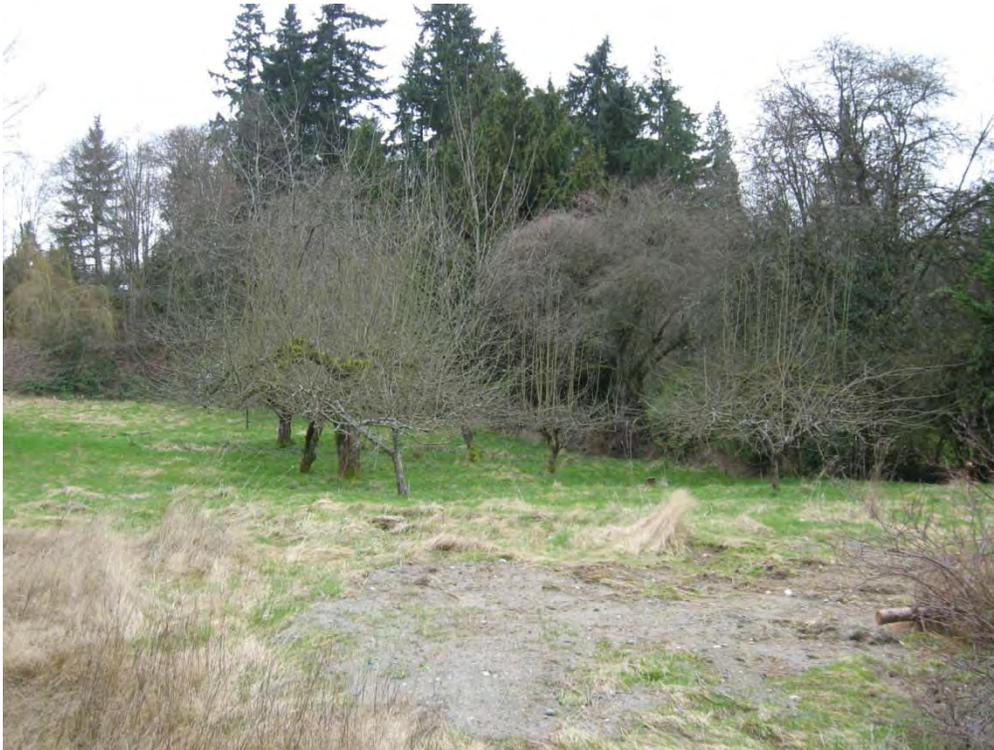
Tree #127 at edge of wetland buffer

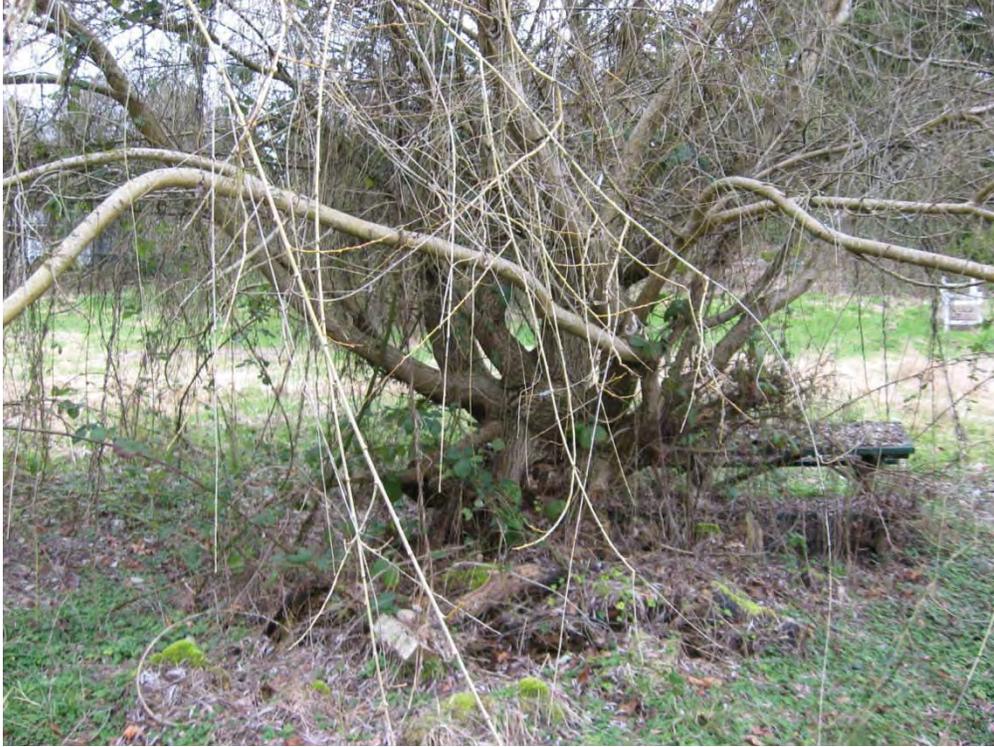
Tree #117 is a mature pear variety. The lower trunk and main scaffold branches have considerable internal decay. The subject has had several recent branch failures. It is falling apart.

Trees #117, #118, #119, #120 and #121
