Culvert Assessment Memorandum

Preliminary Assessments: Fish Passage at City of Kirkland Road and Trail Stream Culverts

August 2014

The Watershed Company Reference Number:
120612

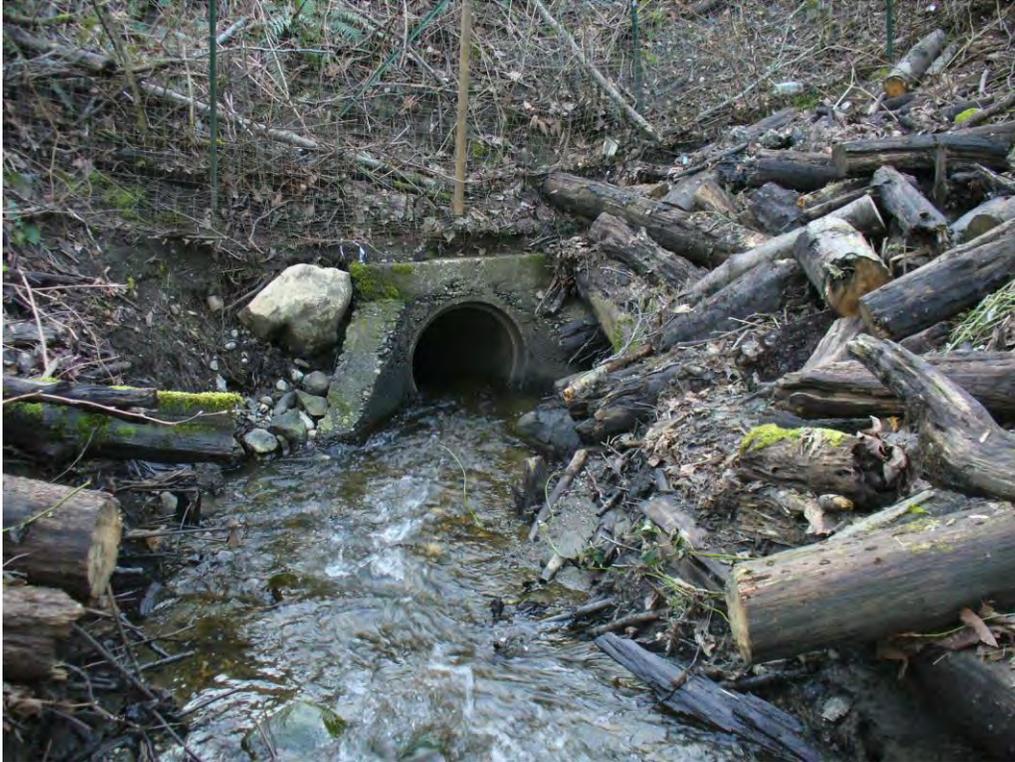
Figure 9. Culvert DE-2 Inlet at Juanita Drive, 3-8-13

Meets WDFW Culvert Design Manual Criteria? No. (1.25 OHW width for no slope, 1.2 OHW width +2 for stream simulation. Hydraulic Option not amenable to field assessment).

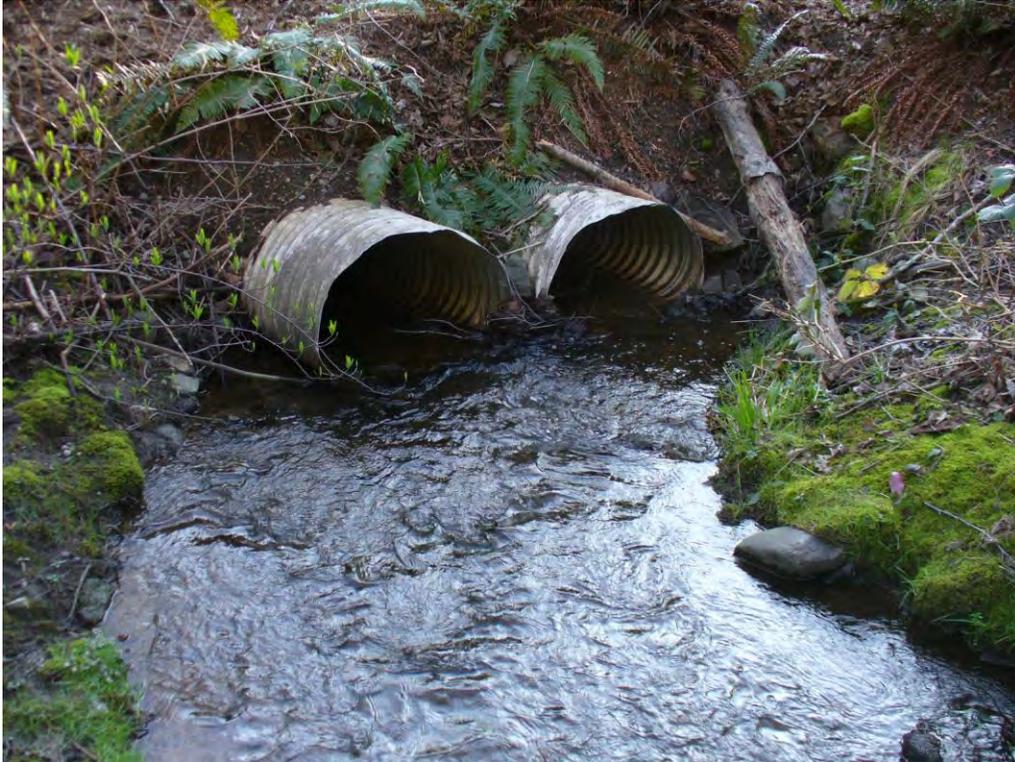
Figure 11. Culvert DE-3 Inlet at 78th Place NE, 3-8-13

Meets WDFW Culvert Design Manual Criteria? No. (1.25 OHW width for no slope, 1.2 OHW width +2 for stream simulation. Hydraulic Option not amenable to field assessment).

DE-3 (A)	Denny Creek	76 ft. twin corrugated pipes 24" high by 36" wide	13433 78th PI NE	2 - Hindrance. Moderate-sized trout could jump into and swim through these culverts.	In open space area in front of home	No fish found in 1998 study, but habitat appears suitable, type F per DNR mapping. Culvert downstream at Juanita Drive is a barrier and would need to be upgraded to allow anadromous access. Some habitat available upstream in low-gradient tributaries and beaver pond habitat. Though relatively low cost, there would be limited benefits to replacing this culvert because it is already largely passable, a downstream barrier is present, and quantity of potential habitat farther upstream is limited.	3	2.3
Champagne Creek								
CH-1 (7)	Champagne Creek	18 in., 226 ft., concrete	Juanita Drive	4 - Full barrier due to plunge at outfall and velocity due to slope and smooth pipe.	Little potential habitat available upstream.	Fish use not expected this far upstream, but cutthroat use documented farther downstream. Downstream incised channel likely includes barriers. There is not significant habitat available upstream so this is not a high priority.	4	2.6

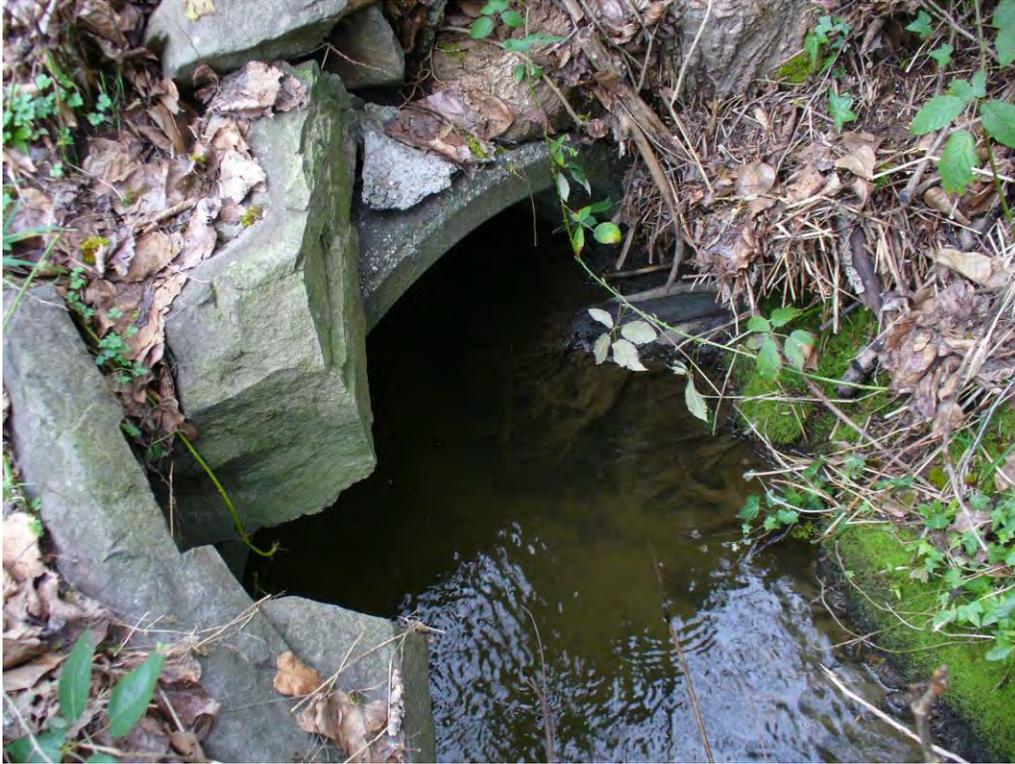
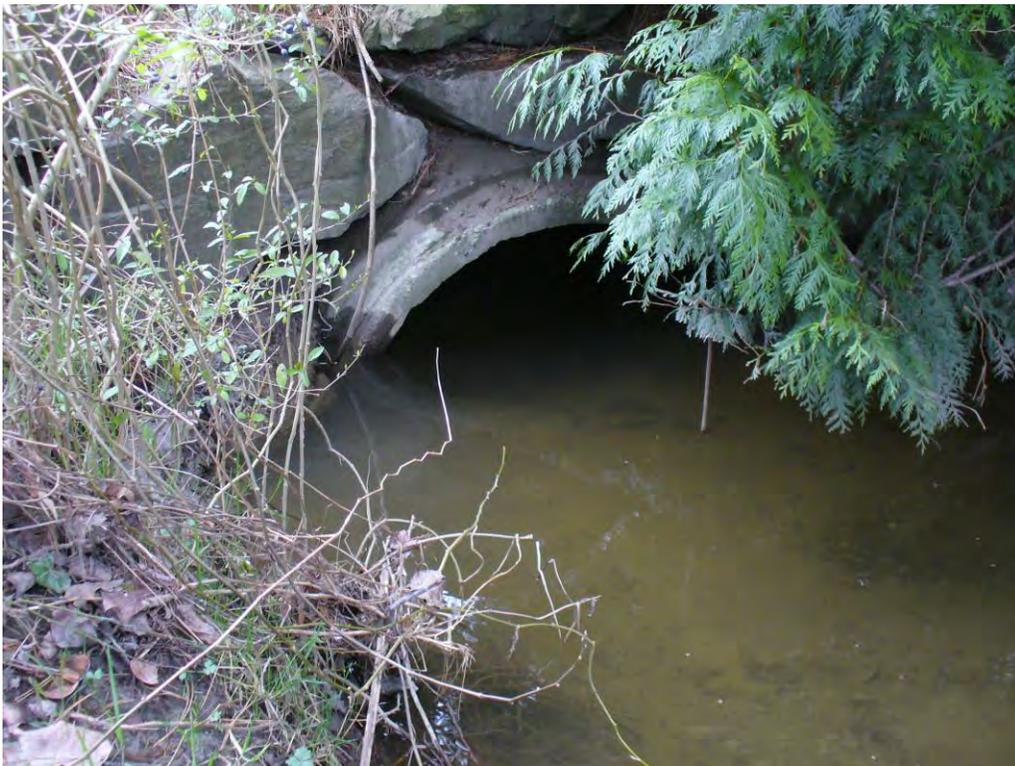
Meets WDFW Culvert Design Manual Criteria? No. (1.25 OHW width for no slope, 1.2 OHW width +2 for stream simulation. Hydraulic Option not amenable to field assessment).

Figure 20. Culvert JC-11 Inlet at NE 140th Place, 3-11-13

Figure 21. Culvert JC-11 Outlet at NE 140th Place, 3-11-13

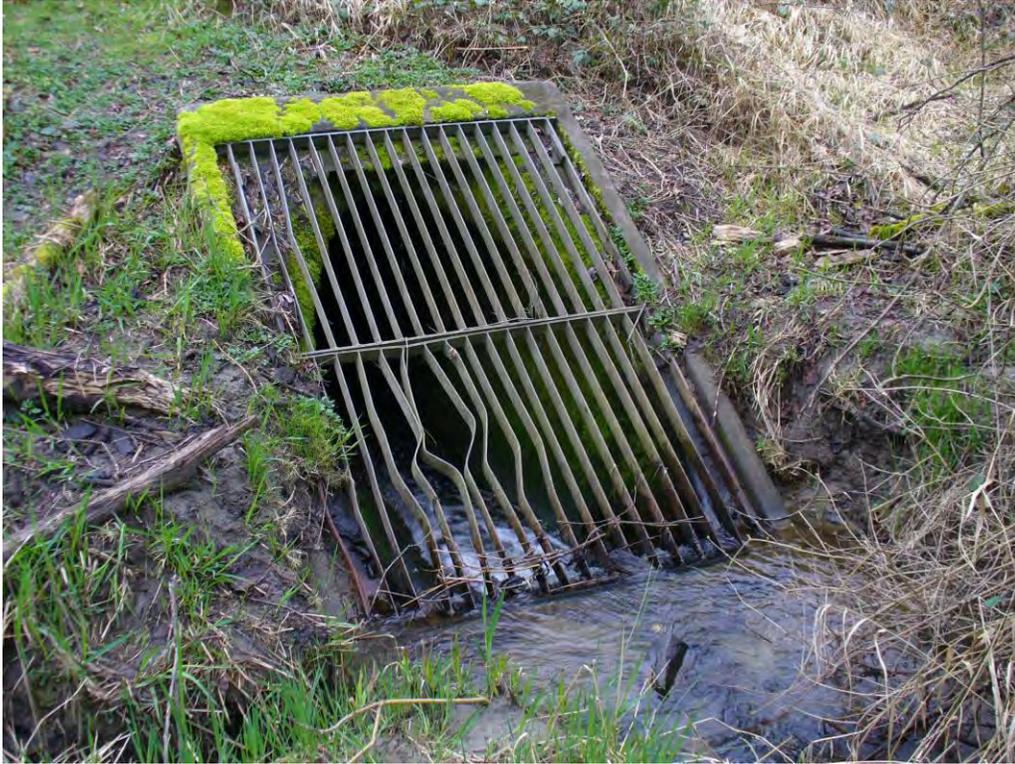
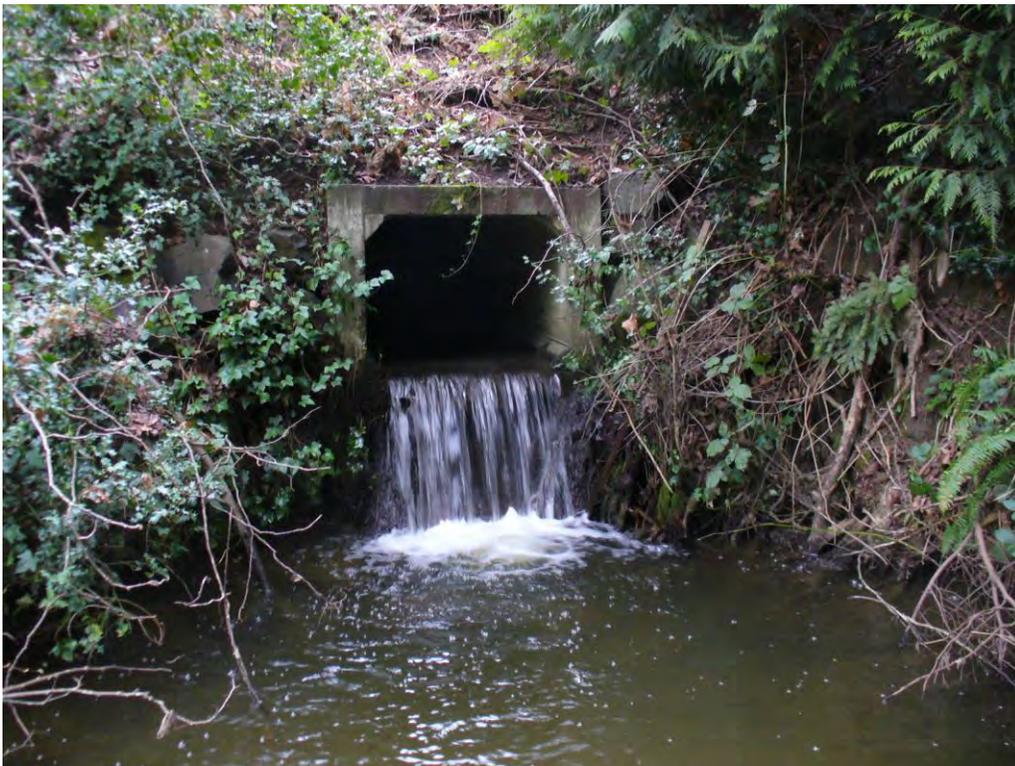
Meets WDFW Culvert Design Manual Criteria? No. 1.25 OHW width for no slope, 1.2 OHW width +2 for stream simulation. Hydraulic Option not amenable to field assessment).

Figure 26. Culvert JC-14 Inlet at 100th Avenue NE, 3-12-13

Figure 27. Culvert JC-14 Outlet at 100th Avenue NE, 3-12-13

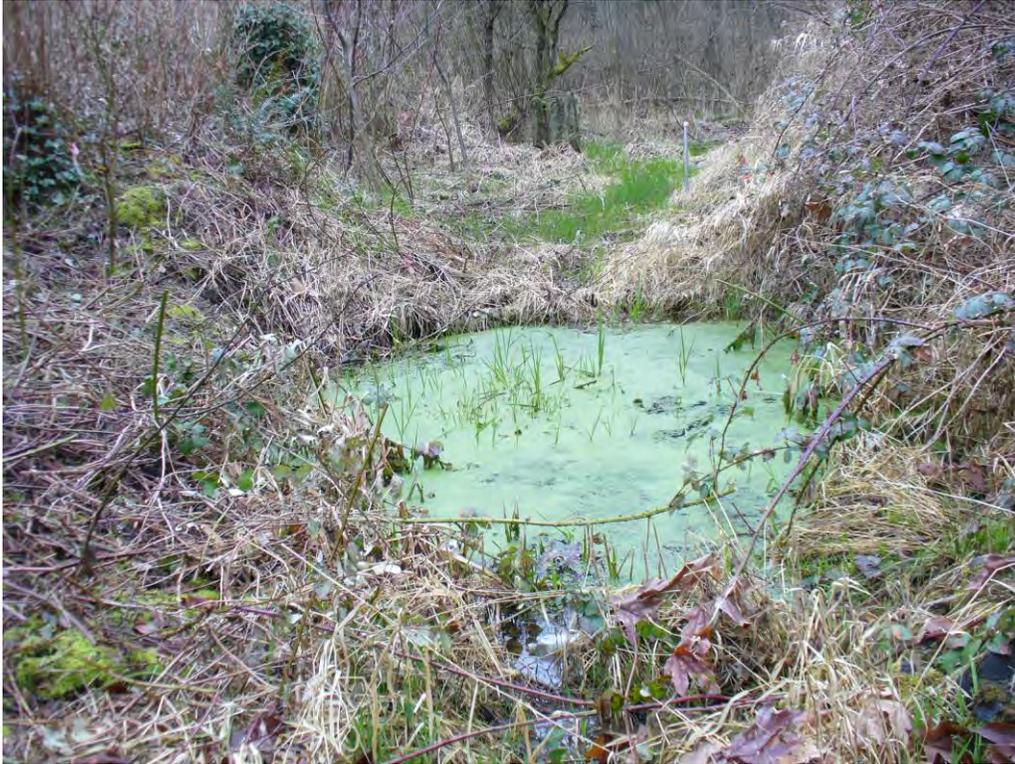
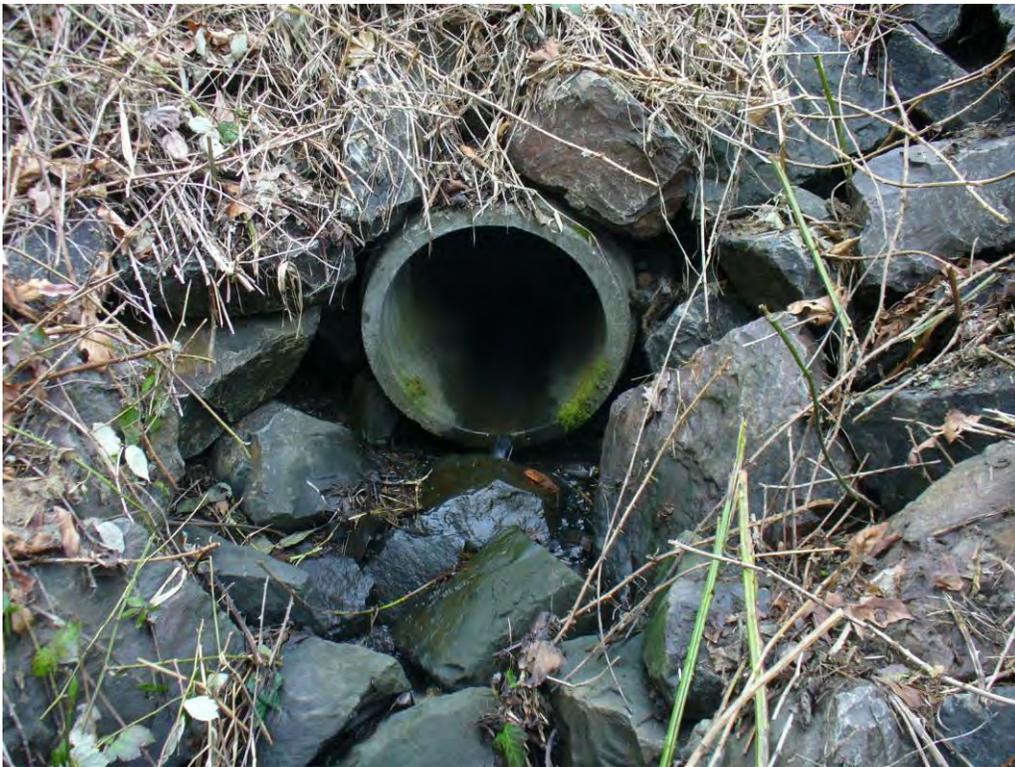
Meets WDFW Culvert Design Manual Criteria? No. (1.25 OHW width for no slope, 1.2 OHW width +2 for stream simulation. Hydraulic Option not amenable to field assessment).

Figure 28. Culvert JC-15 Inlet at Simonds Road, 3-12-13

Figure 29. Culvert JC-15 Outlet at Simonds Road, 3-12-13

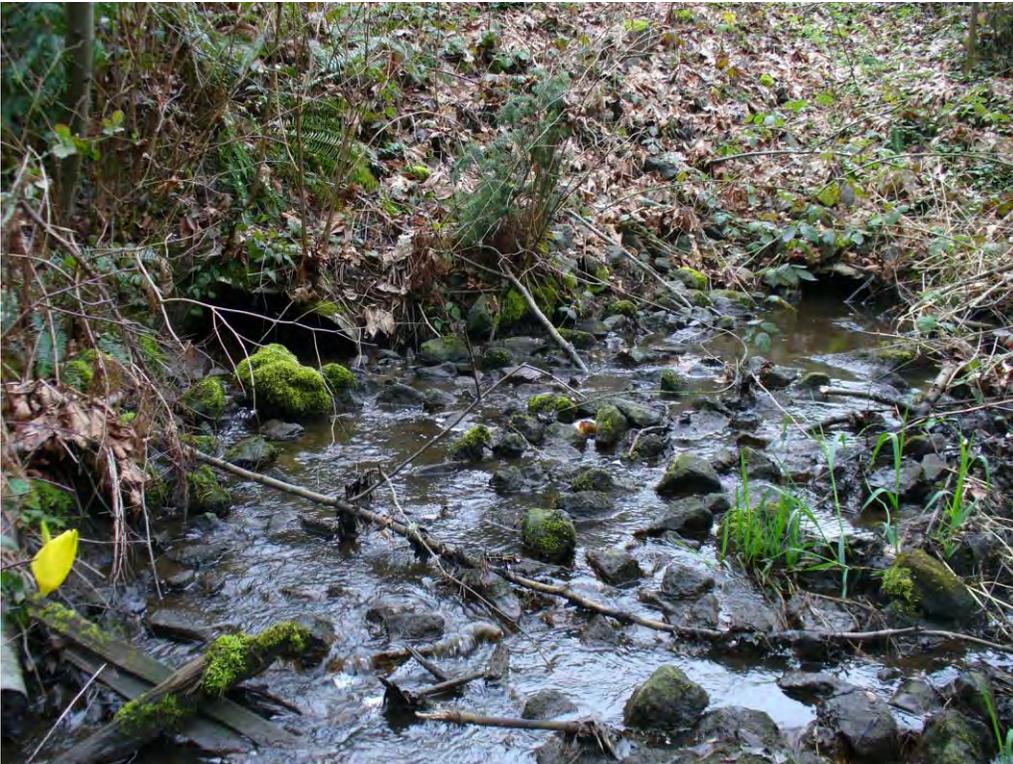
Substrate/roughness w/in culvert? Quarry spalls in pipe at inlet. Little/none at outlet

Notes: Quarry spall heaven! Huge amounts of quarry spalls – fairly old – were placed at this culvert outlet. Also quarry spalls and a lot of accumulated debris at the inlet. Check whether King County has any data on this pipe?

Figure 31. Culvert JC-16 outlet at 88th Avenue NE, 3-12-13

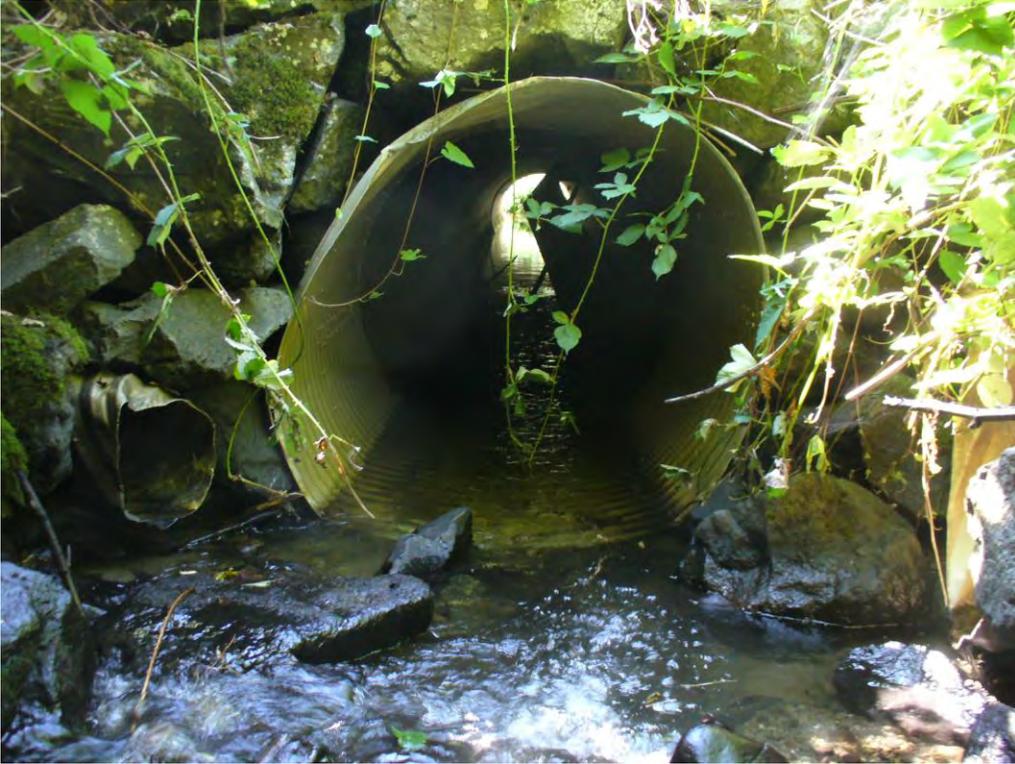
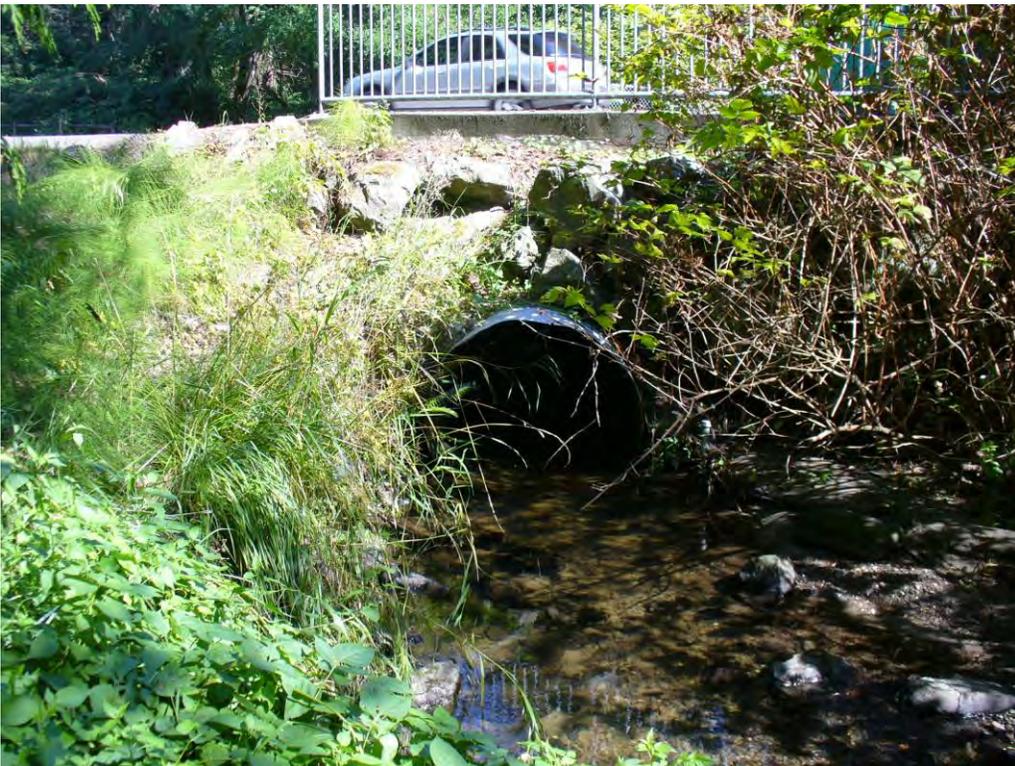
Meets WDFW Culvert Design Manual Criteria? No. (1.25 OHW width for no slope, 1.2 OHW width +2 for stream simulation Hydraulic Option not amenable to field assessment).

Figure 32. Culvert JC-17 Inlet at 108th Avenue NE, 9-12-13

Figure 33. Culvert JC-17 Outlet at 108th Avenue NE, 9-12-13

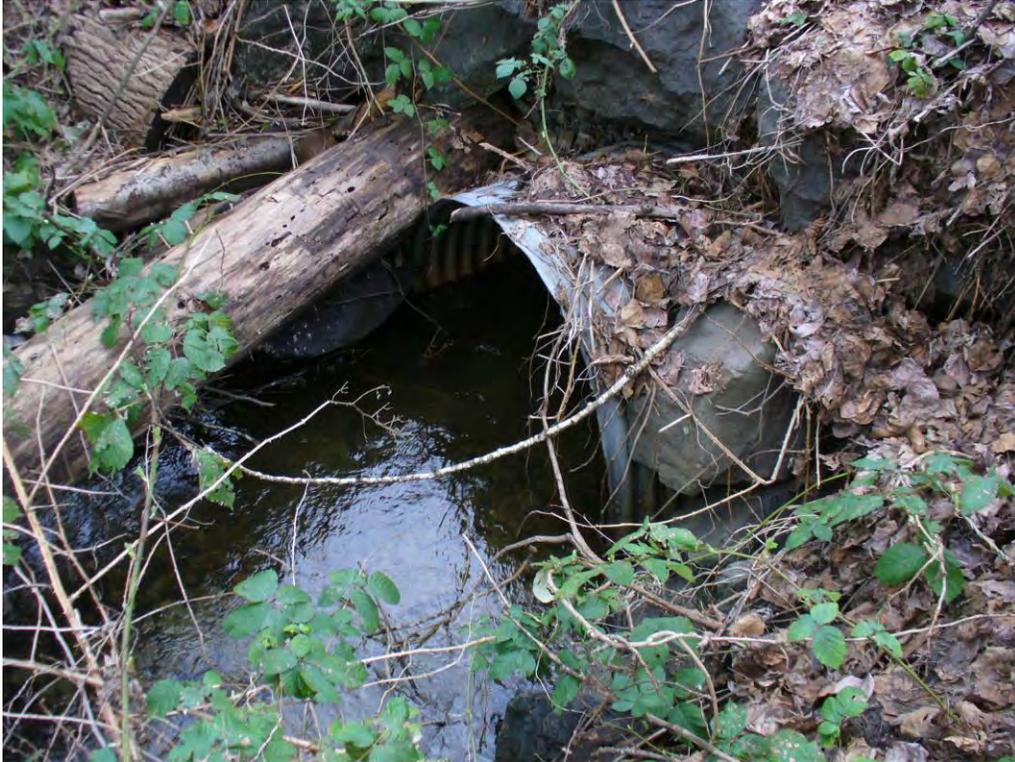
Figure 38. Culvert JC-20 Inlet at 111th Avenue NE, 3-12-13

Passage Assessment – Passable, Full/Partial Barrier: Not a barrier – passage conditions are fairly good.

Meets WDFW Culvert Design Manual Criteria? No, too narrow. (1.25 OHW width for no slope, 1.2 OHW width +2 for stream simulation. Hydraulic Option not amenable to field assessment).

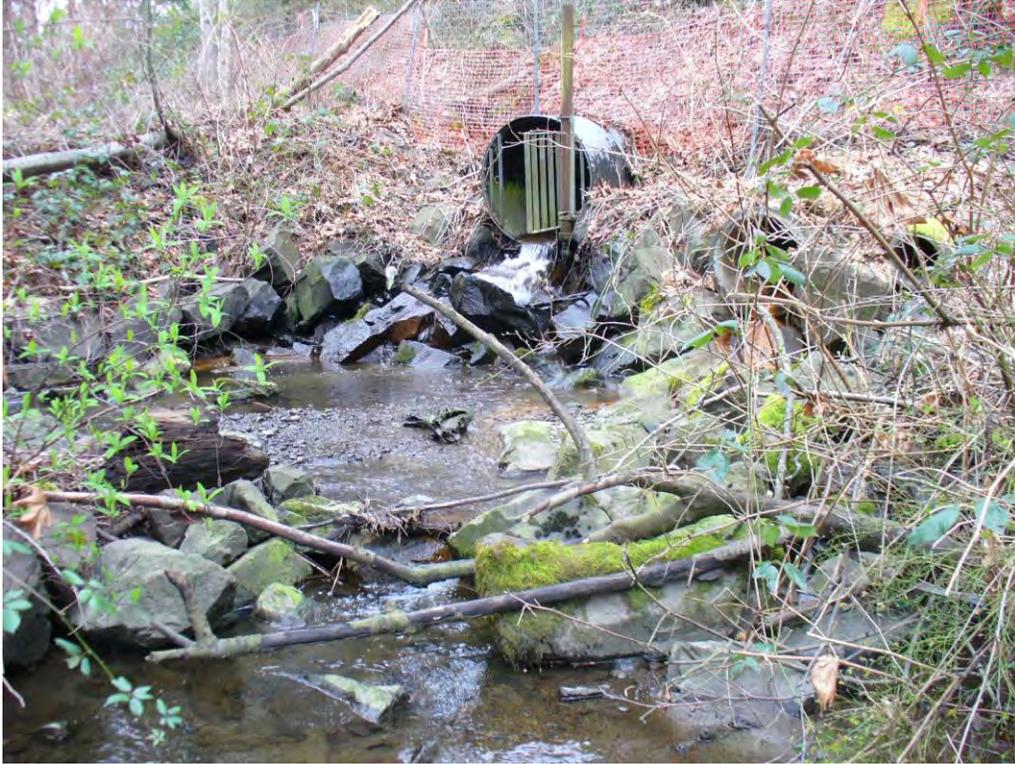
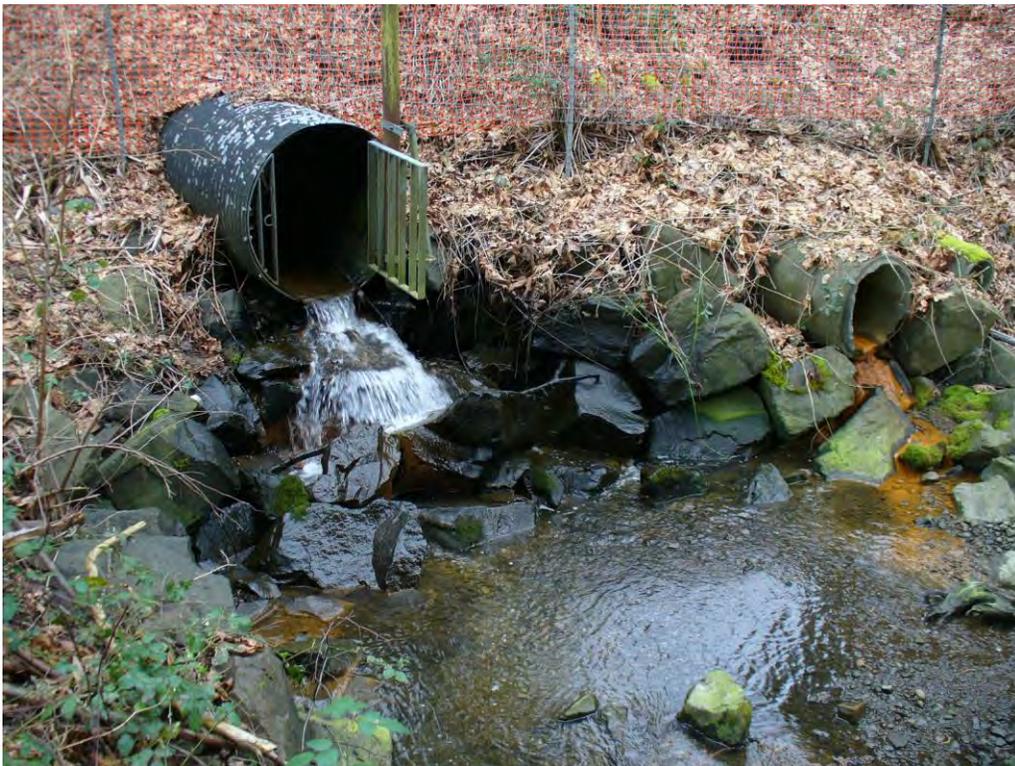
Meets WDFW Culvert Design Manual Criteria? No! (1.25 OHW width for no slope, 1.2 OHW width +2 for stream simulation. Hydraulic Option not amenable to field assessment).

Figure 40. Culvert JC-21 Outlet at I-405, 3-12-13

Figure 41. Culvert JC-21 Outlet at I-405, 3-12-13

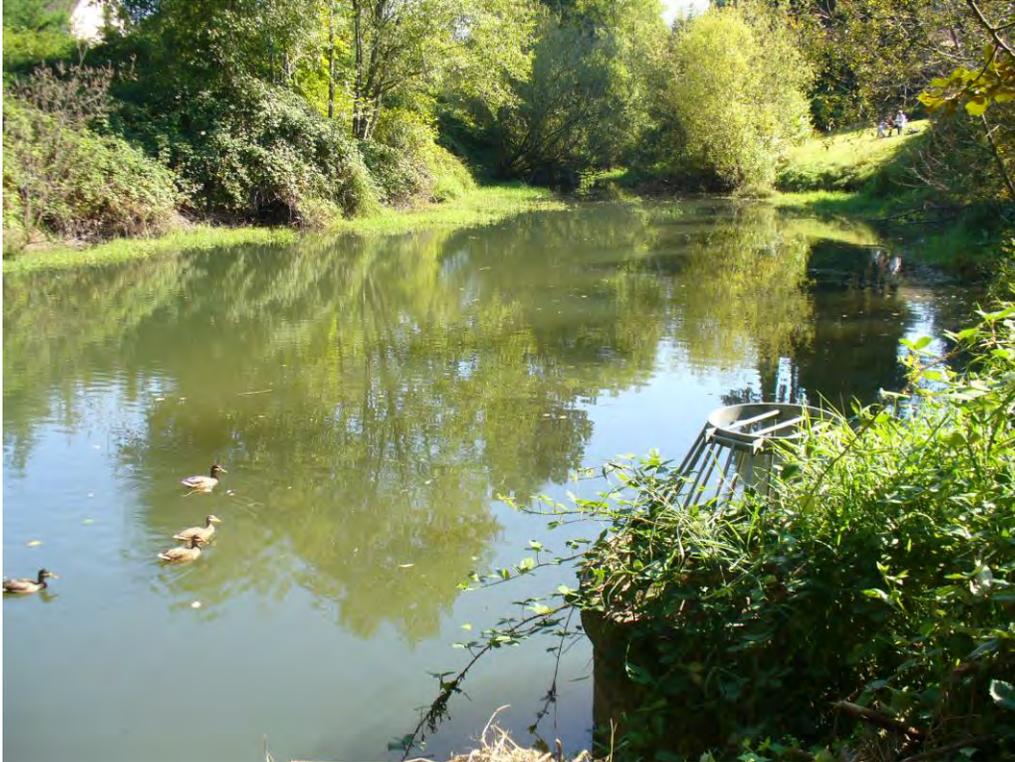
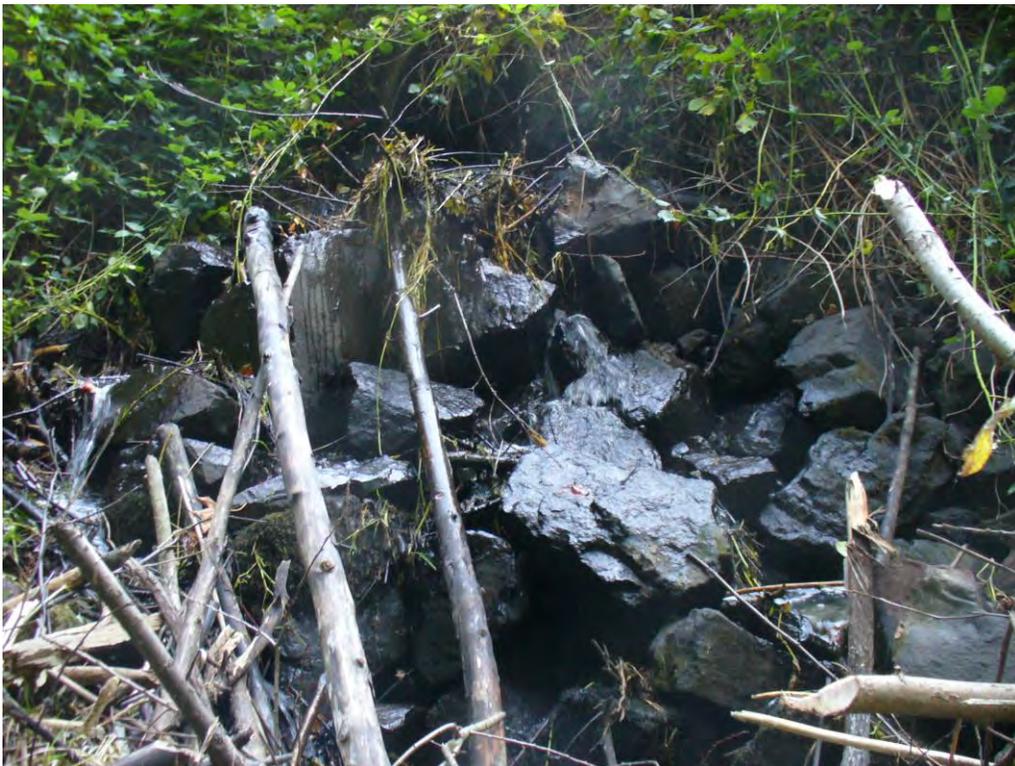
Meets WDFW Culvert Design Manual Criteria? Does not meet width standards (1.25 OHW width for no slope, 1.2 OHW width +2 for stream simulation Hydraulic Option not amenable to field assessment).

Figure 44. Culvert JC-23 Inlet at 109th Avenue NE, 9-12-13

Figure 45. Culvert JC-23 Outlet at 109th Avenue NE, 9-12-13

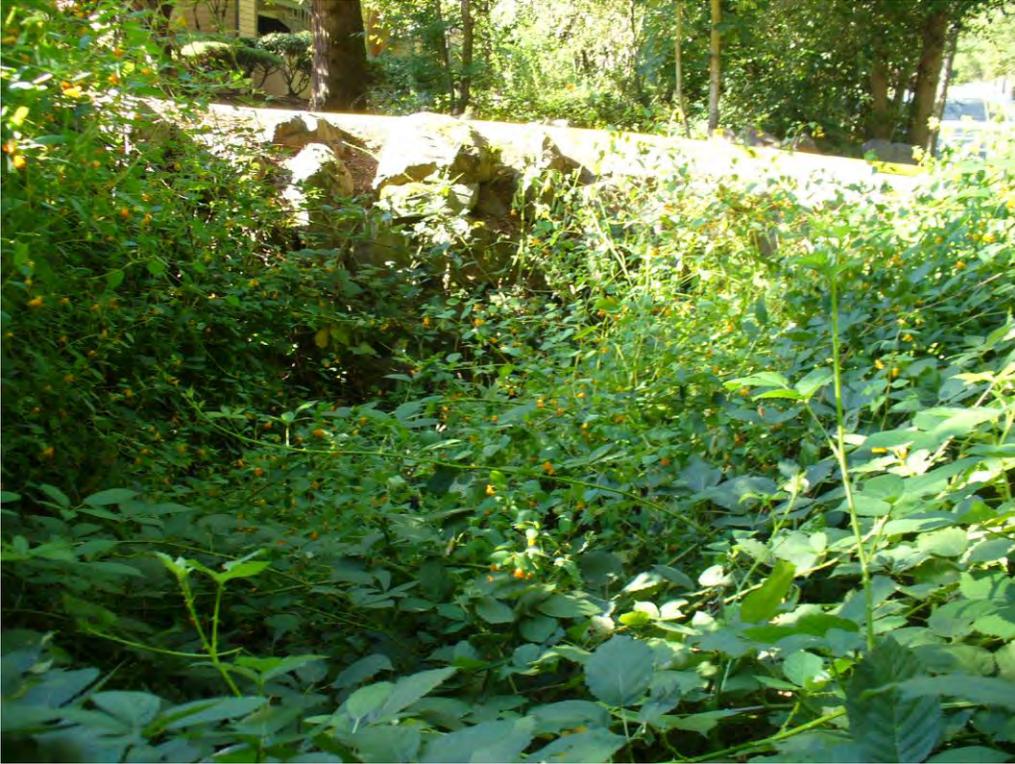
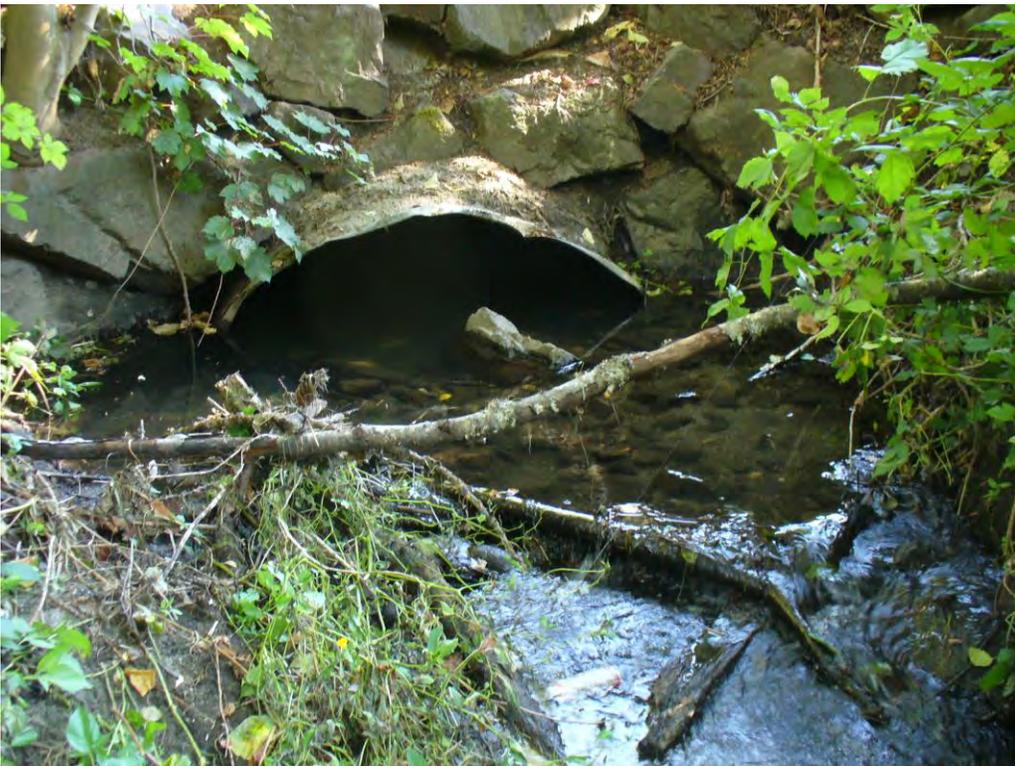
Meets WDFW Culvert Design Manual Criteria? Is fully passable though it does not meet width standards (1.25 OHW width for no slope, 1.2 OHW width +2 for stream simulation Hydraulic Option not amenable to field assessment).

Figure 46. Culvert JC-24 Inlet at 114th Place NE apartment driveway, 9-12-13

Figure 47. Culvert JC-24 Outlet at 114th Place NE apartment driveway, 9-12-13

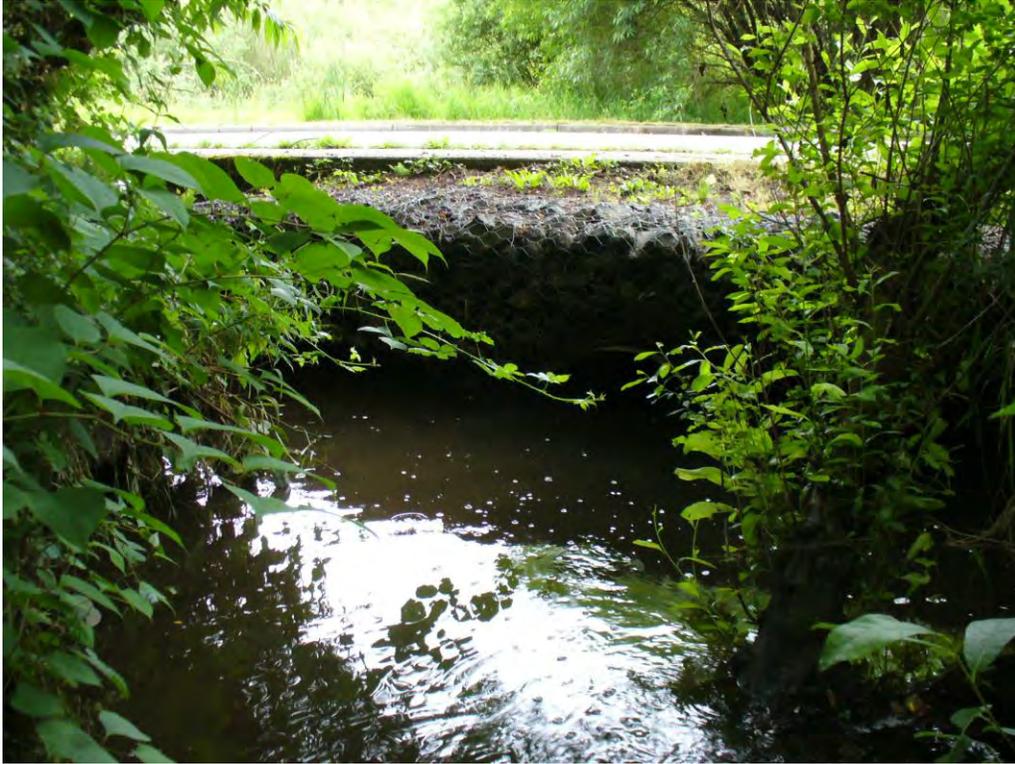
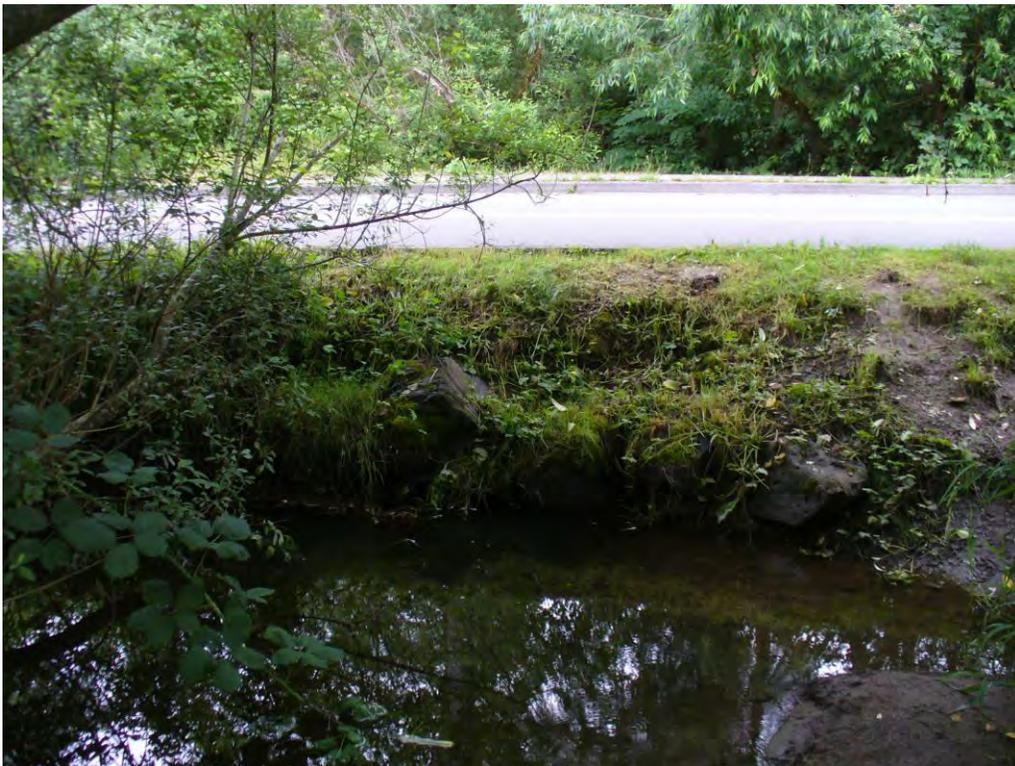
Meets WDFW Culvert Design Manual Criteria? No, does not meet stream simulation width requirements - 1.25 OHW width for no slope, 1.2 OHW width +2 for stream simulation (Hydraulic Option not amenable to field assessment).

Figure 48. Culvert FO-1 Inlet at 108th Avenue NE, 6-27-13

Figure 49. Culvert FO-1 Outlet at 108th Avenue NE, 6-27-13

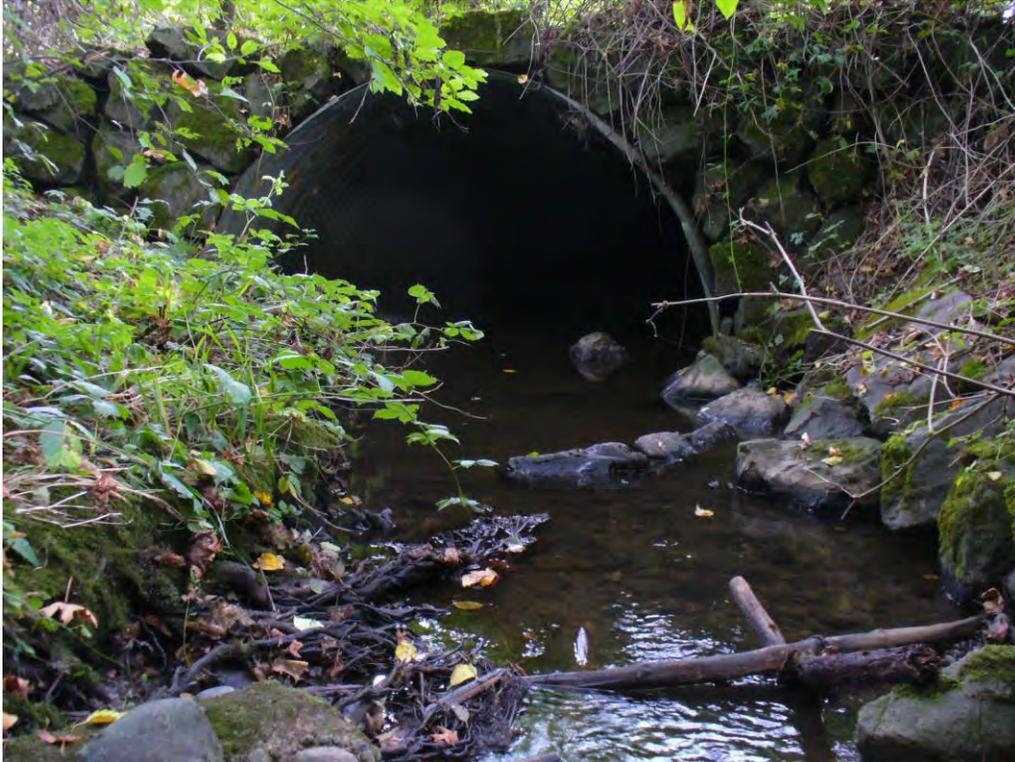
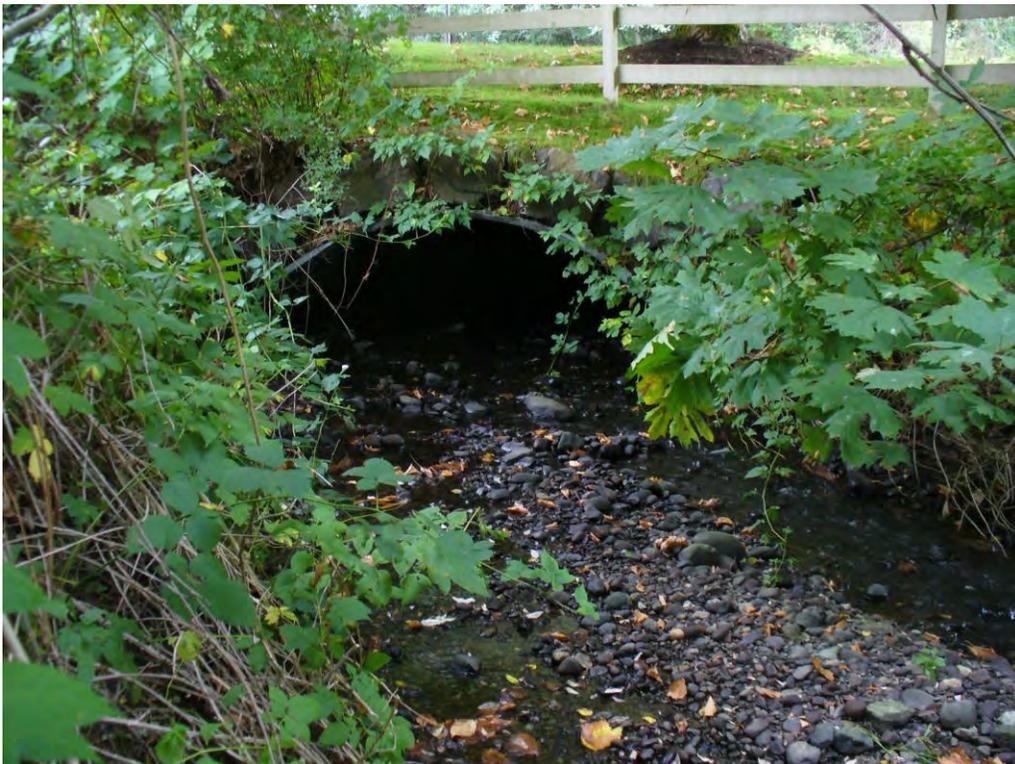
Meets WDFW Culvert Design Manual Criteria? May be slightly under width, but meets Stream simulation in principle. (1.25 OHW width for no slope, 1.2 OHW width +2 for stream simulation Hydraulic Option not amenable to field assessment).

Figure 50. Culvert FO-2 Inlet at Forbes Creek Drive, 9-13-13

Figure 51. Culvert FO-2 Outlet at Forbes Creek Drive, 9-13-13

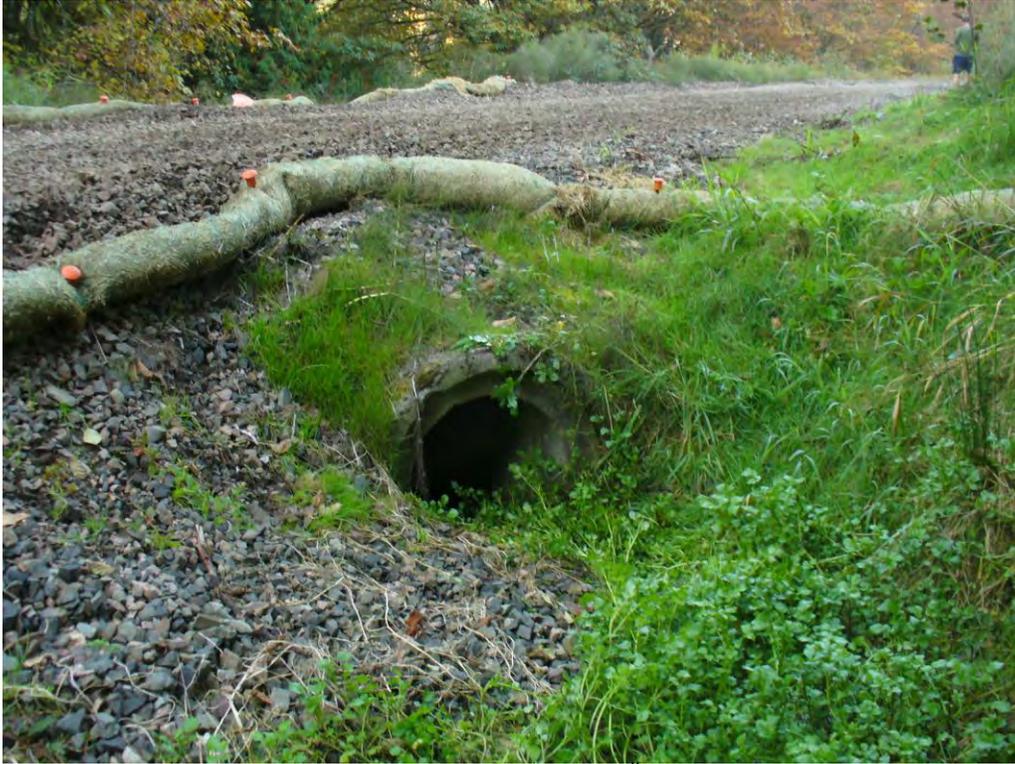
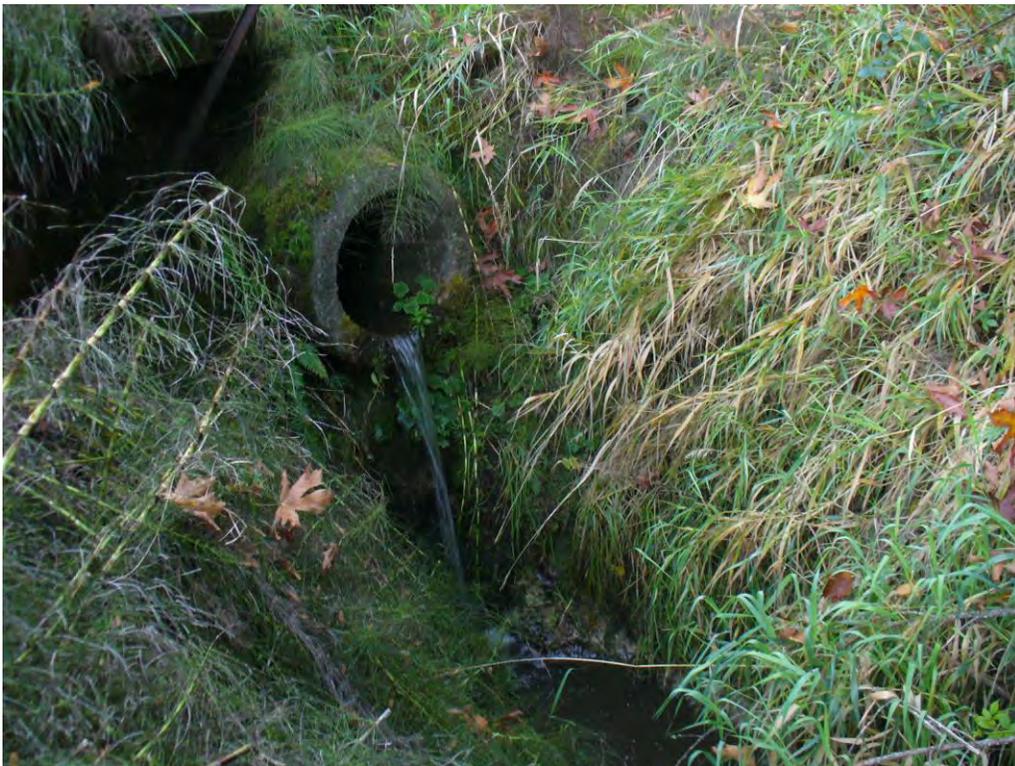
Meets WDFW Culvert Design Manual Criteria? No. 1.25 OHW width for no slope, 1.2 OHW width +2 for stream simulation (Hydraulic Option not amenable to field assessment).

Figure 52. Culvert FO-3 Inlet near dead end of 111th Avenue NE (CKC), 10-18-13

Figure 53. Culvert FO-3 Outlet near dead end of 111th Avenue NE (CKC), 10-18-13

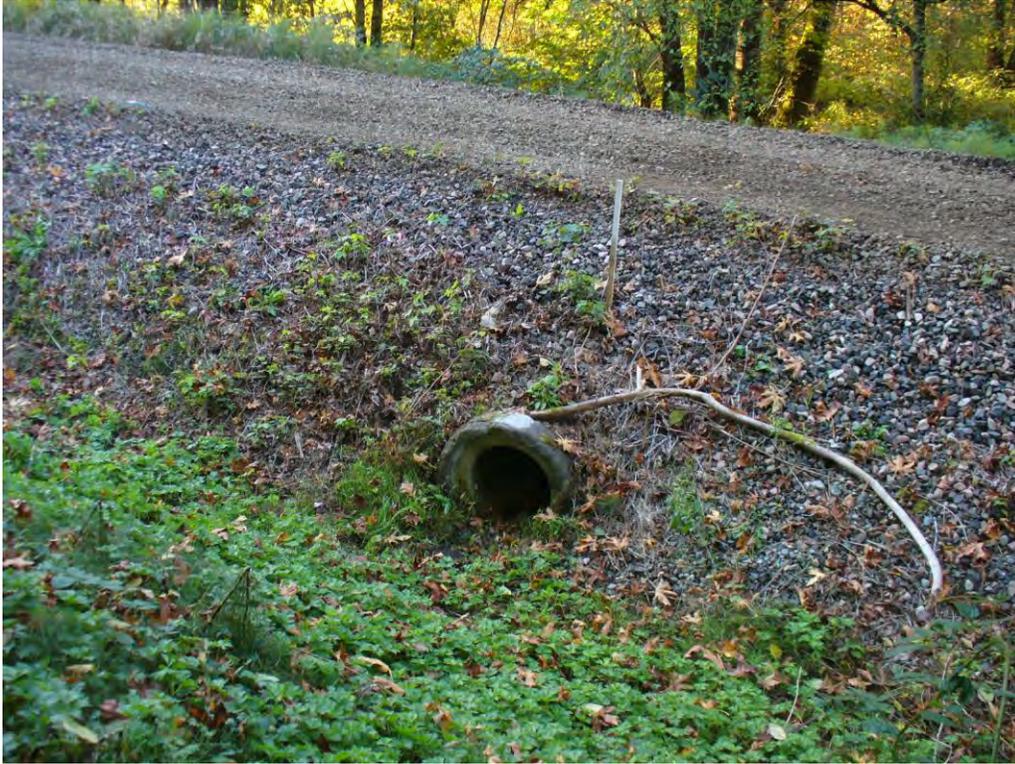
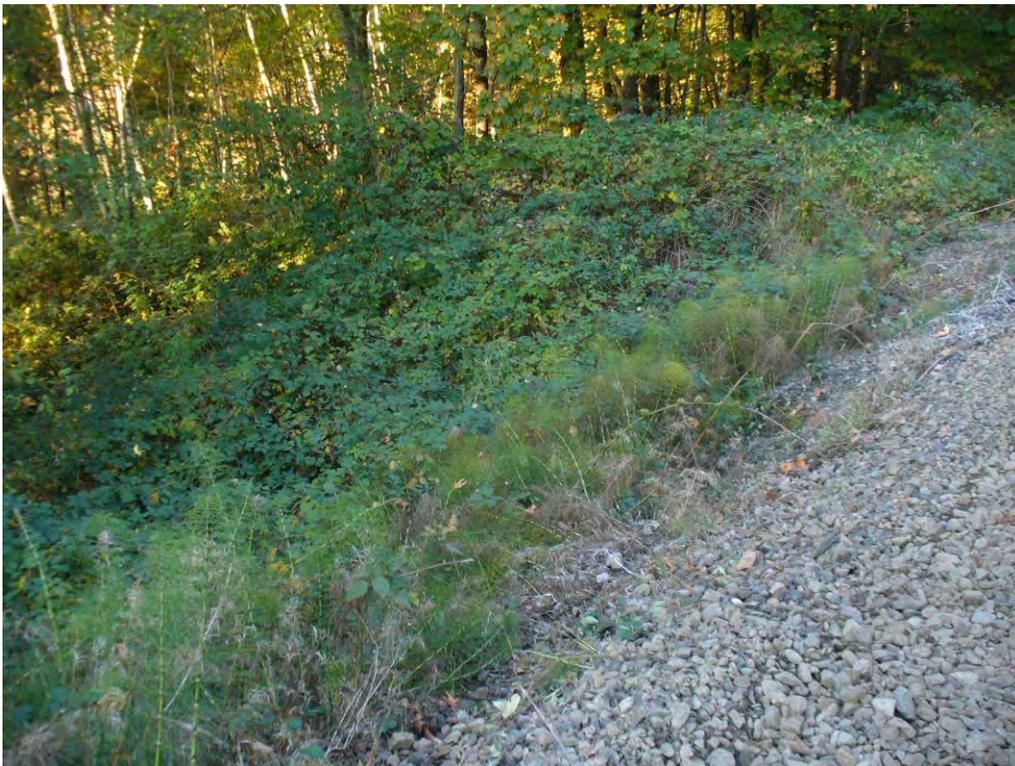
Meets WDFW Culvert Design Manual Criteria? No. 1.25 OHW width for no slope, 1.2 OHW width +2 for stream simulation (Hydraulic Option not amenable to field assessment).

Figure 54. Culvert FO-4 Inlet near dead end of 111th Avenue NE (CKC), 10-18-13

Figure 55. Culvert FO-4 Outlet near dead end of 111th Avenue NE (CKC), 10-18-13

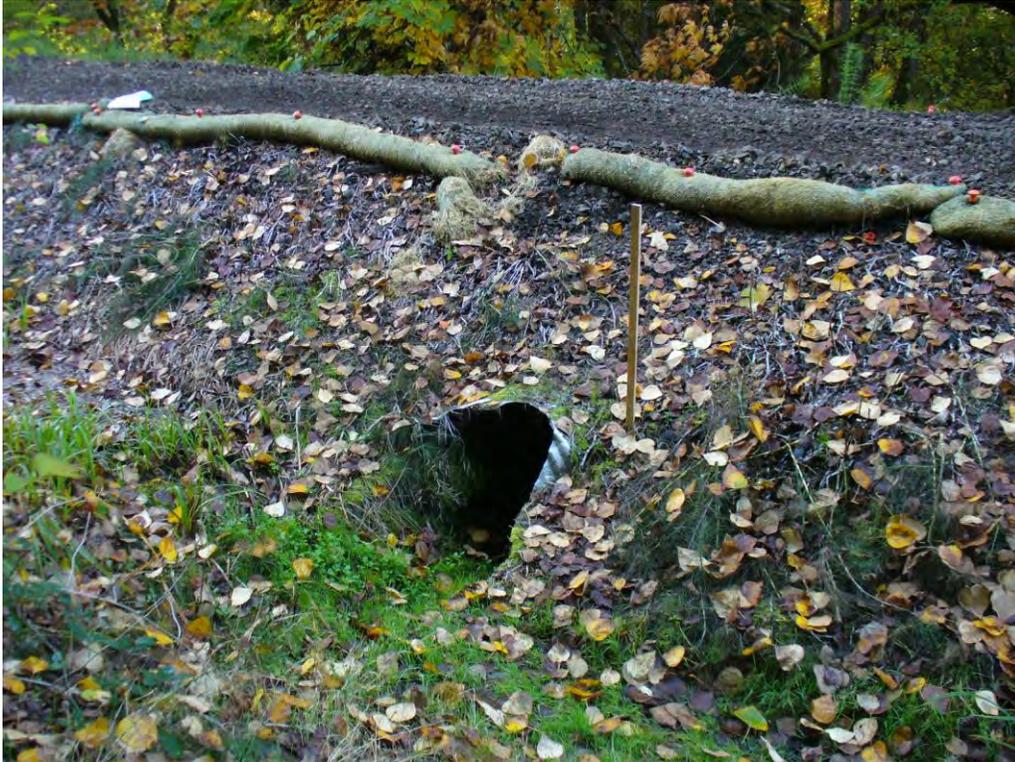
Figure 56. Culvert FO-5 Inlet near Forbes Creek Drive (CKC), 10-18-13

Notes: Trickle of flow on 10/18/13. Incised channel about 5 feet deep extends downstream. This drainage is judged to be too small and steep to be fish habitat and so is a low priority for replacement on that basis, though erosion at the outfall could stand to be addressed. (Assessment does not include parallel access road upstream.)

Meets WDFW Culvert Design Manual Criteria? 1.25 OHW width for no slope, 1.2 OHW width +2 for stream simulation (Hydraulic Option not amenable to field assessment). (No, does not meet criteria.)
