Culvert Assessment Memorandum

Preliminary Assessments: Fish Passage at City of Kirkland Road and Trail Stream Culverts

August 2014

The Watershed Company Reference Number:
120612

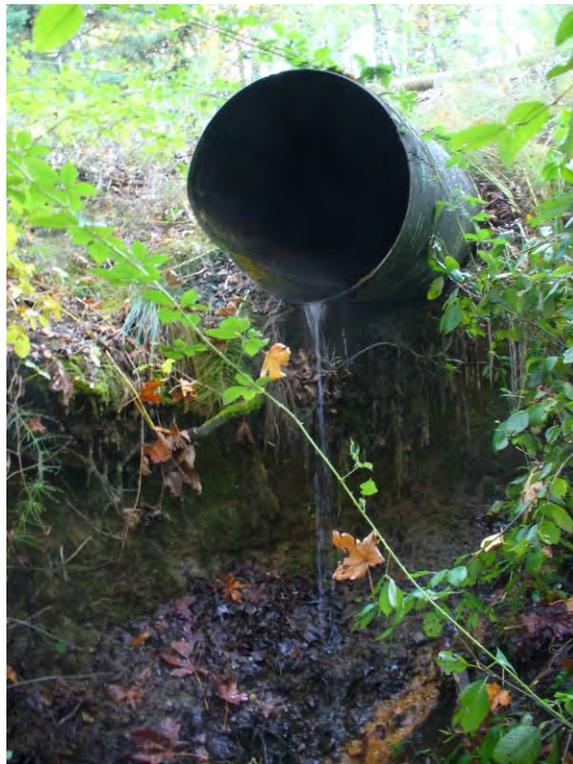
Notes: Trickle of flow on 10/18/13. Incised channel about 5 feet deep extends downstream. This drainage is judged to be too small and steep to be fish habitat and so is a low priority for replacement on that basis, though erosion at the outfall could stand to be addressed. (Assessment does not include parallel access road upstream.)

Figure 57. Culvert FO-5 Outlet near Forbes Creek Drive (CKC), 10-18-13

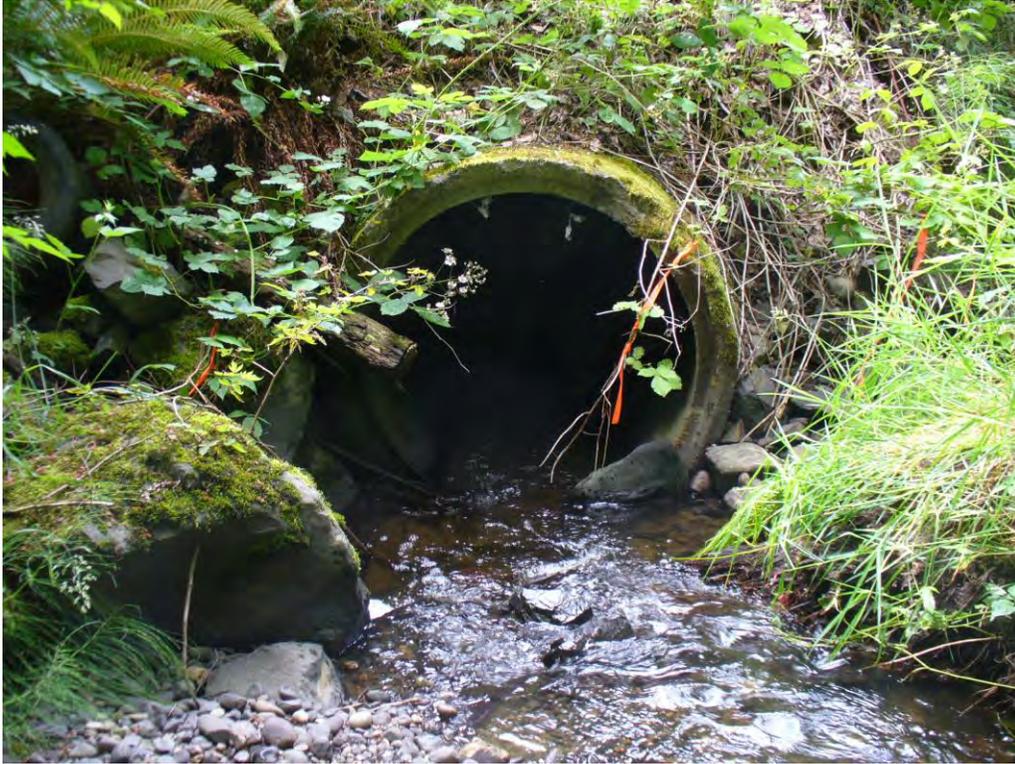
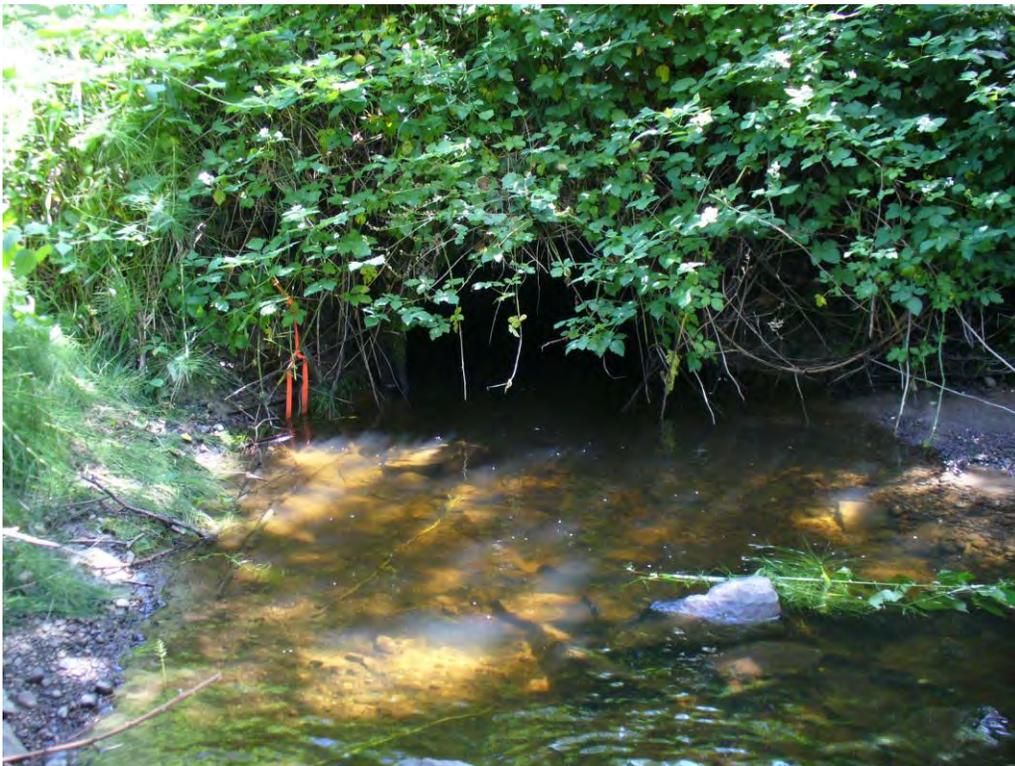
Meets WDFW Culvert Design Manual Criteria? No, does not meet 1.2 OHW width +2 for stream simulation (Hydraulic Option not amenable to field assessment).

Figure 58. Culvert FO-6 Inlet at 117th Place NE and 116th Avenue NE, 6-28-13

Figure 59. Culvert FO-6 Outlet at 117th Place NE and 116th Avenue NE, 6-28-13

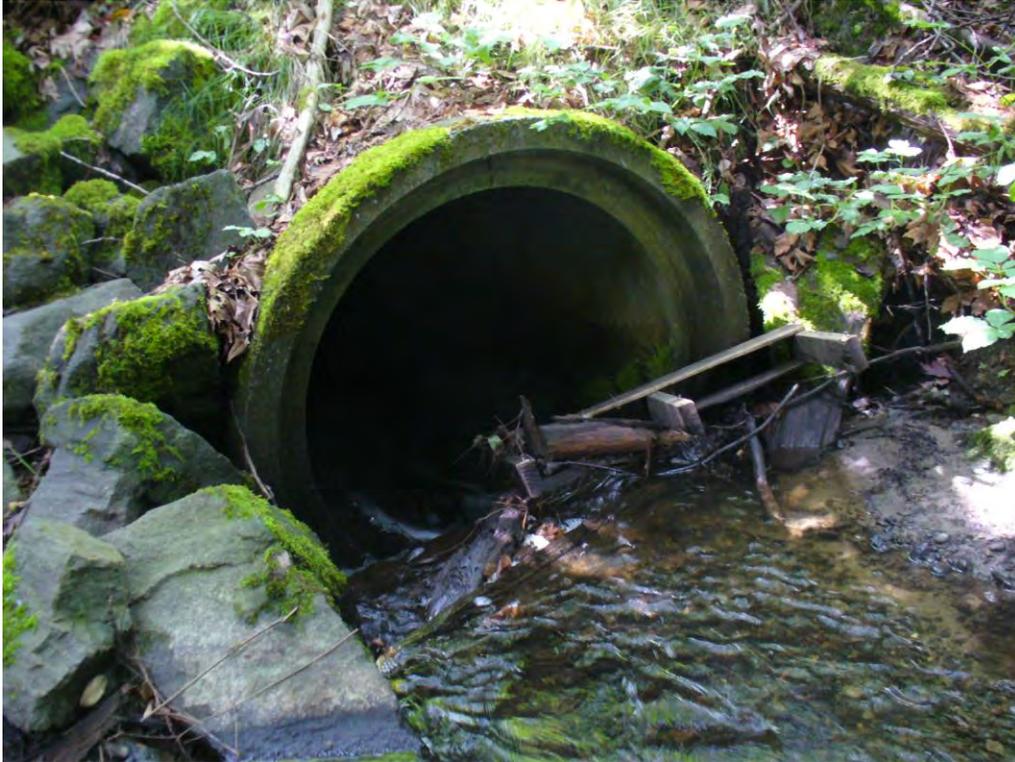
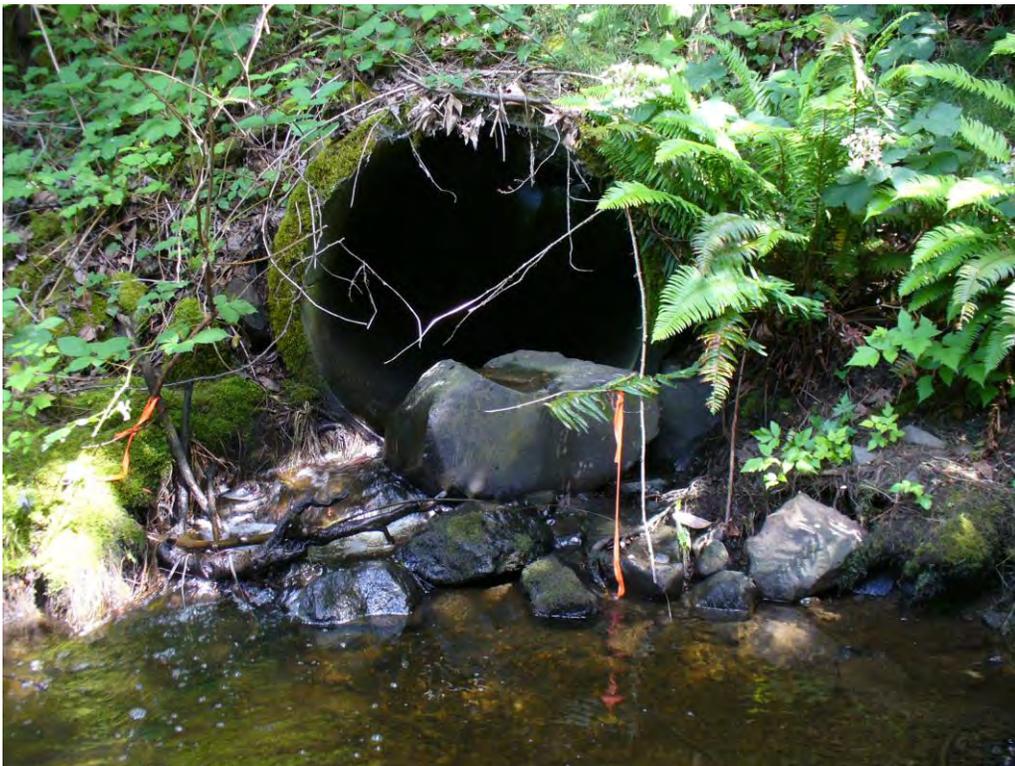
Meets WDFW Culvert Design Manual Criteria? No, does not meet 1.2 OHW width +2 for stream simulation (Hydraulic Option not amenable to field assessment).

Figure 60. Culvert FO-7 Inlet at 117th Place NE and 116th Avenue NE, 6-28-13

Figure 61. Culvert FO-7 Outlet at 117th Place NE and 116th Avenue NE, 6-28-13

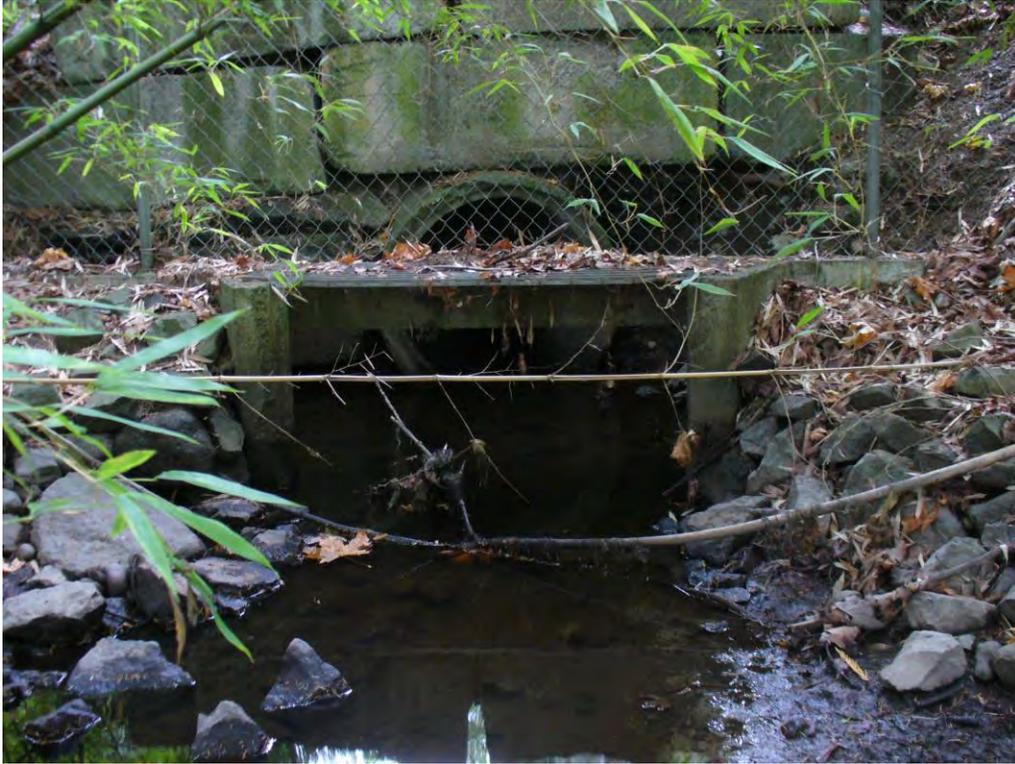
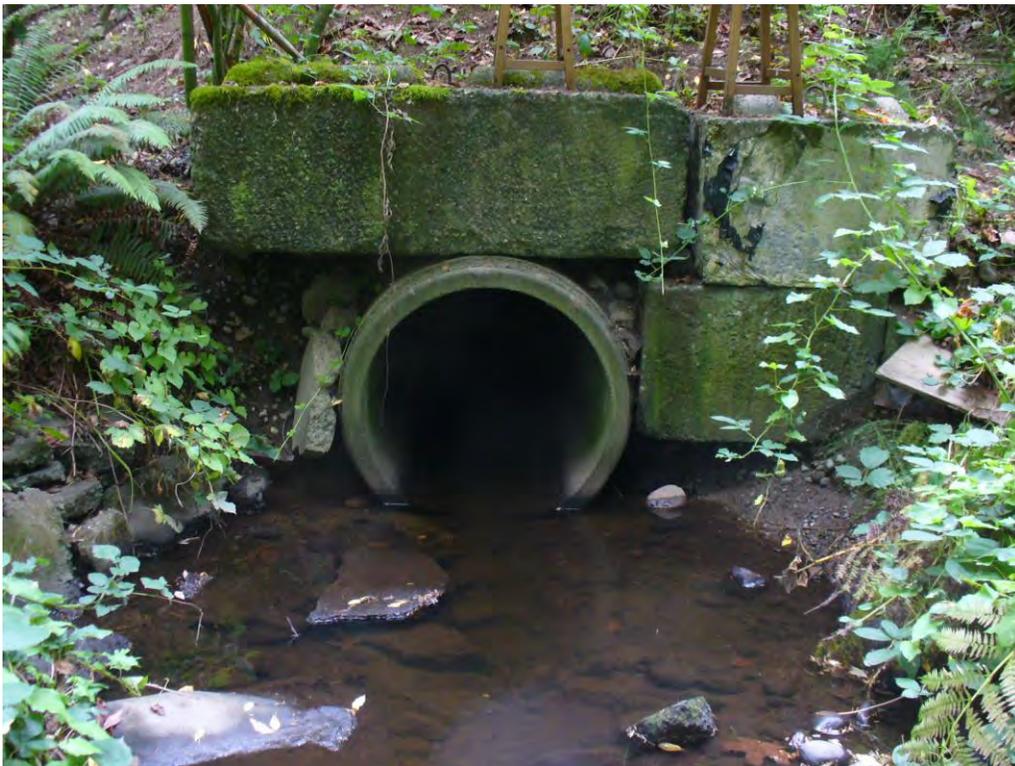
Meets WDFW Culvert Design Manual Criteria? No (1.25 OHW width for no slope, 1.2 OHW width +2 for stream simulation Hydraulic Option not amenable to field assessment).

Figure 62. Culvert FO-9 Inlet at NE 100th Street, 9-17-13

Figure 63. Culvert FO-9 Outlet at NE 100th Street, 9-17-13

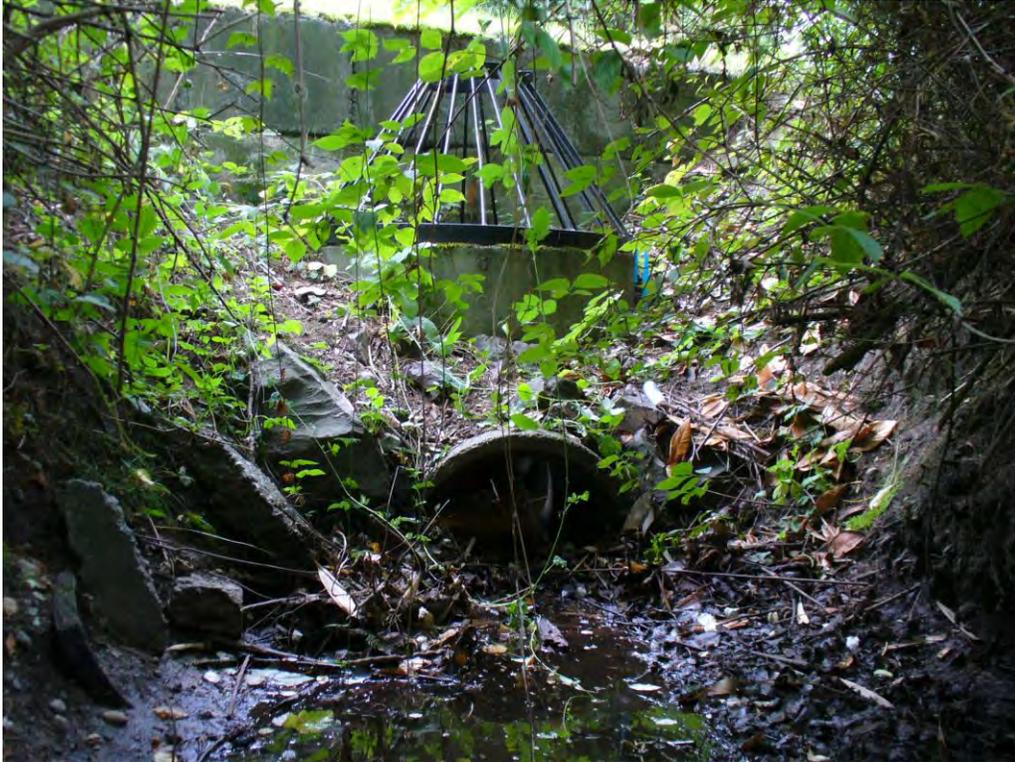
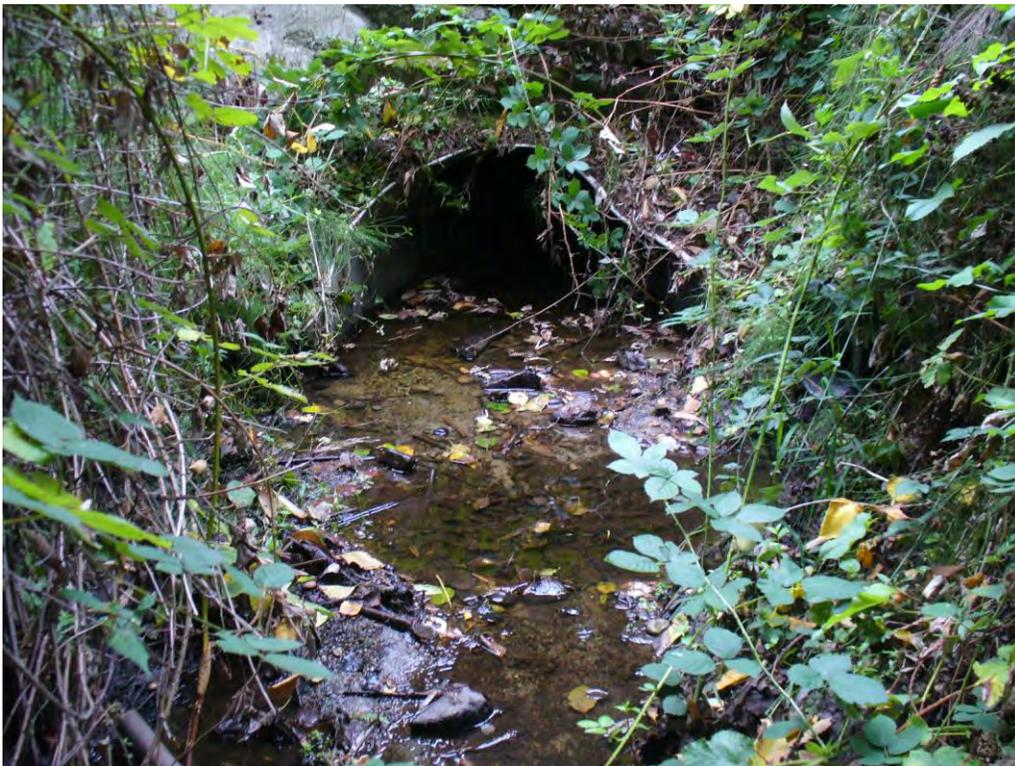
Meets WDFW Culvert Design Manual Criteria? Does not meet with standards, but does have some substrate. (1.25 OHW width for no slope, 1.2 OHW width +2 for stream simulation Hydraulic Option not amenable to field assessment).

Figure 66. Culvert FO-11 Inlet at NE 97th Street, 9-17-13

Figure 67. Culvert FO-12 Outlet at NE 97th Street, 9-17-13

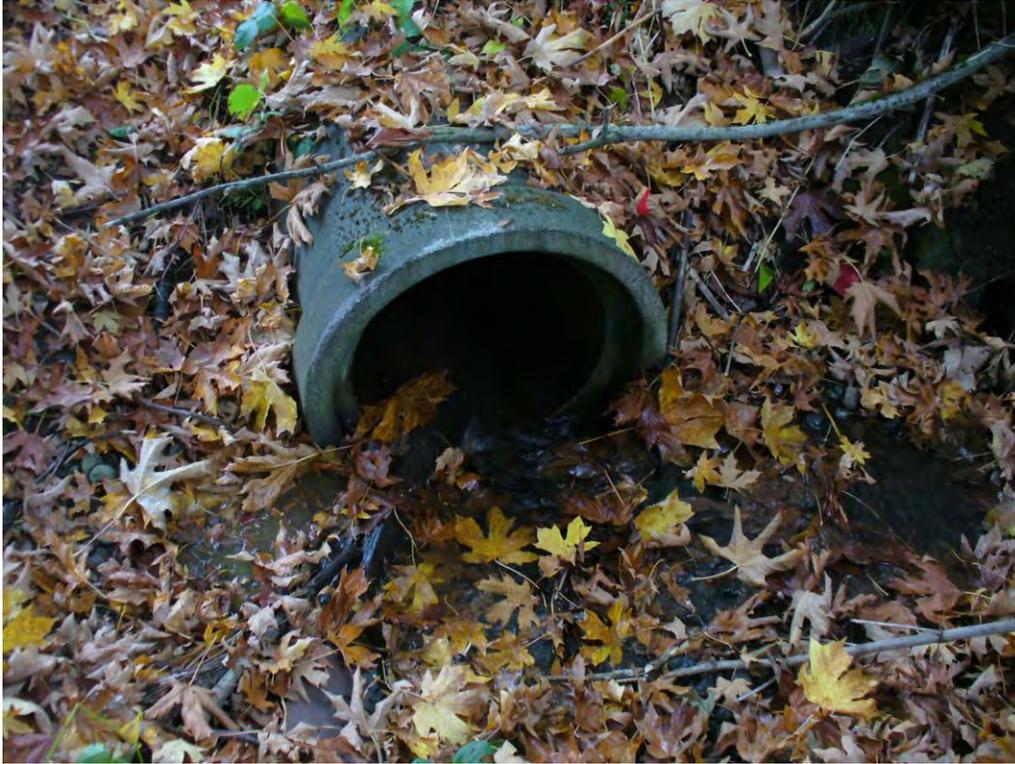
Meets WDFW Culvert Design Manual Criteria? (NO) 1.25 OHW width for no slope, 1.2 OHW width +2 for stream simulation (Hydraulic Option not amenable to field assessment).

Figure 68. Culvert MB-1 Inlet in CKC, 10-25-13

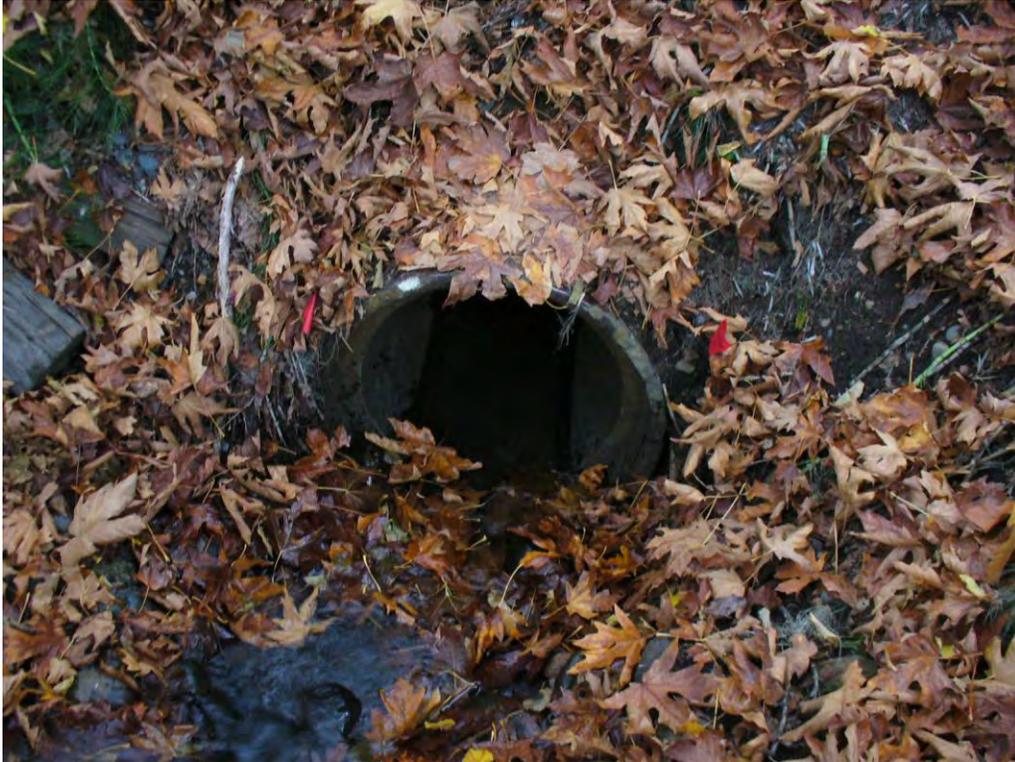
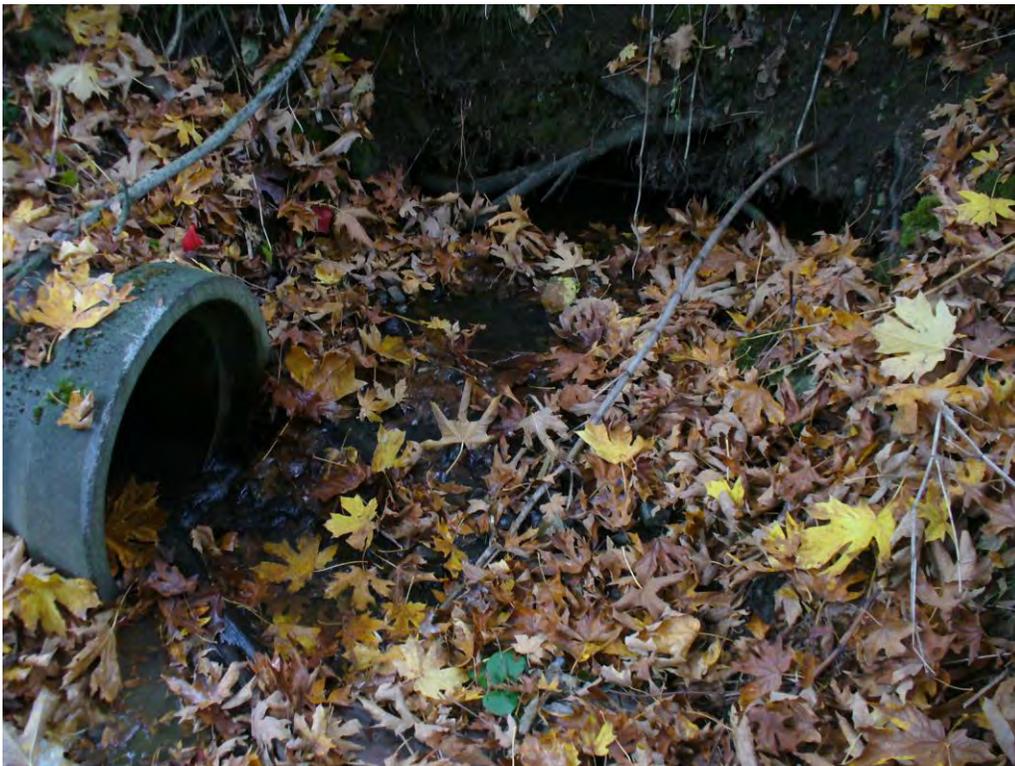
Meets WDFW Culvert Design Manual Criteria? (No). 1.25 OHW width for no slope, 1.2 OHW width +2 for stream simulation (Hydraulic Option not amenable to field assessment).

Figure 69. Culvert MB-2 Inlet at Railroad Avenue (CKC), 10-25-13

Figure 70. Culvert MB-2 Outlet at Railroad Avenue (CKC), 10-25-13

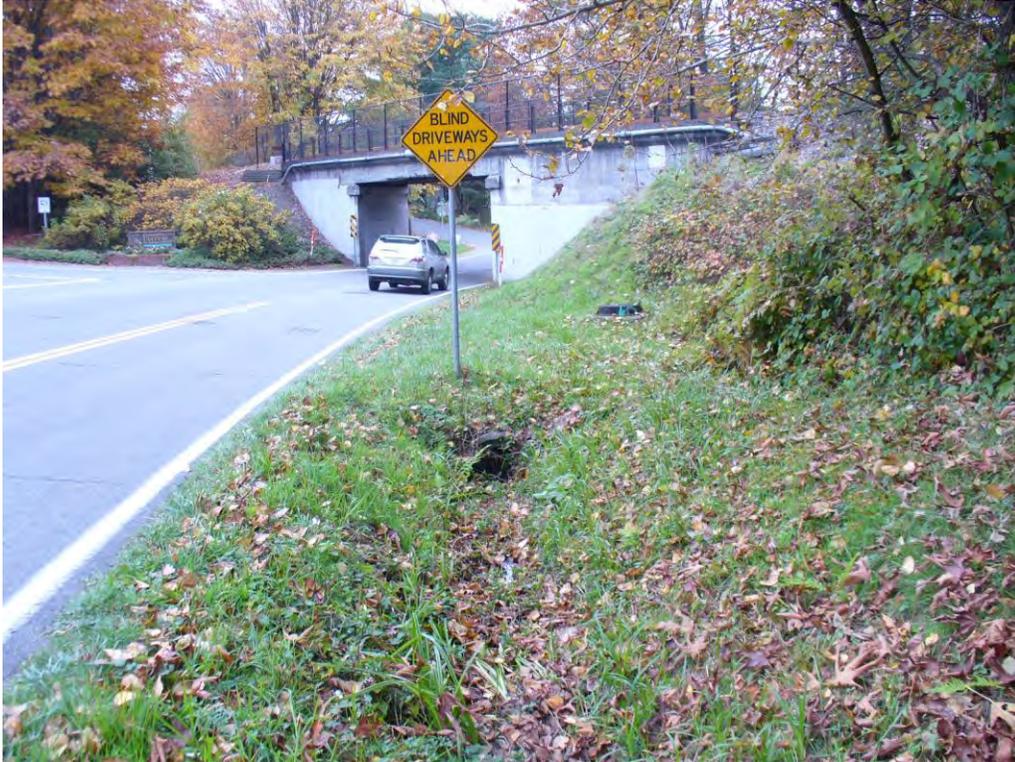
Figure 72. Culvert MB-4 Inlet near Kirkland Way, 10-25-13

Meets WDFW Culvert Design Manual Criteria? (No) 1.25 OHW width for no slope, 1.2 OHW width +2 for stream simulation (Hydraulic Option not amenable to field assessment).

MB-4 (CKC-10)	Moss Bay drainages (mostly piped to mouth)	30-inch RCP	Near Kirkland Way	4 (or N/A?). No flow, no channel at plugged outfall, though flow apparently piped farther downslope in another pipe.	Found 24-inch concrete inlet as the ditch/swale along Kirkland Way. Then "DRAIN" manhole along CKC. Found 30-inch CMP "outfall" on west side of CKC fully filled with concrete! Flow apparently piped farther downslope in another pipe.	Similar to other small CKC drainages, stream is likely too small to be fish-bearing. It is likely not accessible to migratory fish due to long piped sections downstream with possible included plunges and/or velocity barriers. Limited or no habitat upstream. Very low priority. Could be high cost due to convoluted nature of crossing.	4	0.0
MB-5 (CKC-9)	Moss Bay drainages (mostly piped to mouth)	Unable to confirm because the outlet is submerged (36-inch RCP from list)	Kirkland Way	3 - Not a full barrier due to outfall conditions, but upstream unknown.	There is no culvert inlet along CKC. Unable to verify culvert size and type because the outlet is submerged. Slope appears fairly flat due to backwatering at outfall.	Similar to other small CKC drainages, stream is likely too small to be fish-bearing. It is likely not accessible to migratory fish due to long piped sections downstream with possible included plunges and/or velocity barriers. Limited or no habitat upstream. Since there is a lack of habitat upstream, this culvert's improvement for fish passage or habitat purposes should be given a very low priority. Moderate cost.	4	0.0

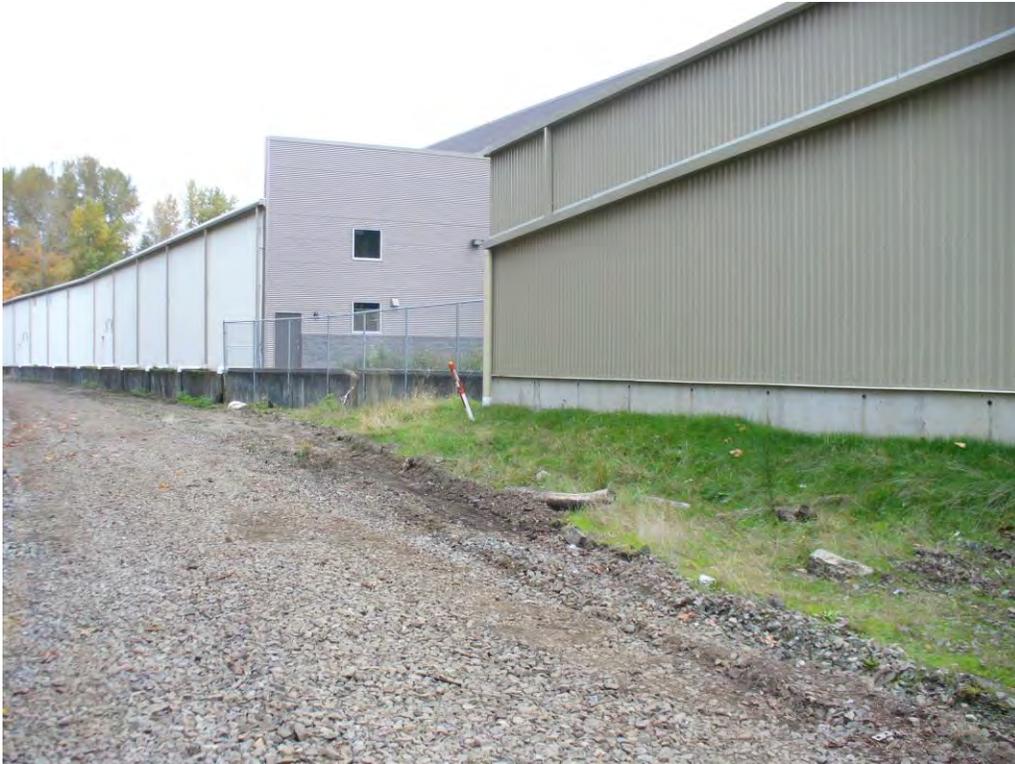
Figure 74. Culvert MB-5 No Inlet at Kirkland Way, 10-25-13

Meets WDFW Culvert Design Manual Criteria? (No) 1.25 OHW width for no slope, 1.2 OHW width +2 for stream simulation (Hydraulic Option not amenable to field assessment).

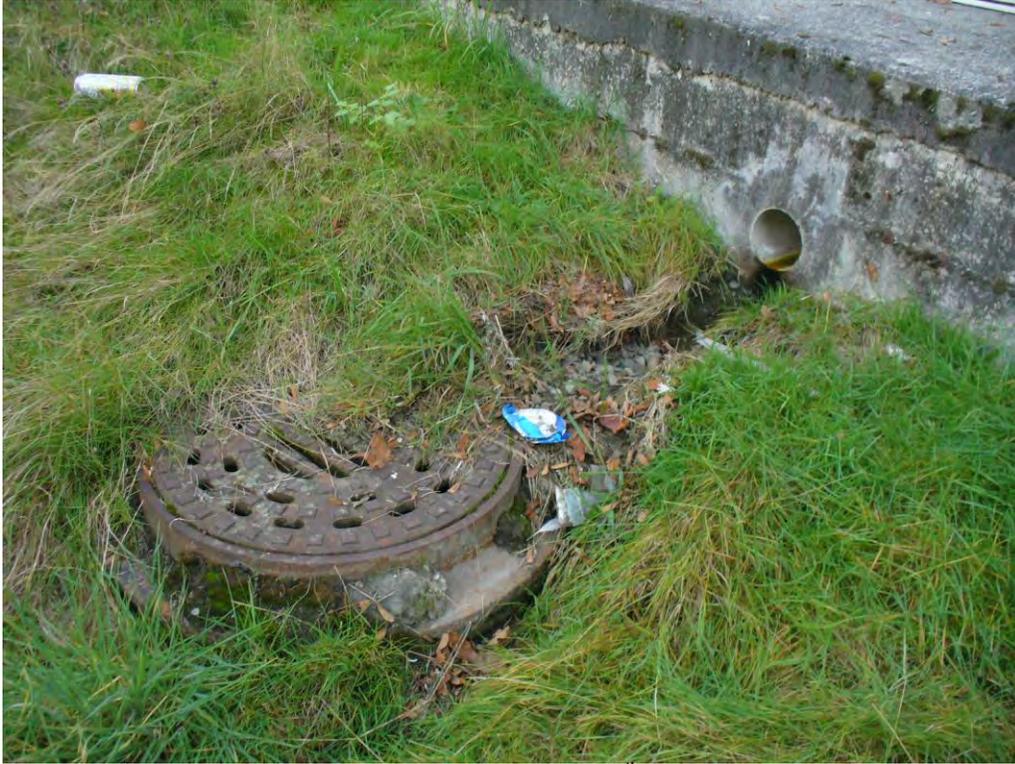
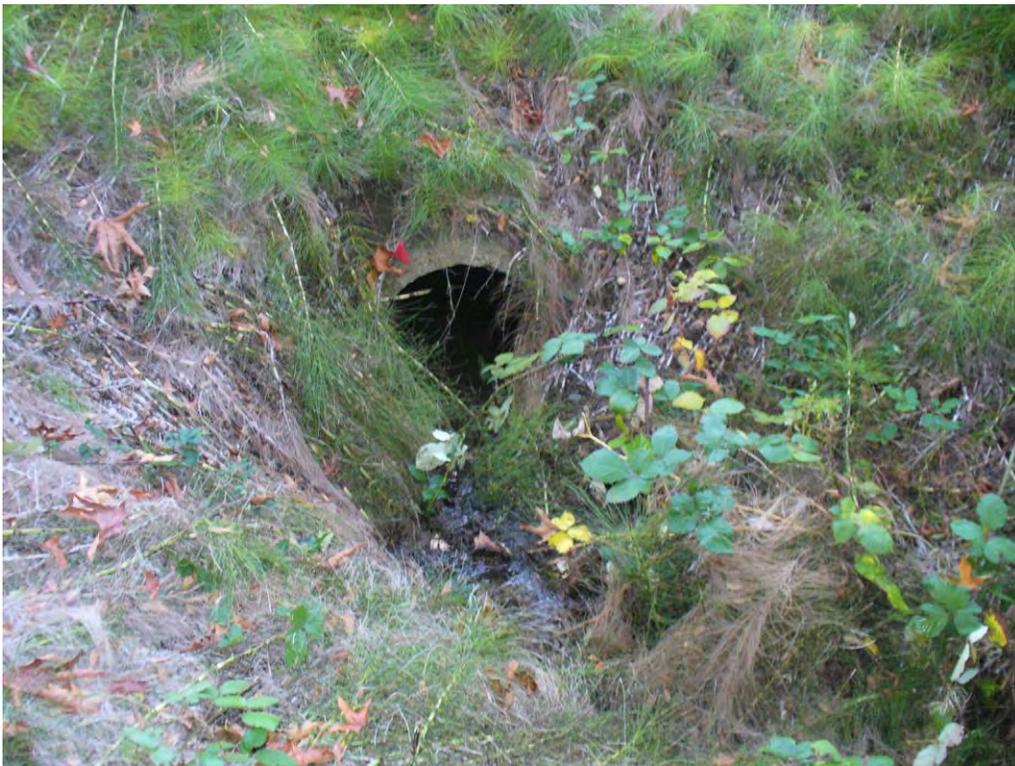
Figure 76. Culvert MB-6 Inlet south of NE 85th Street (CKC), 10-23-13

Figure 77. Culvert MB-6 Outlet south of NE 85th Street (CKC), 10-23-13

Meets WDFW Culvert Design Manual Criteria? (No.) 1.25 OHW width for no slope, 1.2 OHW width +2 for stream simulation (Hydraulic Option not amenable to field assessment).

MB-6 (CKC-8)	Moss Bay drainages (mostly piped to mouth)	24-inch concrete	CKC - South of 85th	2 - The culvert itself is not a barrier to the manhole on the east side	Manhole with no inlet next to storage building on upstream side. Minimal trickle of flow present 10/23.	The culvert is already passable, though it would not meet current standards for width etc. Very low priority since it is already passable and no habitat would be made accessible upstream.	4	0.0
MB-7 (CKC-7)	Moss Bay drainages (mostly piped to mouth)	North CKC swale inlet 18-inch CMP, South CKC swale inlet 12-inch plastic, found inlet to 24-inch CMP upslope	CKC - North of 85th	4 - Full barrier	Pipes enter from both north and south along the CKC, but a stream/drainage culvert inlet was also found beyond the blackberries upstream. A 24-inch CMP with a trickle of flow on 10/23/13. Outlet not found. Slope 6% based on inlet, sounds of plunges within.	Stream is likely too small to be fish-bearing. It is likely not accessible to migratory fish due to long piped sections downstream with possible included plunges and/or velocity barriers. Limited or no habitat upstream. Since there is a lack of habitat upstream, this culvert's improvement for fish passage or habitat purposes should take a fairly low priority. Moderate cost.	4	0.0

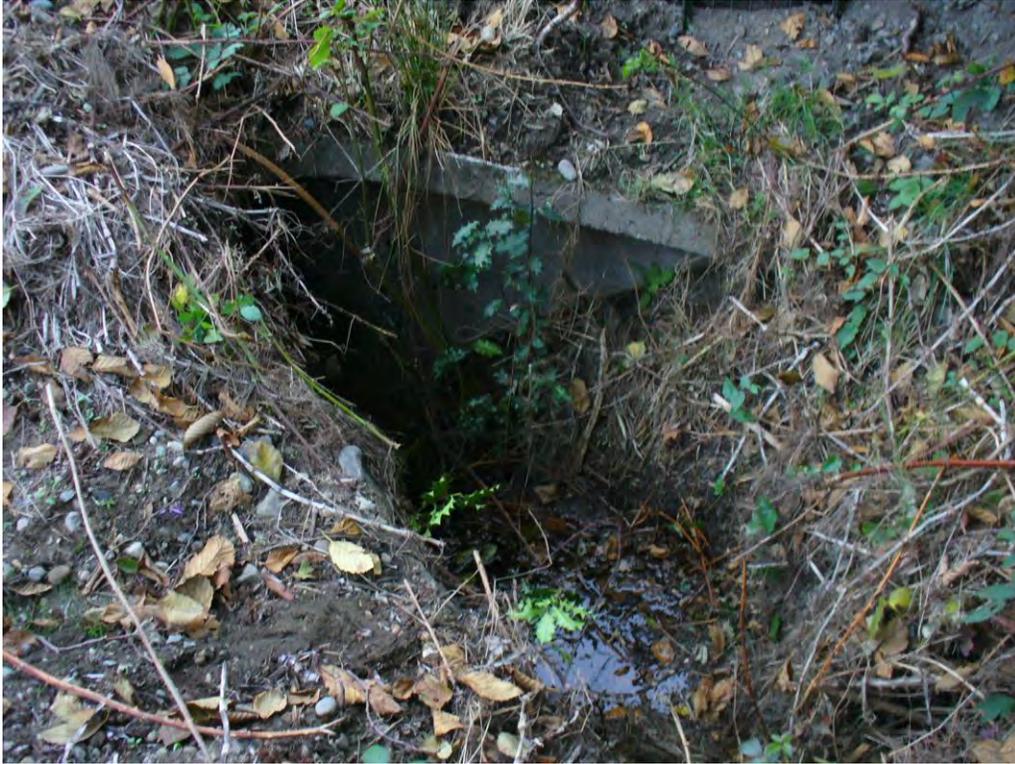
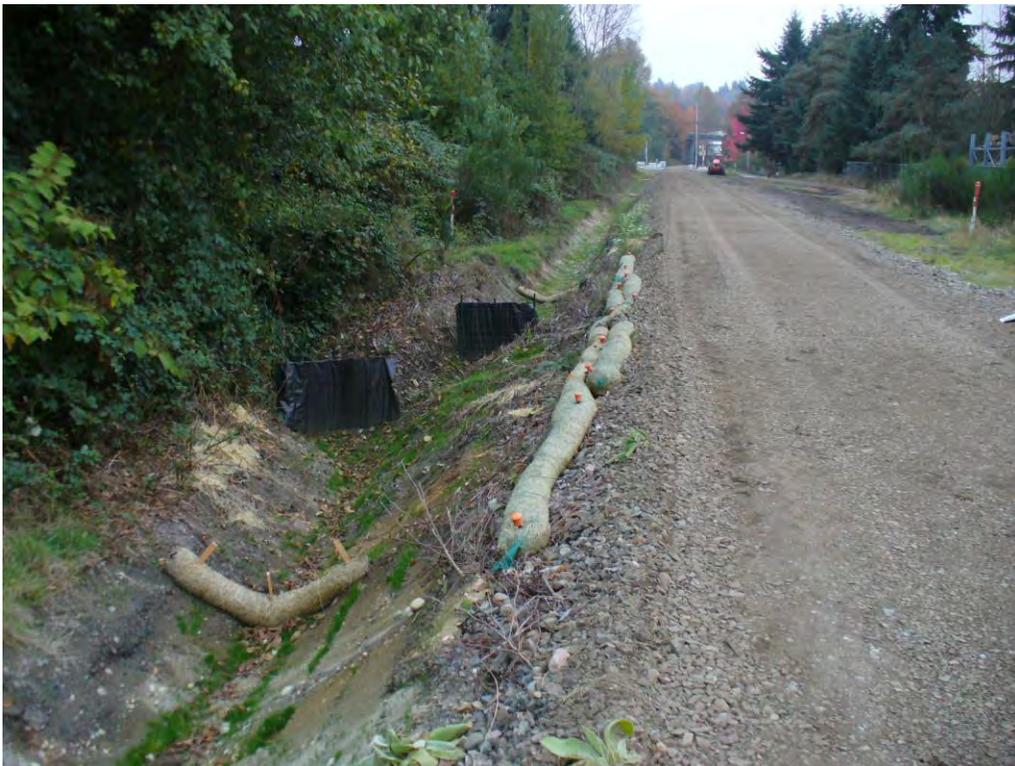
Figure 79. Culvert MB-8 Inlet at 9th Avenue and 9th Street, 10-22-13

Figure 80. Culvert MB-8 Inlet at 9th Avenue and 9th Street, 10-22-13

Meets WDFW Culvert Design Manual Criteria? (No) 1.25 OHW width for no slope, 1.2 OHW width +2 for stream simulation (Hydraulic Option not amenable to field assessment).

MB-8 (CKC-6)	Moss Bay drainage (mostly piped to mouth)	3-foot diameter concrete	9th Ave, 9th Street	4 - Full barrier due to slope and length	Trickle of flow. Steep upstream. Doubtful that there is too much habitat to open up - upstream. Outlet not found. Moderately steep + 5-6%	Stream is likely too small to be fish-bearing. It is likely not accessible to migratory fish due to long piped sections downstream with possible included plunges and/or velocity barriers. However, the creek may have year-around flow. Limited or no habitat upstream. Since there is a lack of habitat upstream, this culvert's improvement for fish passage or habitat purposes should take a fairly low priority. Moderate cost.	4	0.0
MB-9 (CKC-5)	Moss Bay (mostly piped to mouth)	24-inch concrete	NE 96th Street	2 - Passable, but would not meet design standards	This culvert would be readily passable by any, say, resident cutthroat that may inhabit the stream now or going forward, however stream is almost entirely piped downstream. No plunge - culvert is half-full backwatered at outfall	Fish use was not detected by electrofishing in 1998. It is likely not accessible to migratory fish due to long piped sections downstream with possible included plunges and/or velocity barriers. However, the creek may have year-around flow. Limited length of channel and habitat upstream. Since this culvert is mostly passable at present and limited habitat occurs upstream, it's improvement for fish passage or habitat purposes should take a fairly low priority. Moderate cost.	3	1.7

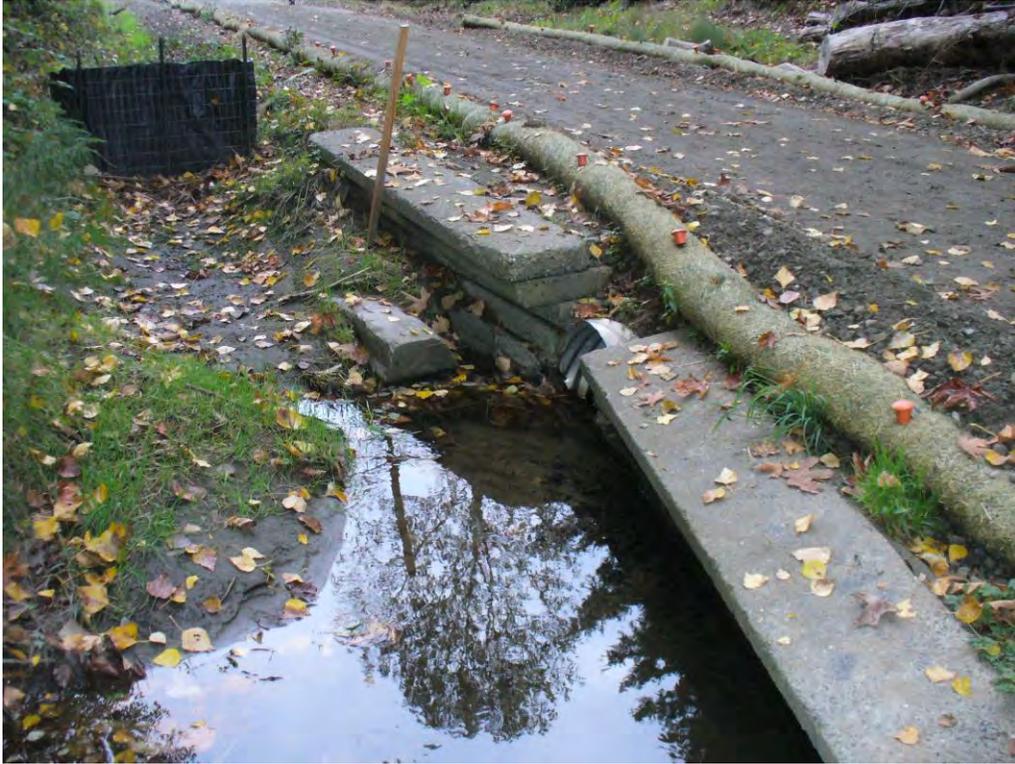
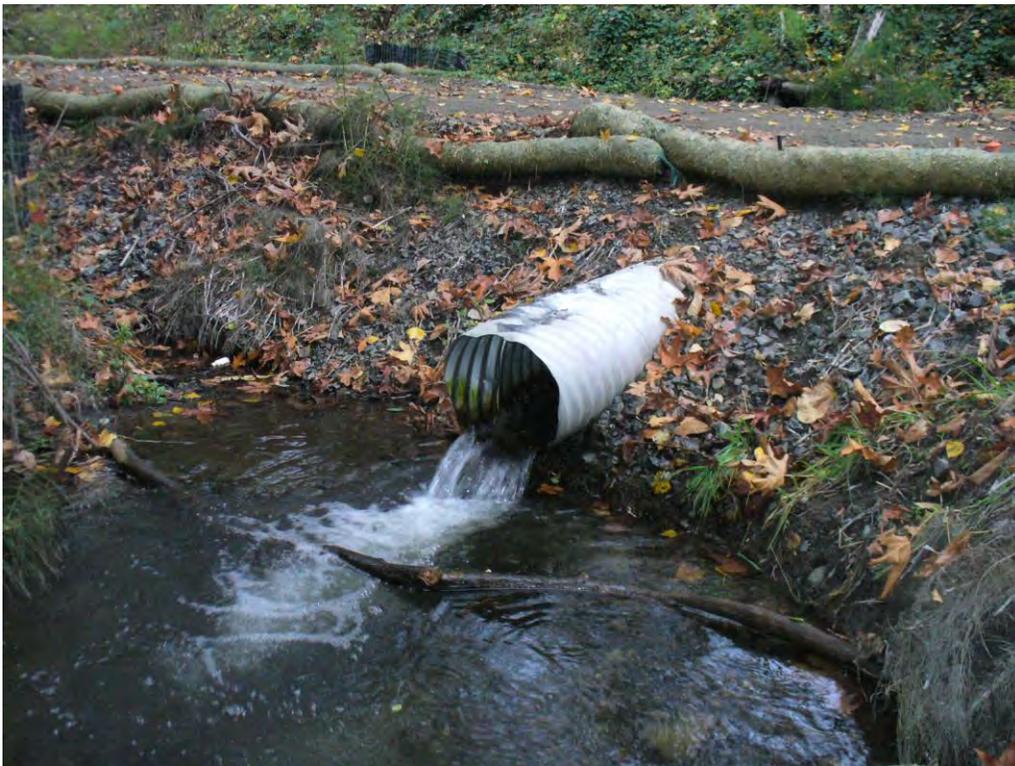
Figure 83. Culvert EC-1 Inlet between 6th Street S and Railroad Avenue, 10-25-13

Figure 84. Culvert EC-1 Outlet between 6th Street S and Railroad Avenue, 10-25-13

Meets WDFW Culvert Design Manual Criteria? (No) 1.25 OHW width for no slope, 1.2 OHW width +2 for stream simulation (Hydraulic Option not amenable to field assessment).

Everest Creek								
EC-1 (CKC-11)	Everest Creek	18-inch CMP	CKC Between 6th Street S. and Railroad Ave.	3 - some fish could get though due to the short length and pool at the outfall.		Everest Creek is likely not accessible to migratory fish due to long piped sections downstream with possible included plunges and/or velocity barriers. However, would rank this culvert fairly high for replacement in spite of moderate PI: 1) It is a problem 2) The stream has good year-around flows and could support fish if re-introduced 3) The culvert is short and near the surface - so should be relatively low-cost and so a good value. Fair amount of habitat available upstream through Everest Park. Another culvert is just upstream that should also be included in the project. Cascades farther upstream. Everest has good year-around flow and could probably support resident trout, if introduced.	1	2.7

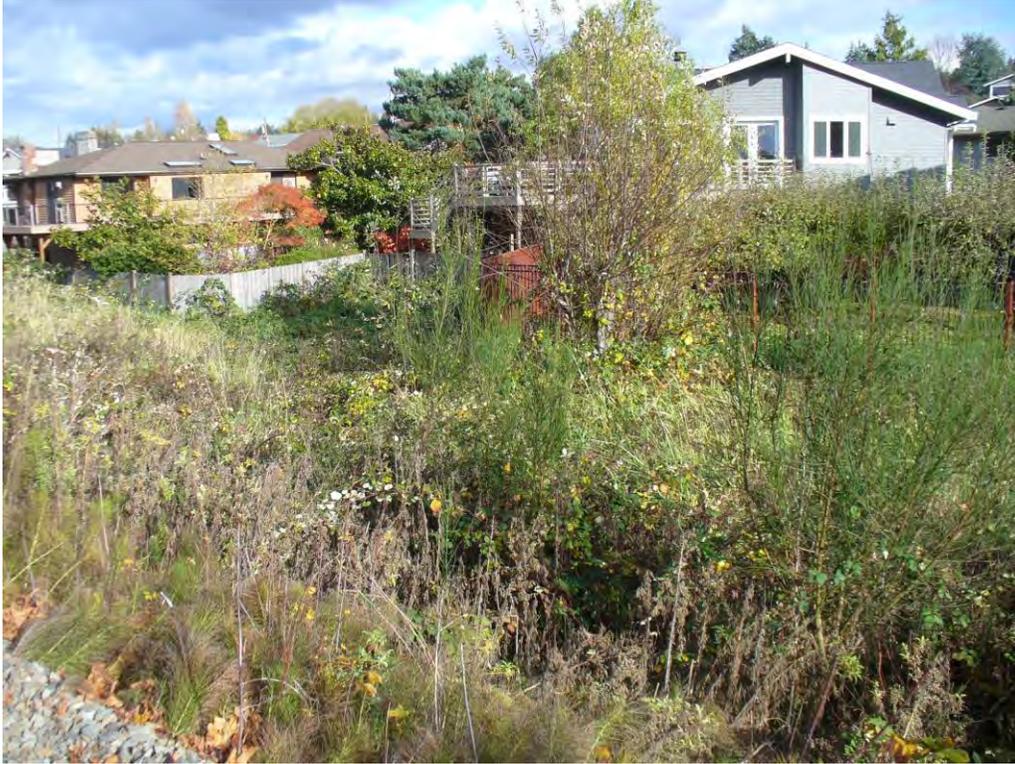
Figure 87. Culvert HSA-1 Inlet between 62nd and 64th Streets, 11-8-13

Meets WDFW Culvert Design Manual Criteria? Would not meet (any?) fish passage design standards. (1.25 OHW width for no slope, 1.2 OHW width +2 for stream simulation Hydraulic Option not amenable to field assessment).

Houghton Slope A								
HSA-1 (CKC-12)	Houghton Slope A	4-foot-diameter concrete	Between 62nd and 64th Streets	4 - full, absolute barrier due to 1) 6-foot cascade plunge at outfall, 2) very long and very steep within, 3) piped for some distance upstream of CKC.	Good flow on 11/8/13. Bank instability on right side. Lots of boulder armoring. Wood in pool below culvert. Fish use unknown, but possible habitat for isolated trout. Culvert inlet(s) not found – mapped as piped for some distance upstream. 5-6 foot boulder cascade plunge, then large pool about 3-1/2 feet deep with wood and boulders. This pool absorbs a lot of energy.	Houghton Slope A Creek. No fish found in 1998 study, but appears to have good flows. Not accessible to migratory fish due to long piped sections downstream with possible included plunges and/or velocity barriers. Possible habitat for a present or future isolated trout population. Extensively piped upstream, so little habitat would be made available without including upstream sections as well. Channel is very steep. Low priority due to barrier(s) downstream and questionable fish presence or fish habitat due to steepness of channel. Very expensive to replace due to high fill of the CKC and extensive piped sections extending upstream.	2	2.3

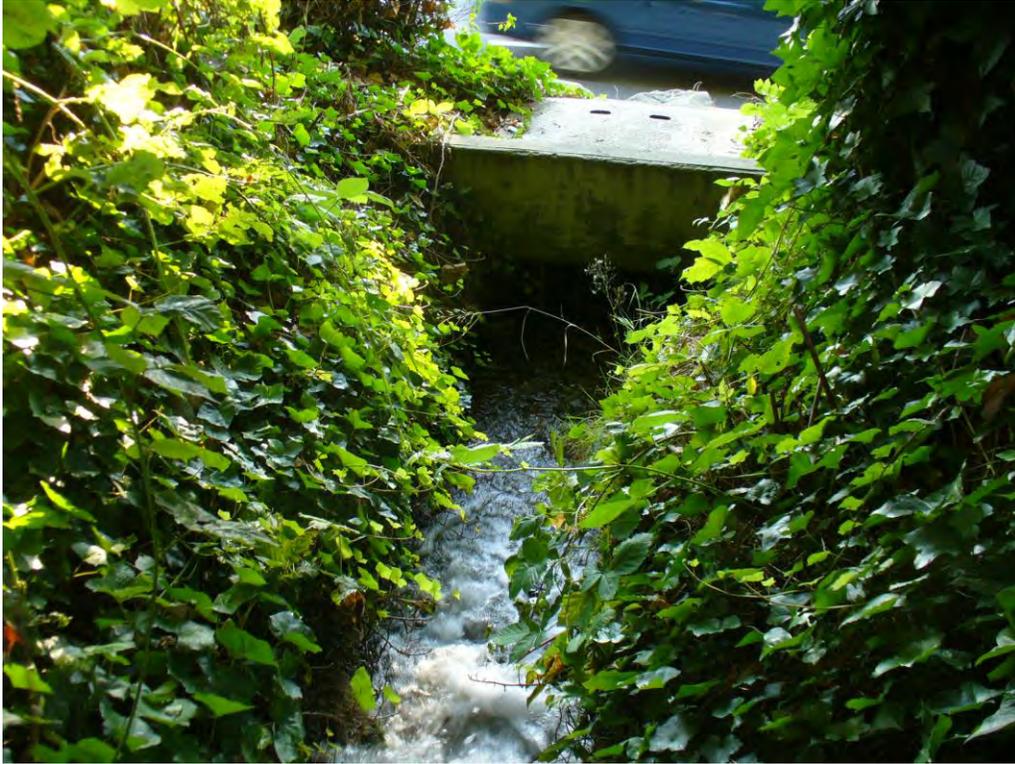
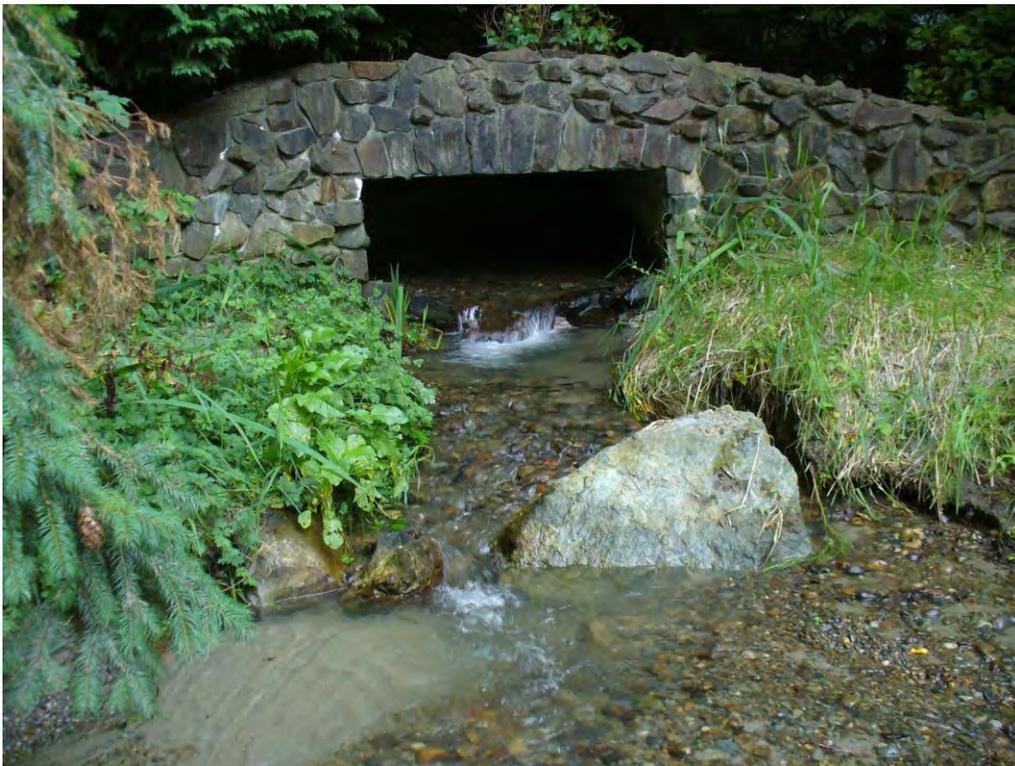
Figure 89. Culvert CC-1 Inlet at Lake Washington Boulevard, 9-12-13

Figure 90. Culvert CC-1 Outlet at Lake Washington Boulevard, 9-12-13

Meets WDFW Culvert Design Manual Criteria? Would not meet (any?) fish passage design standards. (1.25 OHW width for no slope, 1.2 OHW width +2 for stream simulation Hydraulic Option not amenable to field assessment).

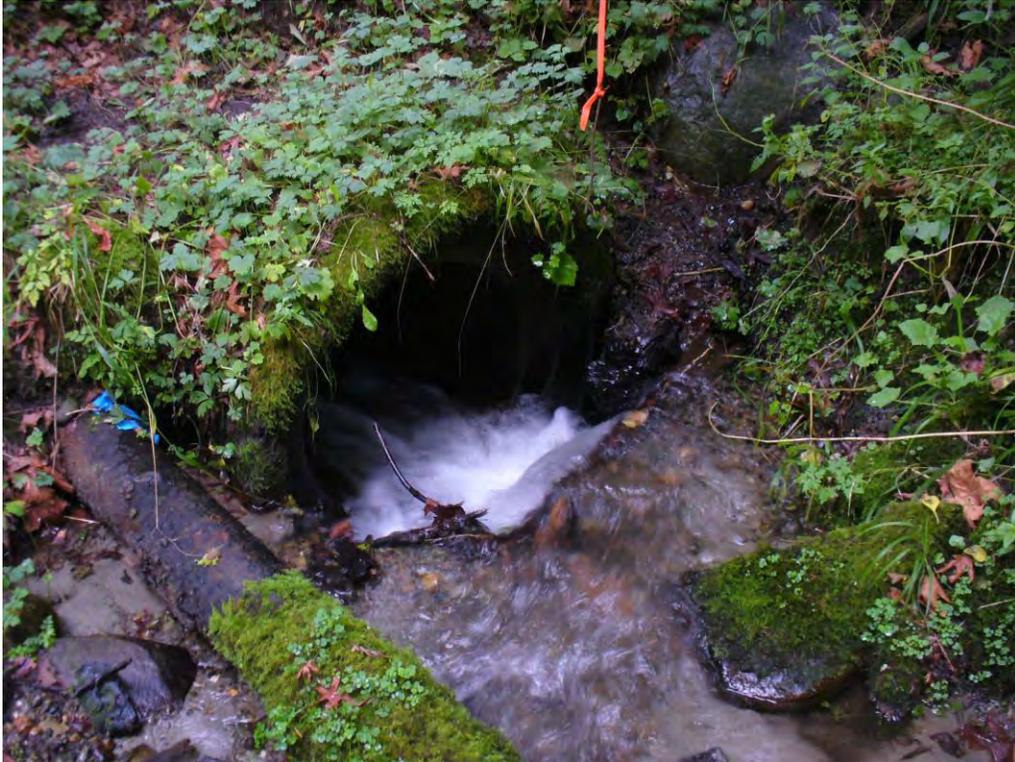
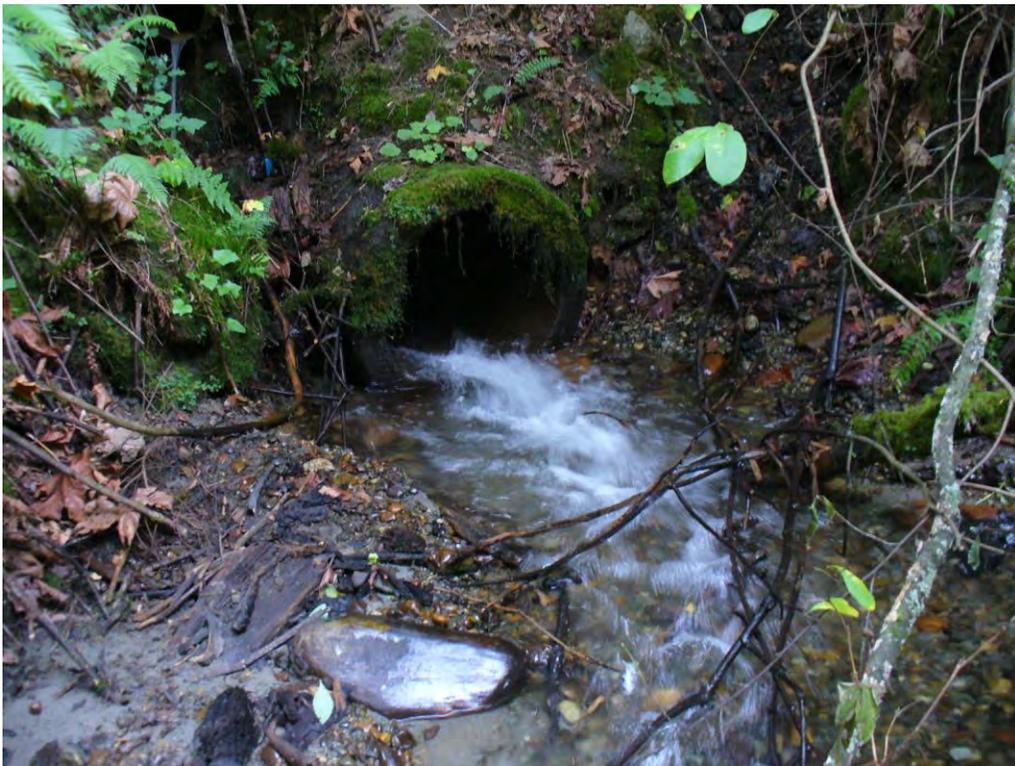
Notes: This is a very steep culvert along a very steep stream segment. Very high fill embankment – expensive to replace at Cross-Kirkland Corridor. Fish presence not known but doubtful due to downstream barriers and overall steepness of the channel.

Figure 91. Culvert CC-2 Inlet at Cross Kirkland Corridor, 9-13-13

Figure 92. Culvert CC-2 Outlet at Cross Kirkland Corridor, 9-13-13
