Culvert Assessment Memorandum

Preliminary Assessments: Fish Passage at City of Kirkland Road and Trail Stream Culverts

August 2014

The Watershed Company Reference Number:
120612

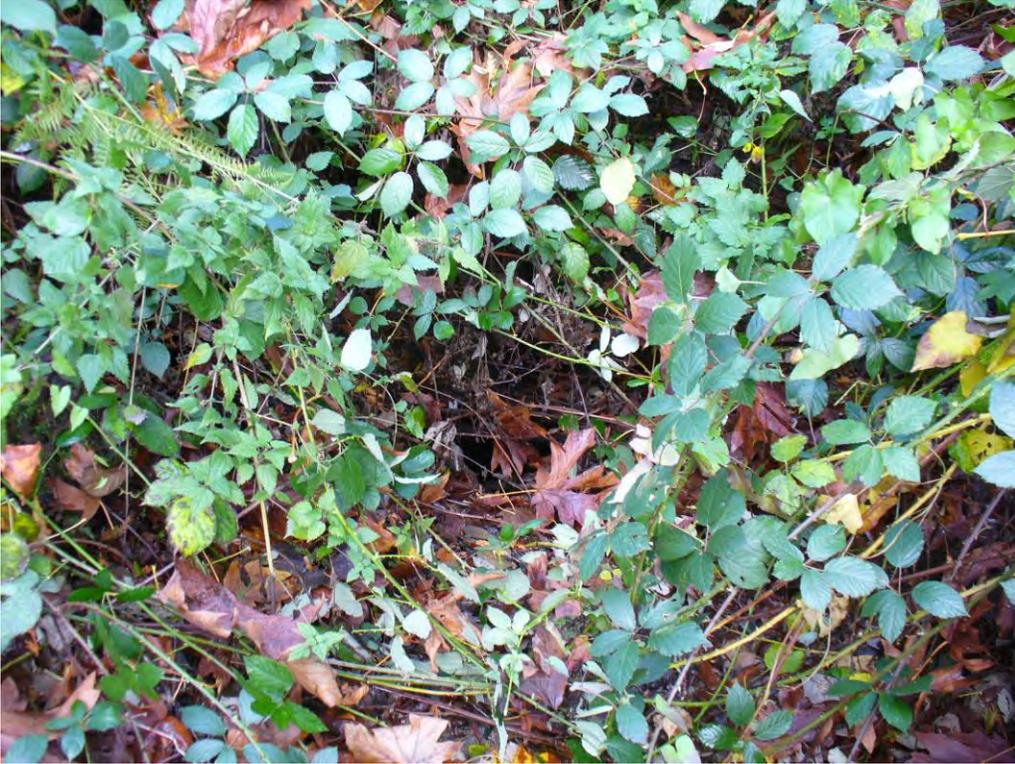
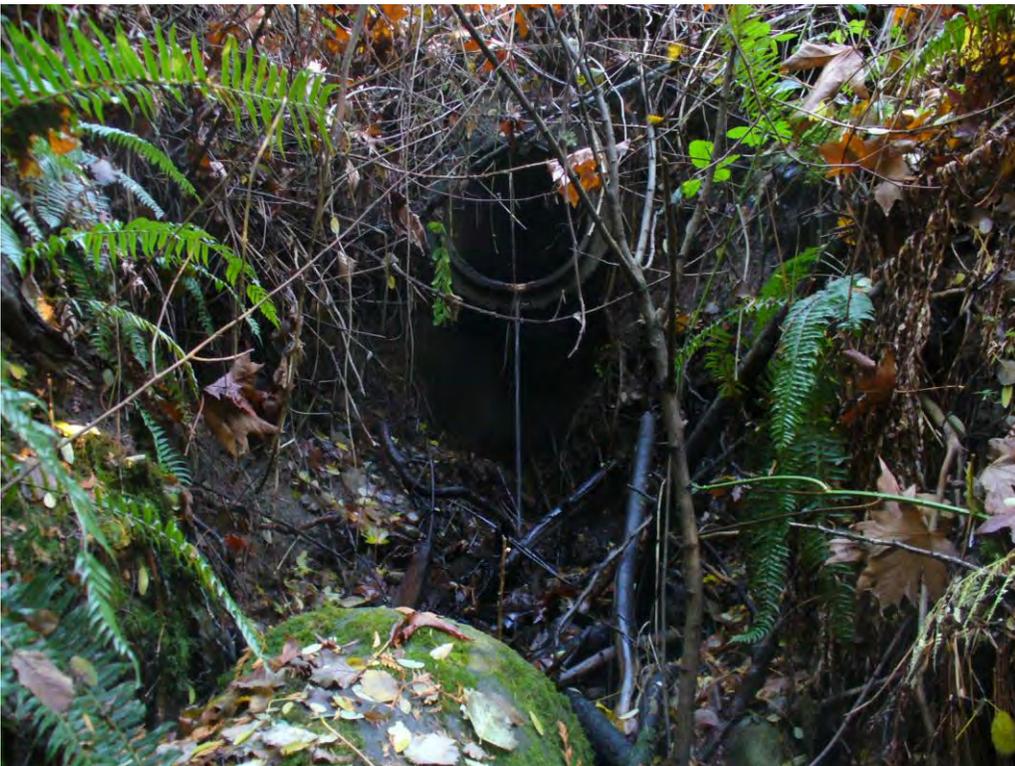
Figure 95. Culvert HSB-2 Inlet at NE 44th Street, 11-8-13

Figure 96. Culvert HSB-2 Outlet at NE 44th Street, 11-8-13
