Culvert Assessment Memorandum

Preliminary Assessments: Fish Passage at City of Kirkland Road and Trail Stream Culverts

Fish Passage at City of Kirkland Road and Trail Stream Culverts

August 2014

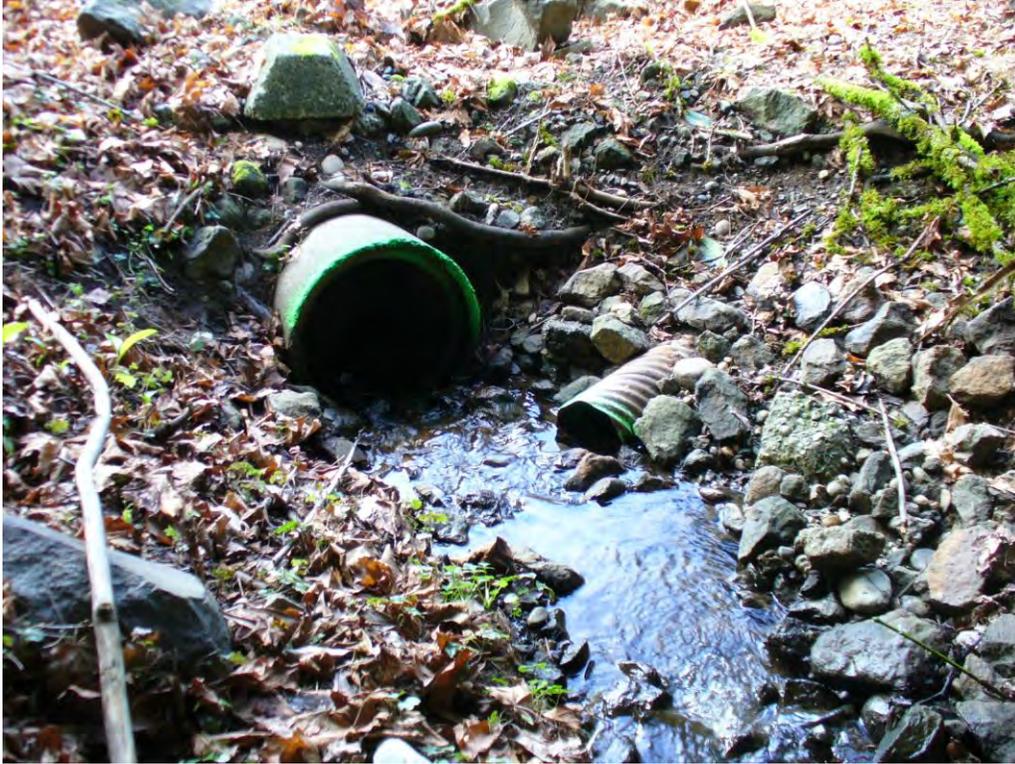
Figure 13. Culvert CH-1 Inlet at Juanita Drive, 2-8-13

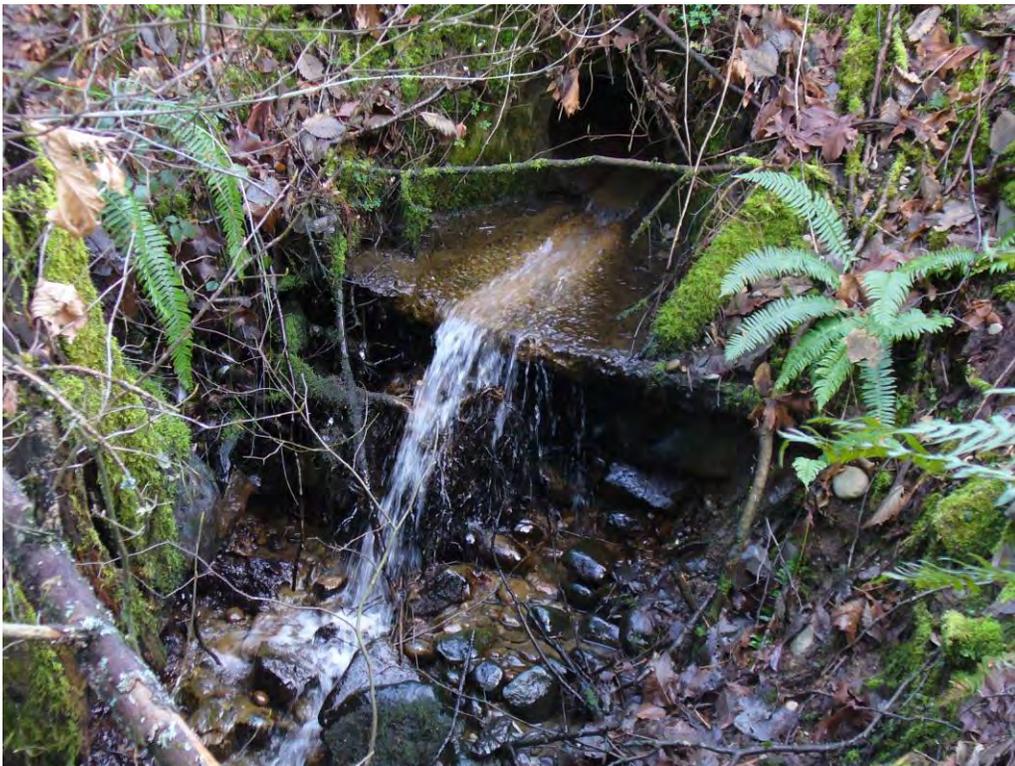
Figure 14. Culvert CH-1 Outlet at Juanita Drive, 2-8-13

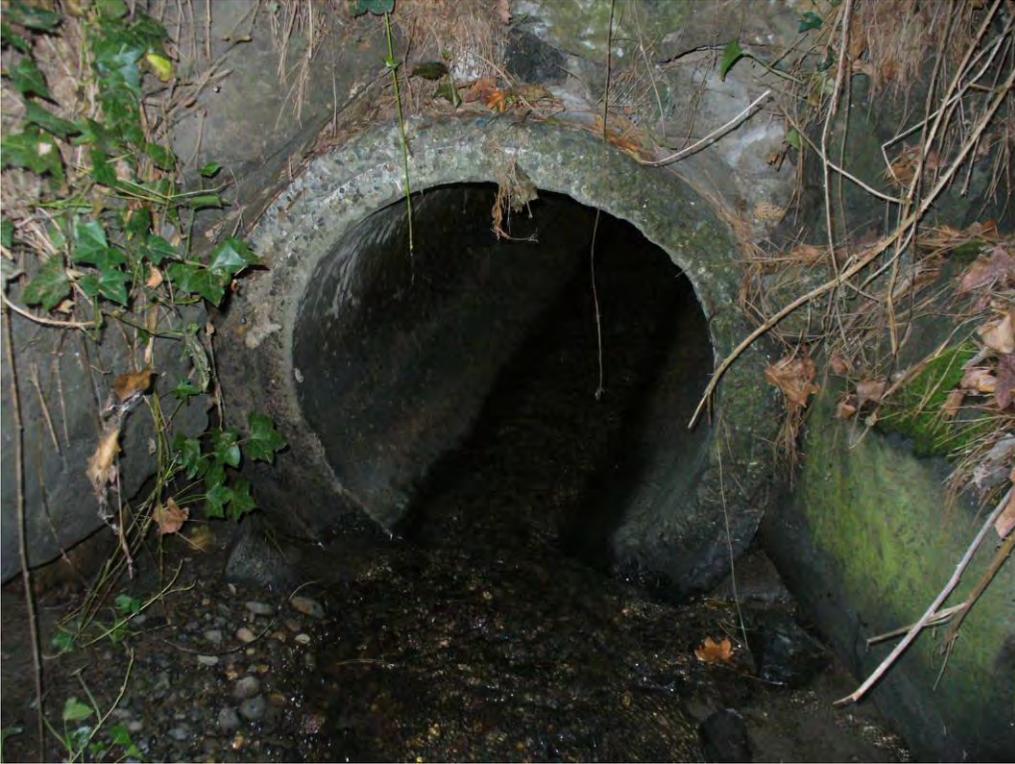
Figure 17. Culvert JC-9 Juanita NW Tributary Inlet at NE 137th Place

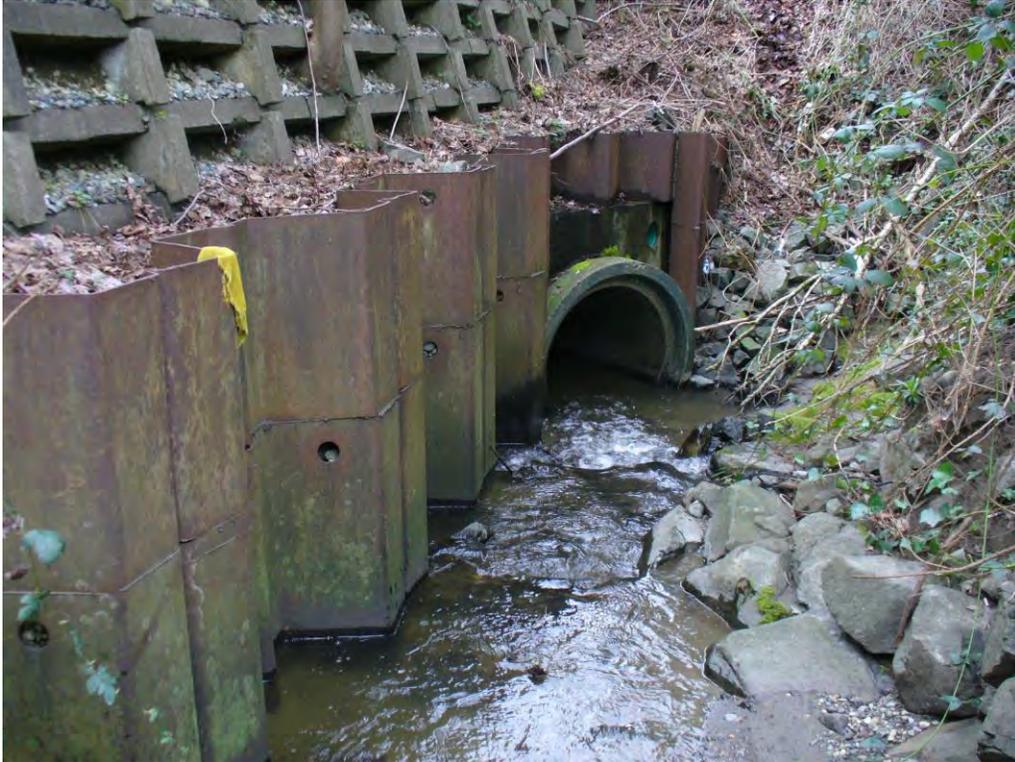
Meets WDFW Culvert Design Manual Criteria? No. (1.25 OHW width for no slope, 1.2 OHW
width +2 for stream simulation. (Hydraulic Option not amenable to field assessment).

Figure 18. Culvert JC-10 Inlet at Juanita Woodinville Way, 3-11-13

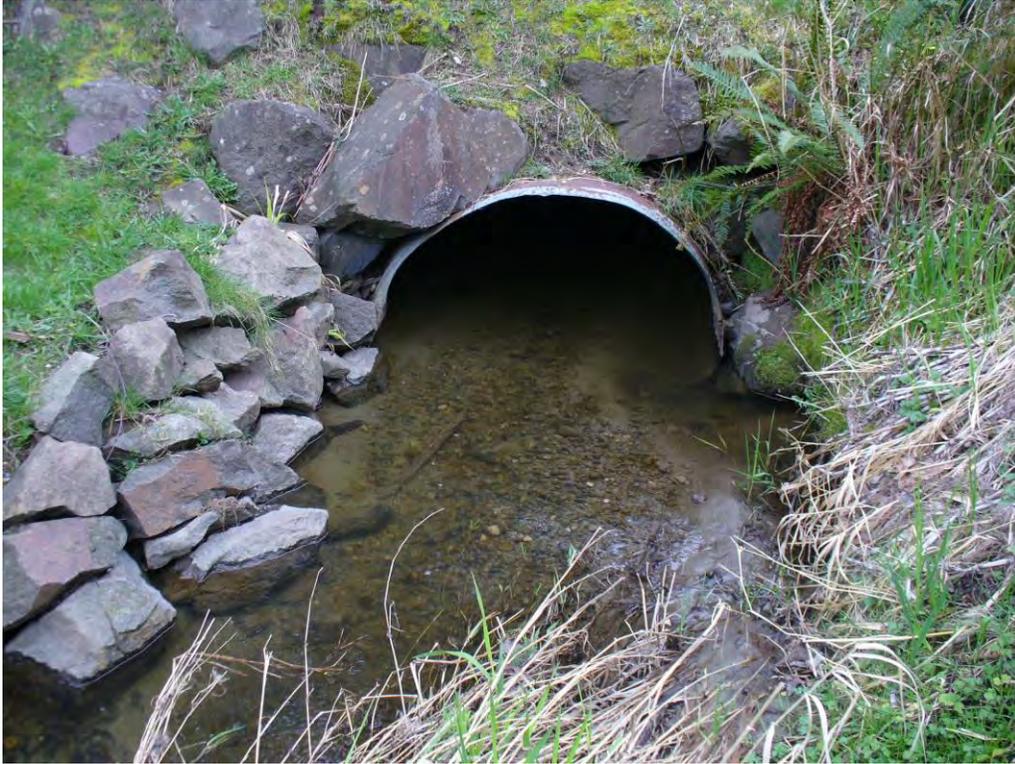
Meets WDFW Culvert Design Manual Criteria? No, too narrow. (1.25 OHW width for no slope, 1.2 OHW width +2 for stream simulation. Hydraulic Option not amenable to field assessment).

Figure 24. Culvert JC-13 Inlet at 101st Place NE, 3-11-13

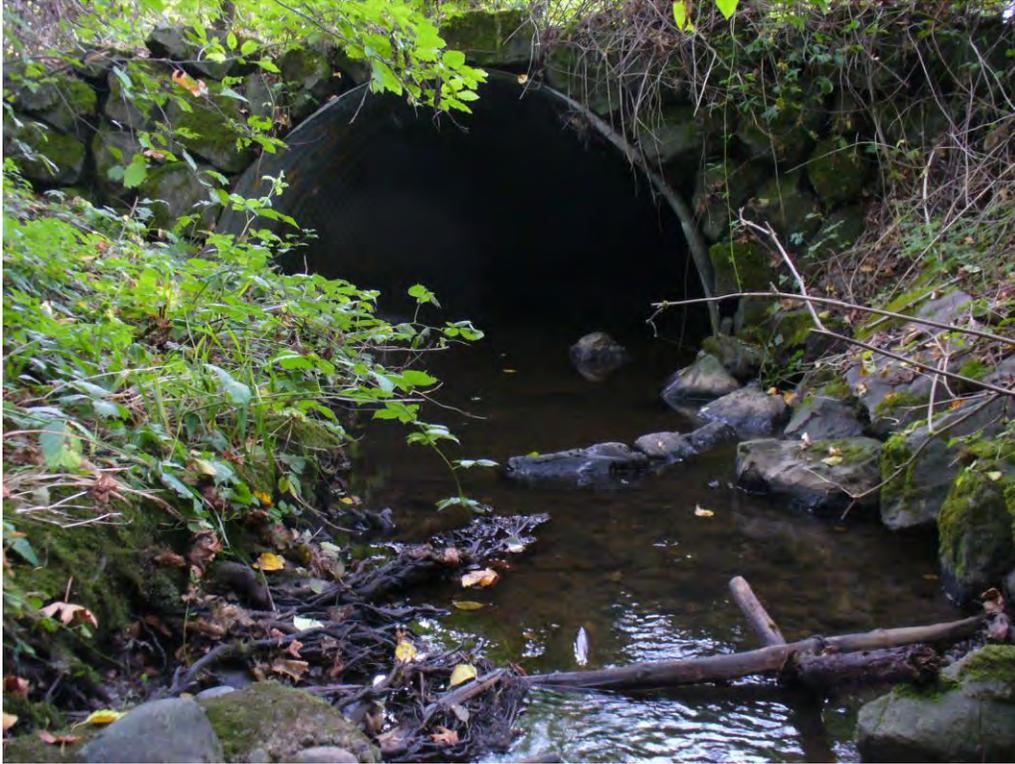
Figure 50. Culvert FO-2 Inlet at Forbes Creek Drive, 9-13-13

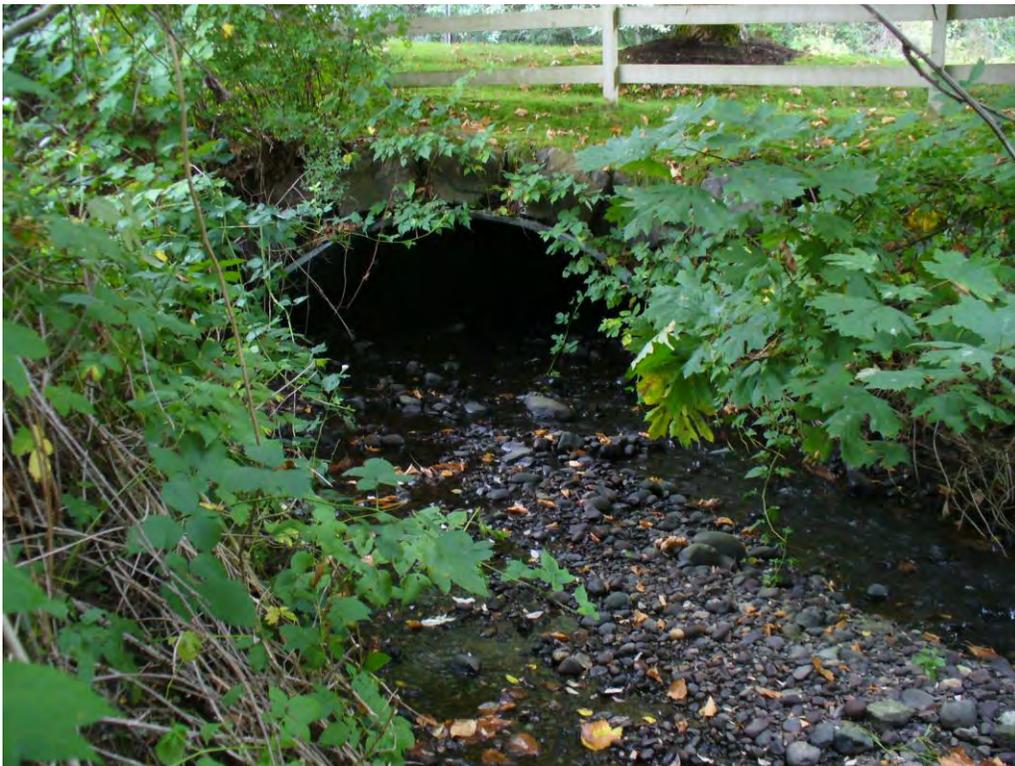
Figure 51. Culvert FO-2 Outlet at Forbes Creek Drive, 9-13-13

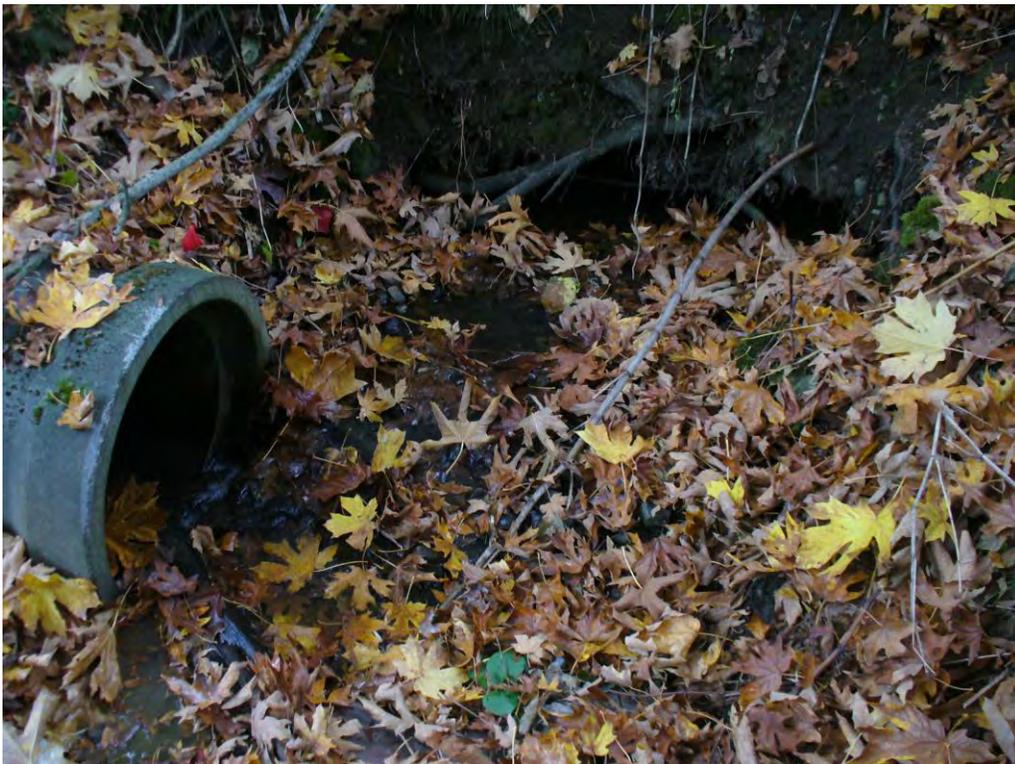
Figure 70. Culvert MB-2 Outlet at Railroad Avenue (CKC), 10-25-13

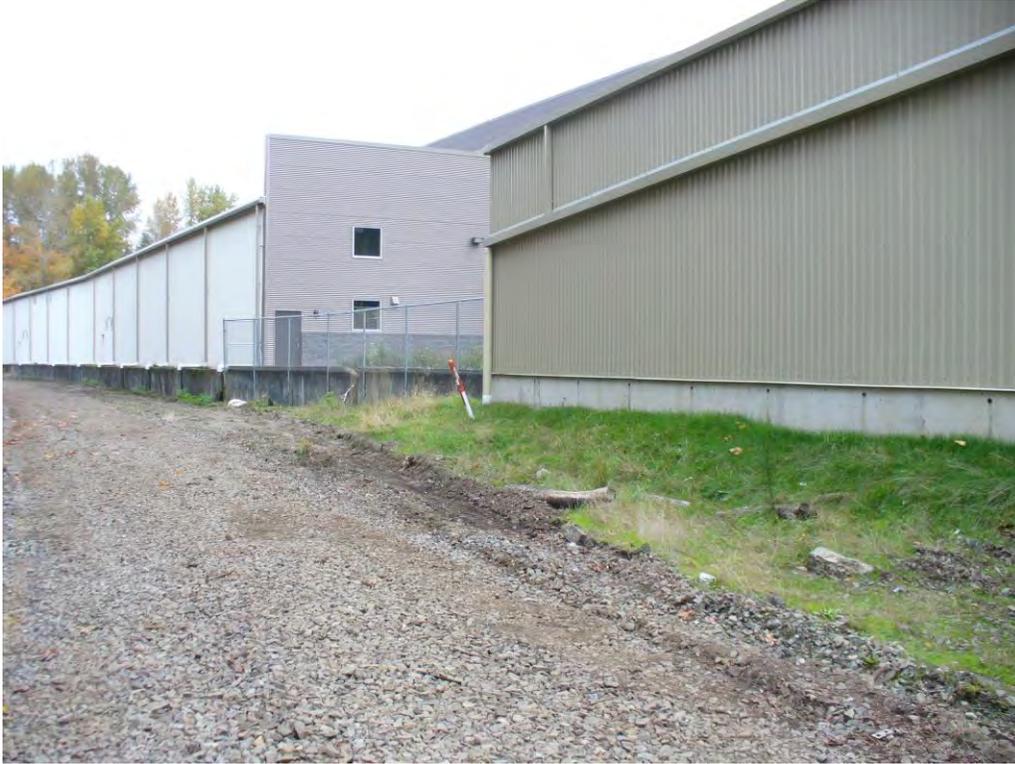
Figure 74. Culvert MB-5 No Inlet at Kirkland Way, 10-25-13

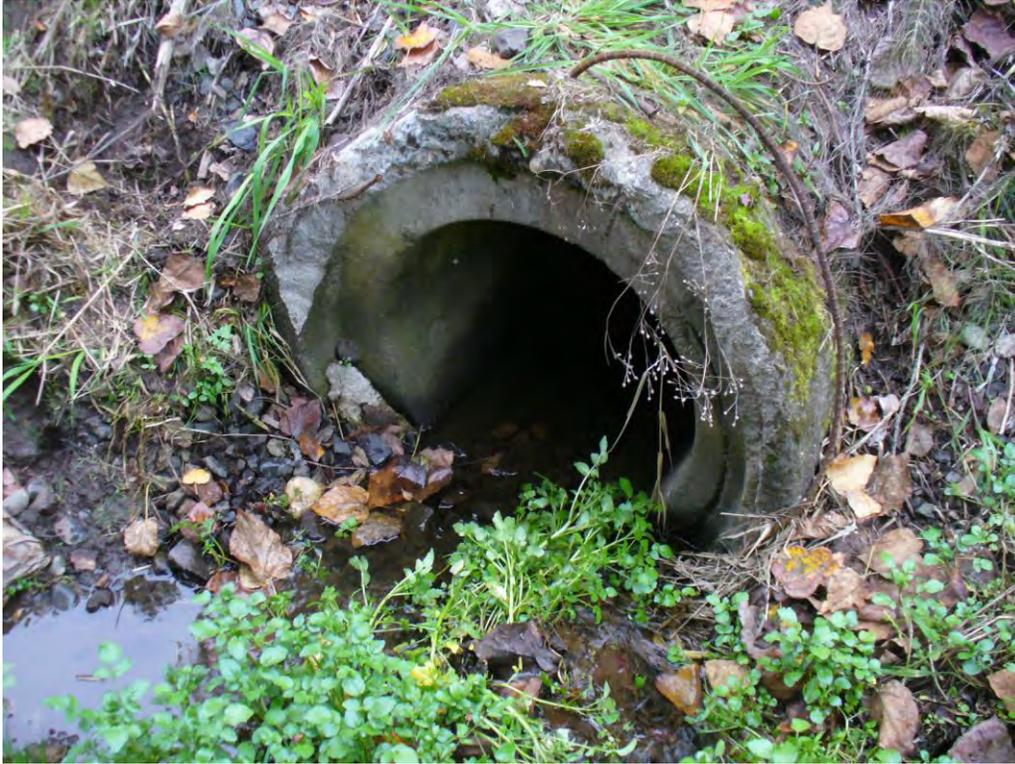
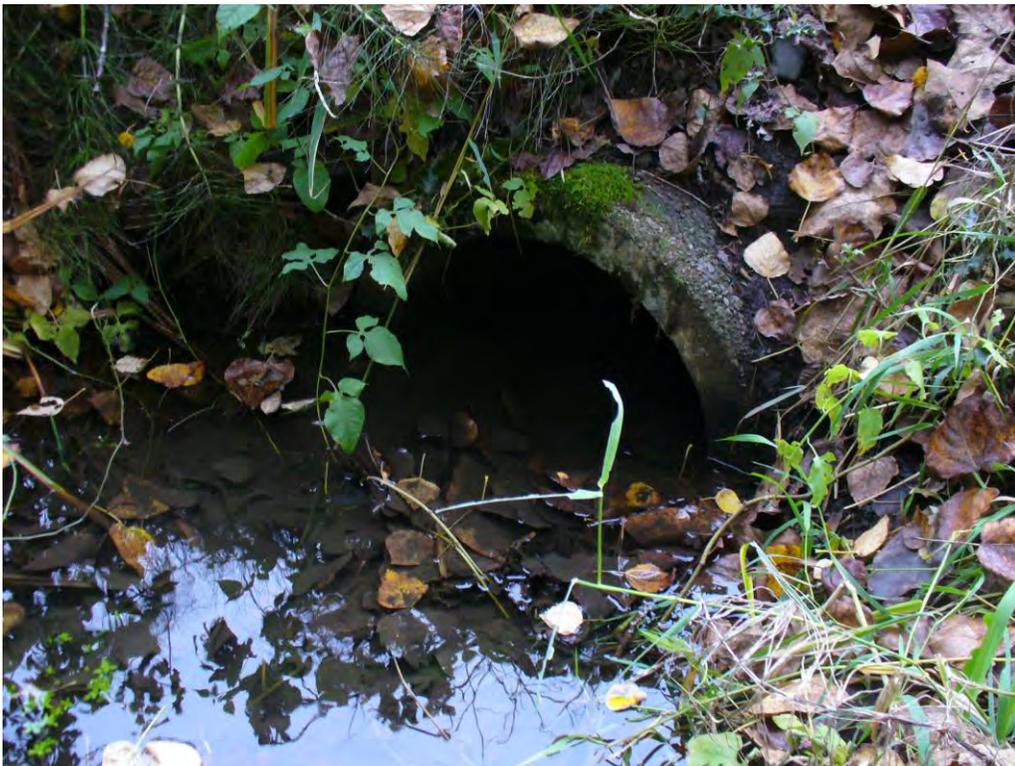
Meets WDFW Culvert Design Manual Criteria? No. 1.25 OHW width for no slope, 1.2 OHW width +2 for stream simulation (Hydraulic Option not amenable to field assessment).

Figure 81. Culvert MB-9 Inlet at NE 96th Street, 10-22-13

Figure 82. Culvert MB-9 Outlet at NE 96th Street, 10-22-13

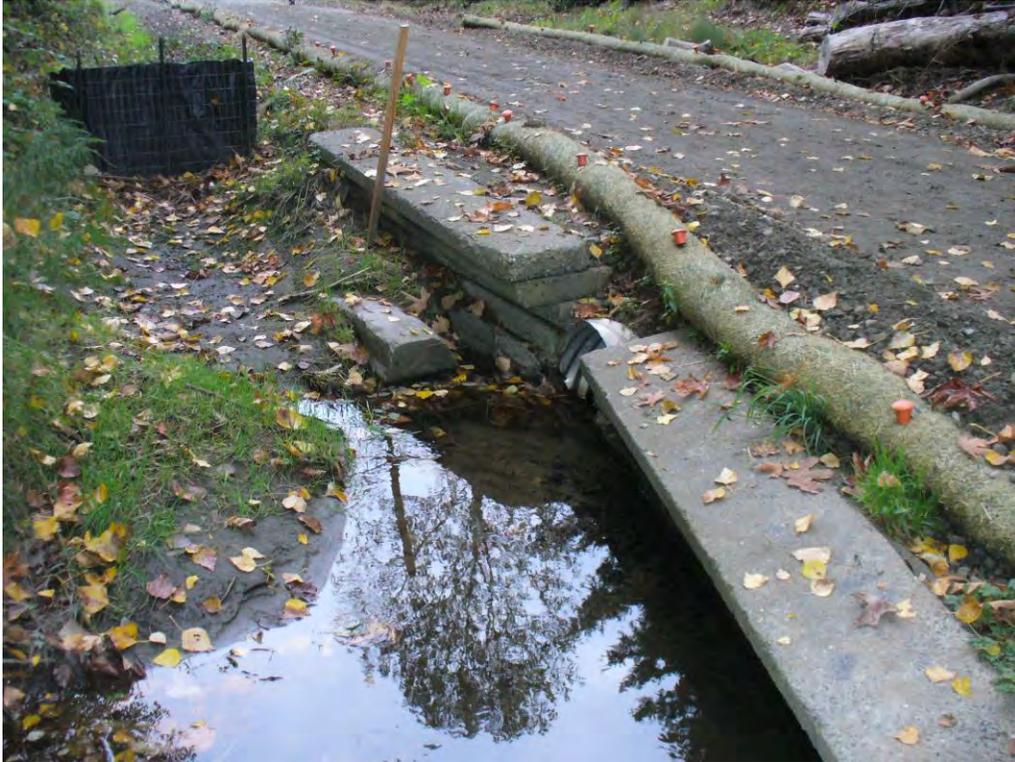
Notes: Would rank this culvert quite high for replacement:

Figure 83. Culvert EC-1 Inlet between 6th Street S and Railroad Avenue, 10-25-13

Figure 84. Culvert EC-1 Outlet between 6th Street S and Railroad Avenue, 10-25-13

Everest Creek								
EC-1 (CKC-11)	Everest Creek	18-inch CMP	CKC Between 6th Street S. and Railroad Ave.	3 - some fish could get though due to the short length and pool at the outfall.		Everest Creek is likely not accessible to migratory fish due to long piped sections downstream with possible included plunges and/or velocity barriers. However, would rank this culvert fairly high for replacement in spite of moderate PI: 1) It is a problem 2) The stream has good year-around flows and could support fish if re-introduced 3) The culvert is short and near the surface - so should be relatively low-cost and so a good value. Fair amount of habitat available upstream through Everest Park. Another culvert is just upstream that should also be included in the project. Cascades farther upstream. Everest has good year-around flow and could probably support resident trout, if introduced.	1	2.7

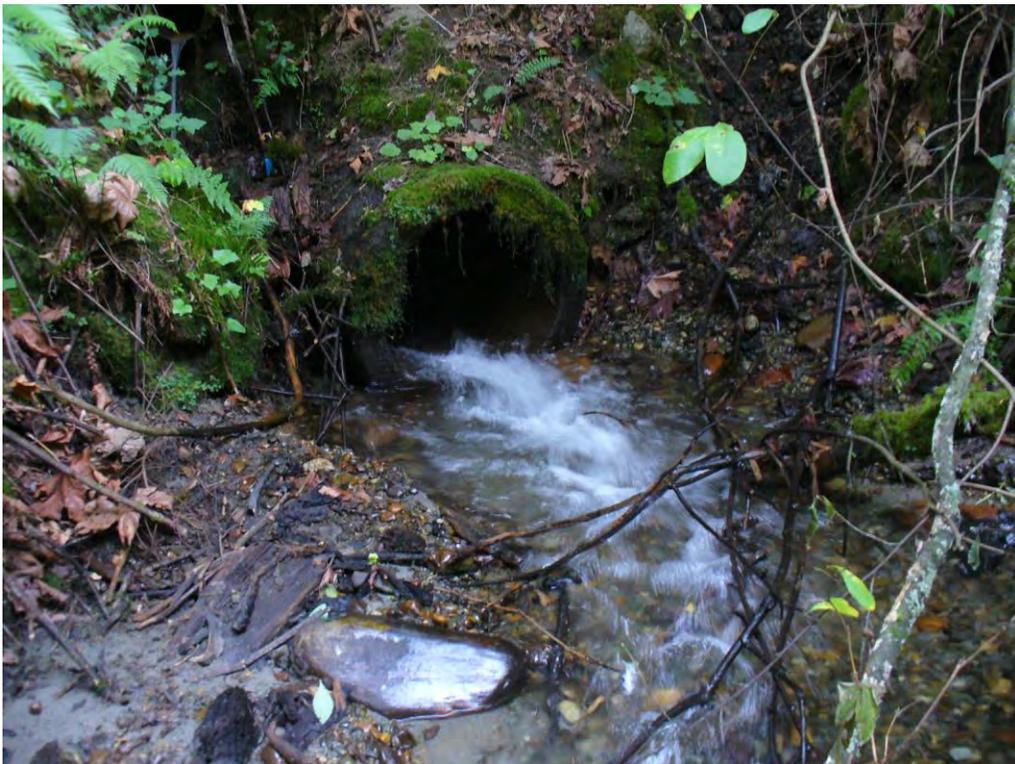
Notes: This is a very steep culvert along a very steep stream segment. Very high fill embankment – expensive to replace at Cross-Kirkland Corridor. Fish presence not known but doubtful due to downstream barriers and overall steepness of the channel.

Meets WDFW Culvert Design Manual Criteria? Would not meet (any?) fish passage design standards. (1.25 OHW width for no slope, 1.2 OHW width +2 for stream simulation Hydraulic Option not amenable to field assessment).

Figure 91. Culvert CC-2 Inlet at Cross Kirkland Corridor, 9-13-13

Figure 92. Culvert CC-2 Outlet at Cross Kirkland Corridor, 9-13-13

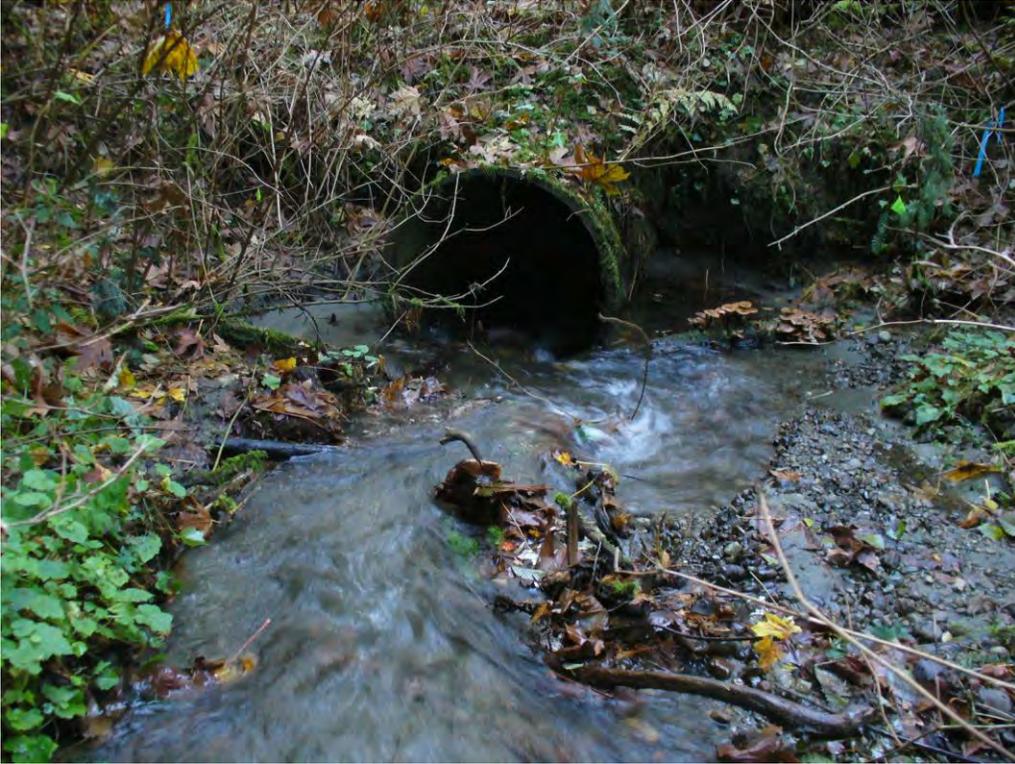
Notes: Flow perhaps 2 cfs on 11/8/13. The CKC prism above the culvert is high and massive.
Expensive to replace, however the flows are here to support fish. High cutthroat usage
documented downstream to Lake Washington.

Meets WDFW Culvert Design Manual Criteria? (No) 1.25 OHW width for no slope, 1.2 OHW
width +2 for stream simulation (Hydraulic Option not amenable to field assessment).

Figure 97. Culvert CO-3 Inlet at NE 38th Place, 11-8-13
