Subject: American Legion Hall

Subject: American Legion Hall at 138 5th Avenue

HISTORIC PROPERTY INVENTORY FORM

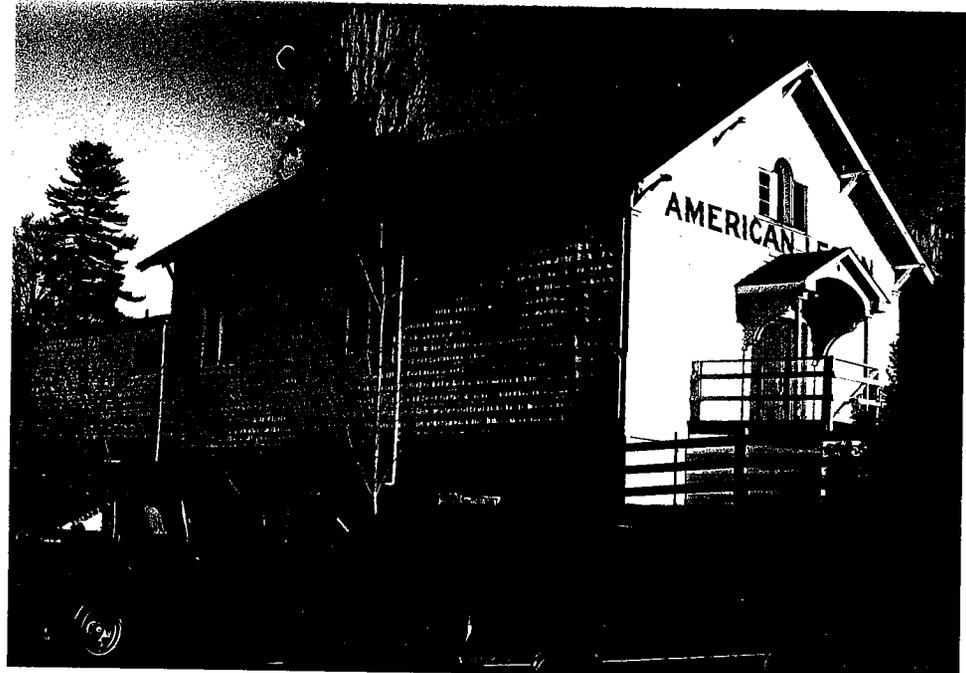
Photography Neg. No. R.1,F.17
(Roll No. & Frame No.)
View of South Facade
Date 12/16/91
