SW 1/4 SECTION 22, TOWNSHIP 26 N, RANGE 5 E, W.M.
CALVERT ANDERSON PUD

CALVERT ANDERSON PUD/DP SUBMITTAL
 INTEGRATED TREE PLAN
 12204, 12224, & 12234 NORTH AVE NE
 BENTONVILLE, MISSOURI 64826

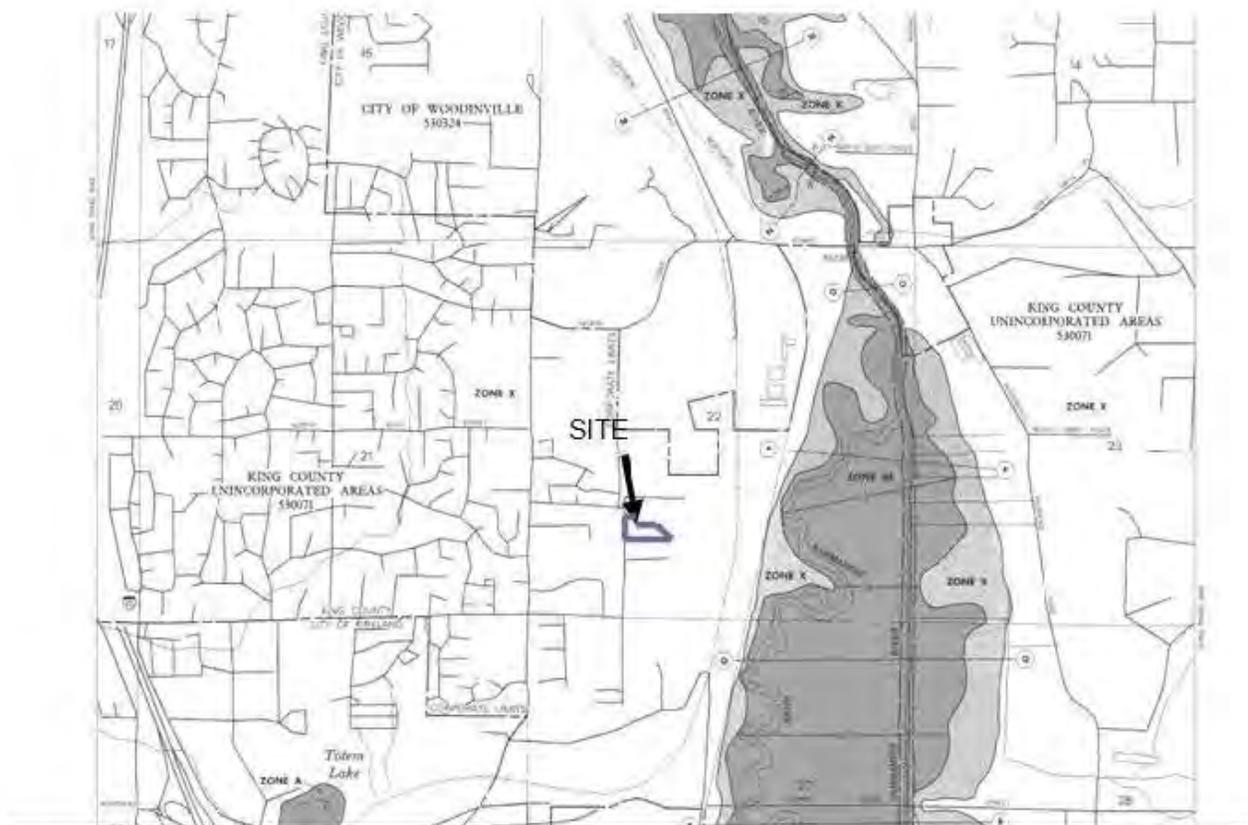
**FIGURE 11
FEMA MAP**

NATIONAL FLOOD INSURANCE PROGRAM

FIRM
FLOOD INSURANCE RATE MAP

KING COUNTY,
WASHINGTON AND
INCORPORATED AREAS

PANEL 685 OF 1725

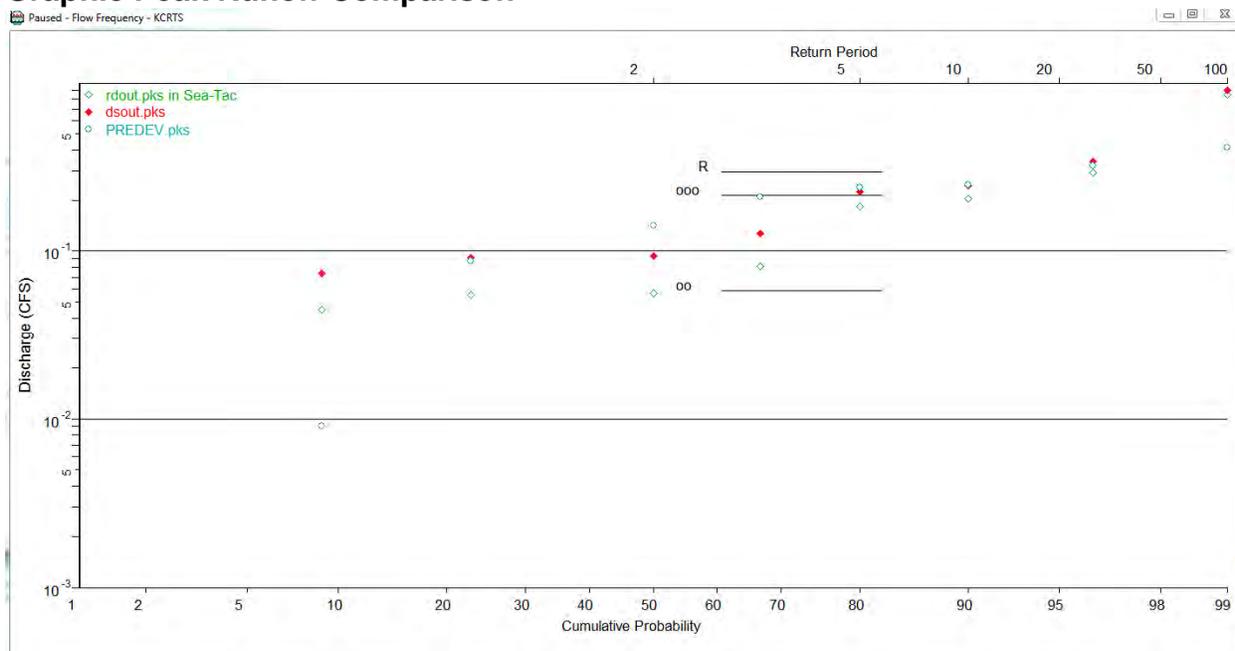
Graphic Peak Runoff Comparison

Maximum negative excursion = 0.017 cfs (-17.2%)
 occurring at 0.100 cfs on the Base Data:predev.tsf
 and at 0.083 cfs on the New Data:dsout.tsf

The Project is located in a Conservation Flow Control Area and will therefore adhere to Level 2 Flow Control Standards, forested conditions. One detention vault will provide flow control as required. The Project is required to match developed discharge durations to predeveloped durations for the range of predeveloped discharge rates from 50% of the two-year peak flow up to the full 50-year peak flow. Also match developed peak discharge rates to predeveloped peak discharge rates for the 2 and the 10 year return periods. Assum(ing) historic conditions as the predeveloped condition.+ (KCSWDM, Sec. 1.2).
