**ADVISORY REPORT
 FINDINGS, CONCLUSIONS, AND RECOMMENDATIONS**

File: Fairfax Hospital Supplemental Parking Lot, File No. ZON13-01903

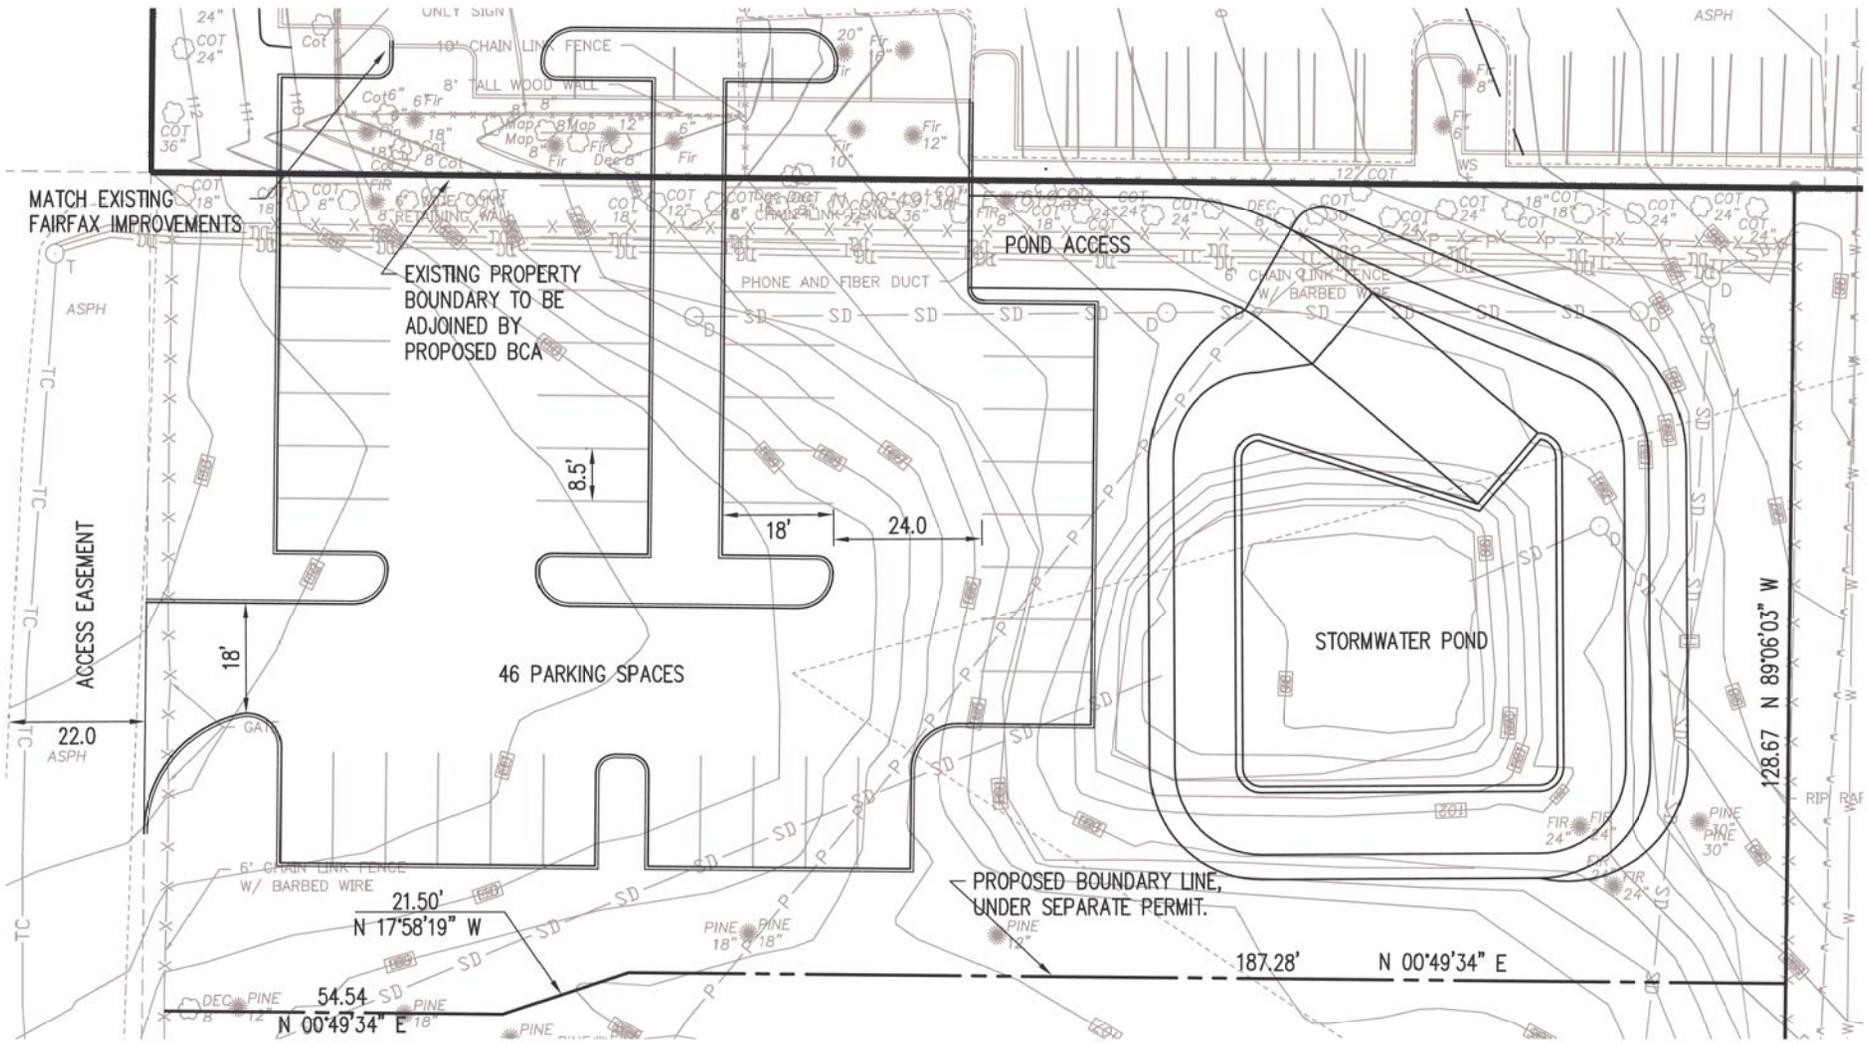
TOPOGRAPHIC SURVEY
OF A PORTION OF
SEC. 20 TWP 26 N, R 5 E, W.M.,
AT THE REQUEST OF
FAIRFAX HOSPITAL ET AL

SURVEYORS NOTES:
THE PURPOSE OF THIS SURVEY IS TO MAP EXISTING SITE CONDITIONS AS THEY EXISTED IN MARCH OF 2013. ANY ALTERATIONS TO THE PROPERTY BEYOND THIS DATE WILL NOT BE REFLECTED BY THIS SURVEY.

THE ASPHALT ON-SITE IS IN POOR CONDITION.

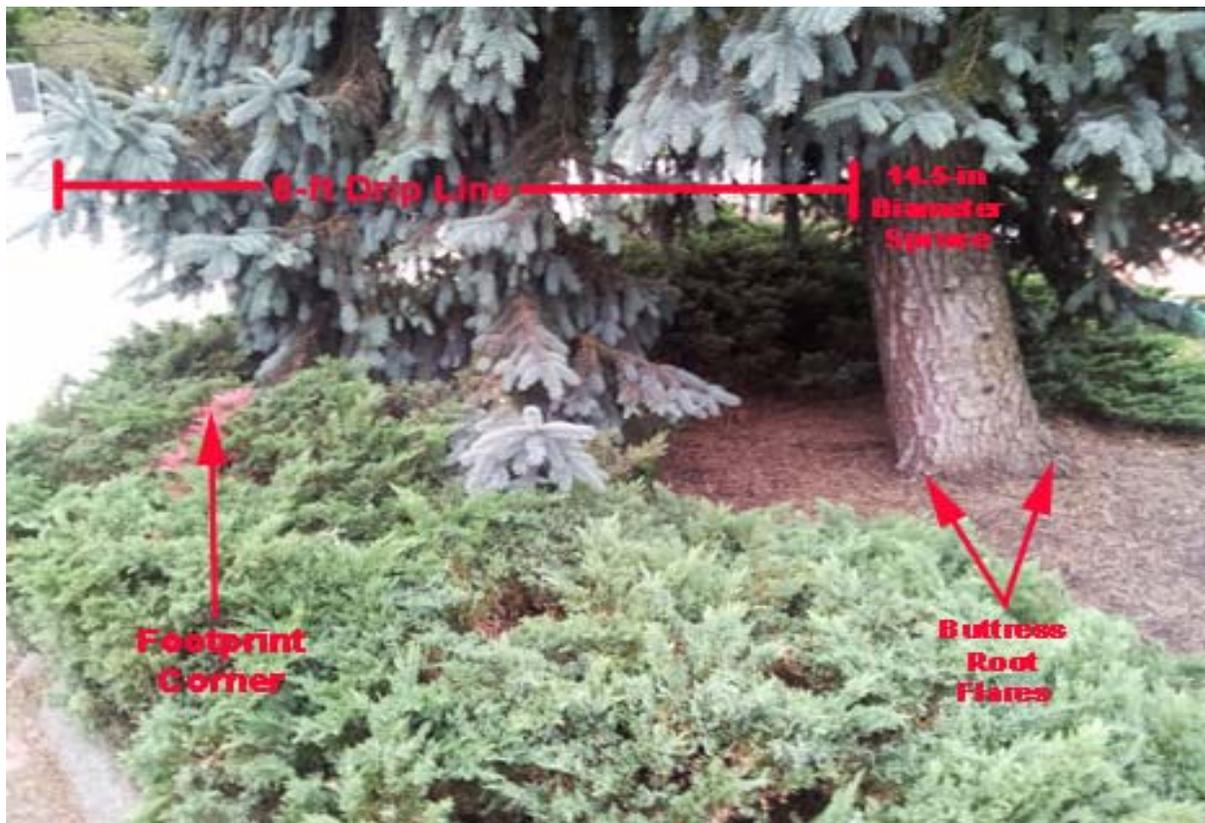
Photo-2

- Lines marking Chamber Footprint are based on the existing Storm Tech Chamber and paint marking the corner of the completed structure.

At the base of the tree the root crown flares or bulges on the northern and western side of the trunk. Growth like this indicates buttress roots travel in these directions (Photo-2).

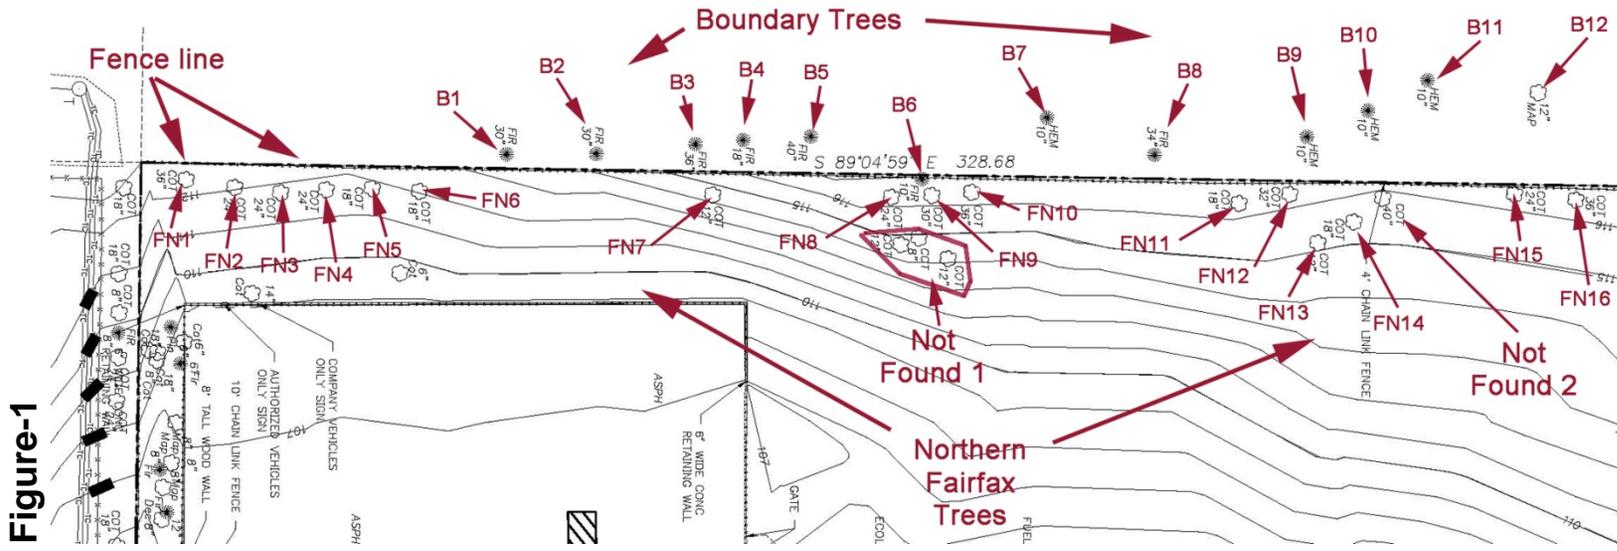
Figure-1

Right side of image is North

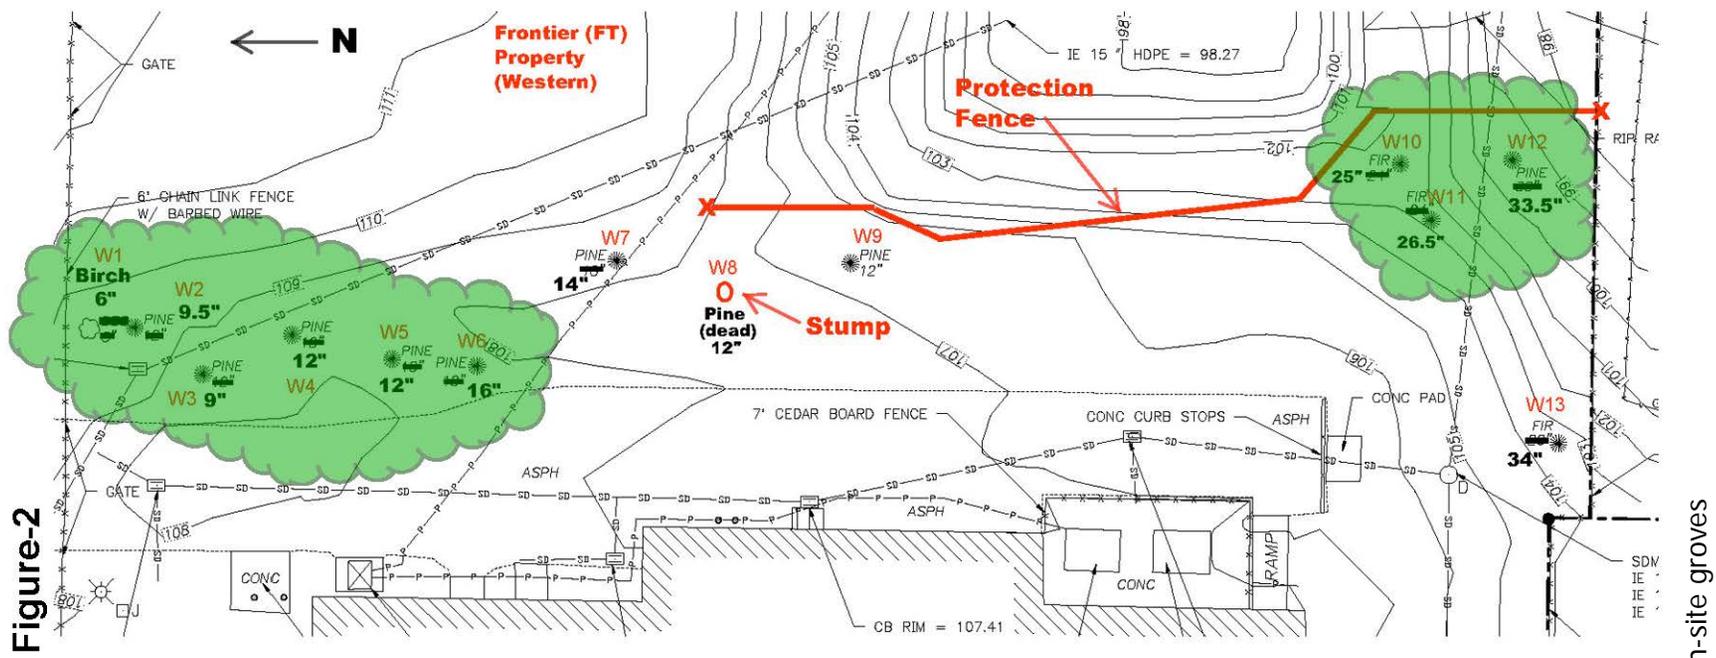
Figure-2

On-site groves

A Berger Partnership diagram provides a sketch of tree protection fencing (Figure-2). The diagram matches standard measures for preservation. Some key points include
