APPENDIX B

Fecal Coliform Sampling Results, AmTest, 2005

**GEOTECHNICAL HAZARDS INVESTIGATION
PROPOSED HIGHLAND GLEN SHORT PLAT
10405 111TH AVENUE NE
KIRKLAND, WASHINGTON**

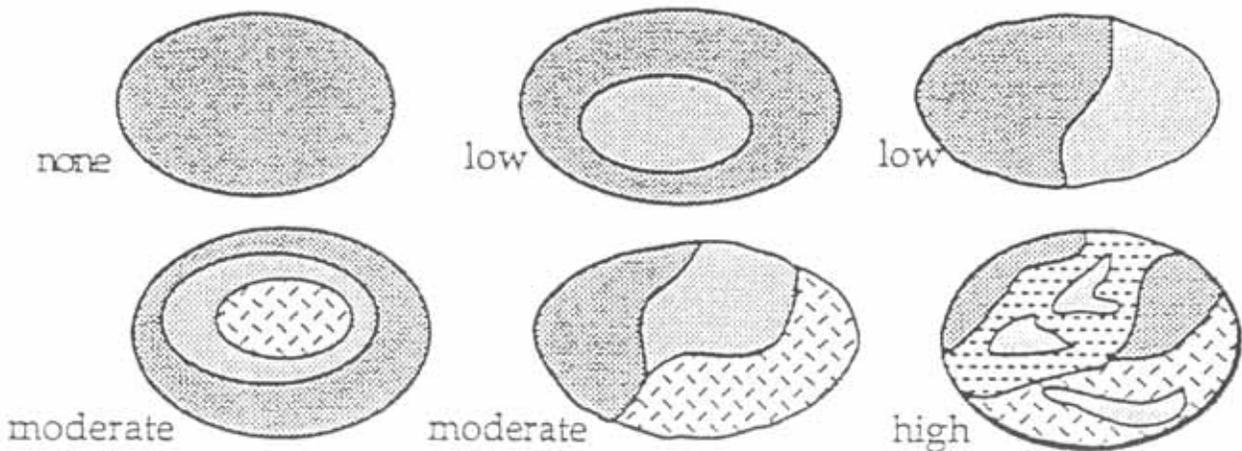
Decide from the diagrams below whether interspection between wetland classes is high, moderate, low or none

- 3 = High
 - 2 = Moderate
 - 1 = Low
 - 0 = None
- 1

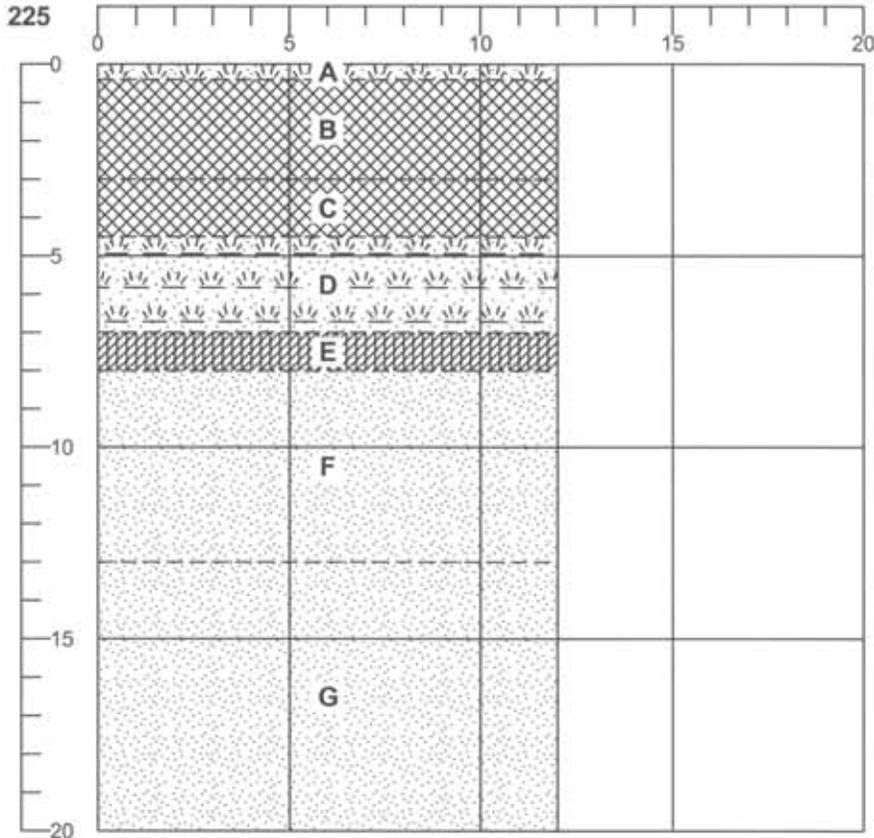
LOG OF TEST PIT TP-1

Temp 40 °F Weather Rain Engineer AMJ/SJW Operator _____
 Equipment Deere 160LC Contractor Custom Date 11/04/05
 Elevation 162.0 ft Datum AMSL Job 053-1672
 Location N End of Property

SAMPLES		
NO.	DEPTH (ft)	MOISTURE (%)
1	2.0	
2	3.5	
3	7.5	
4	12.0

Bottom of Test Pit at 20.0 ft

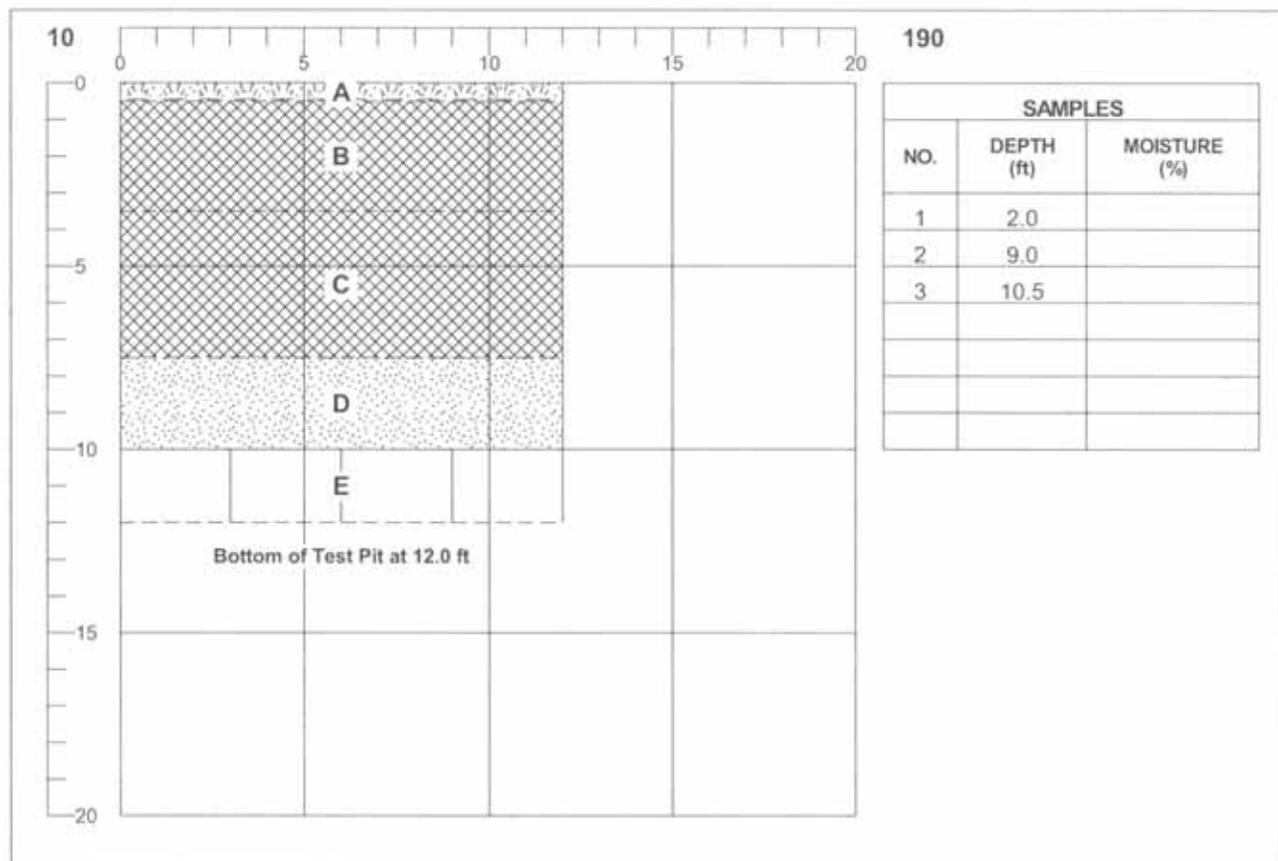
SAMPLES		
NO.	DEPTH (ft)	MOISTURE (%)
1	2.0	
2	9.0	
3	10.5

LITHOLOGIC DESCRIPTIONS AND EXCAVATION NOTES	
A	0.0 - 0.5 ft: Sandy SILT TOPSOIL with abundant organic material (roots, leaves, etc.).
B	0.5 - 3.5 ft: Dense to very dense, mottled pale and dark yellowish orange, scattered black organics (charcoal; upper 2 ft), silty SAND, some fine to coarse subangular and faceted gravel, dry. (SM) (FILL)
C	3.5 - 7.5 ft: Dense to very dense, yellowish gray, silty SAND, some fine to coarse subangular and faceted gravel, abrupt color change with overlying material, dry. (SM) (FILL?)
D	7.5 - 10.0 ft: Dense, moderate yellowish brown/light olive gray mottling, non-stratified, medium to coarse SAND, some fine to coarse subrounded gravel, trace to little silt, sloping contact from about 4 to 10 feet with overlying material, buried topsoil at contact, moist to wet. (SW) (OUTWASH)
E	10.0 - 12.0 ft: Hard, medium gray, non-stratified, SILT to CLAYEY SILT, little sand, little socketed fine gravel, moist. (ML) (TRANSITION BEDS)

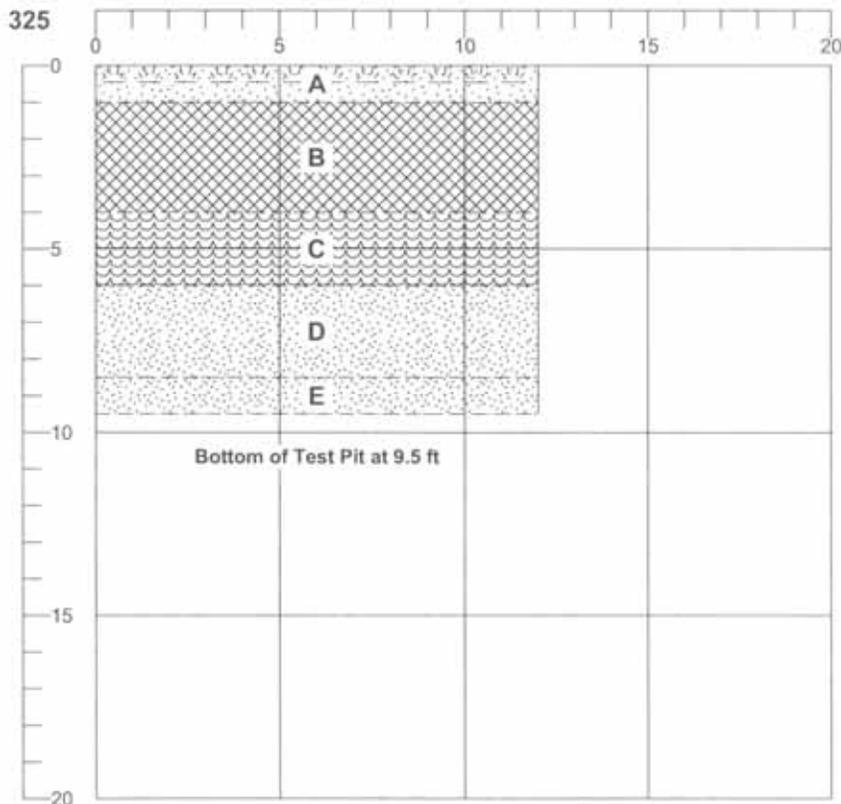
LOG OF TEST PIT TP-3

Temp 40 °F Weather Rain Engineer AMJ/SJW Operator _____
 Equipment Deere 160LC Contractor Custom Date 11/04/05
 Elevation 187.0 ft Datum AMSL Job 053-1672
 Location Kirkland, WA

SAMPLES		
NO.	DEPTH (ft)	MOISTURE (%)
1	5.0	
2	7.0	
3	9.0

LITHOLOGIC DESCRIPTIONS AND EXCAVATION NOTES	
A	0.0 - 1.0 ft: Sandy TOPSOIL
B	1.0 - 4.0 ft: Loose, mottled moderate yellowish brown to olive gray, fine to coarse SAND, some fine to coarse subangular to subrounded gravel, wet, organics (roots, stump). (SW) (FILL)
C	4.0 - 6.0 ft: Soft, medium dark gray, non-stratified, organic SILT, organic odor, organic material (roots), wet. (OH)
D	6.0 - 8.5 ft: Compact (?), medium gray, medium to coarse SAND, some fine to coarse subangular to subrounded gravel, trace silt, wet. (SW) (ADVANCE OUTWASH)
E	8.5 - 9.5 ft: Dense (?), mottled yellowish orange and dark yellowish orange, crudely stratified, fine SAND, trace to little silt, wet. (SP) (ADVANCE OUTWASH)

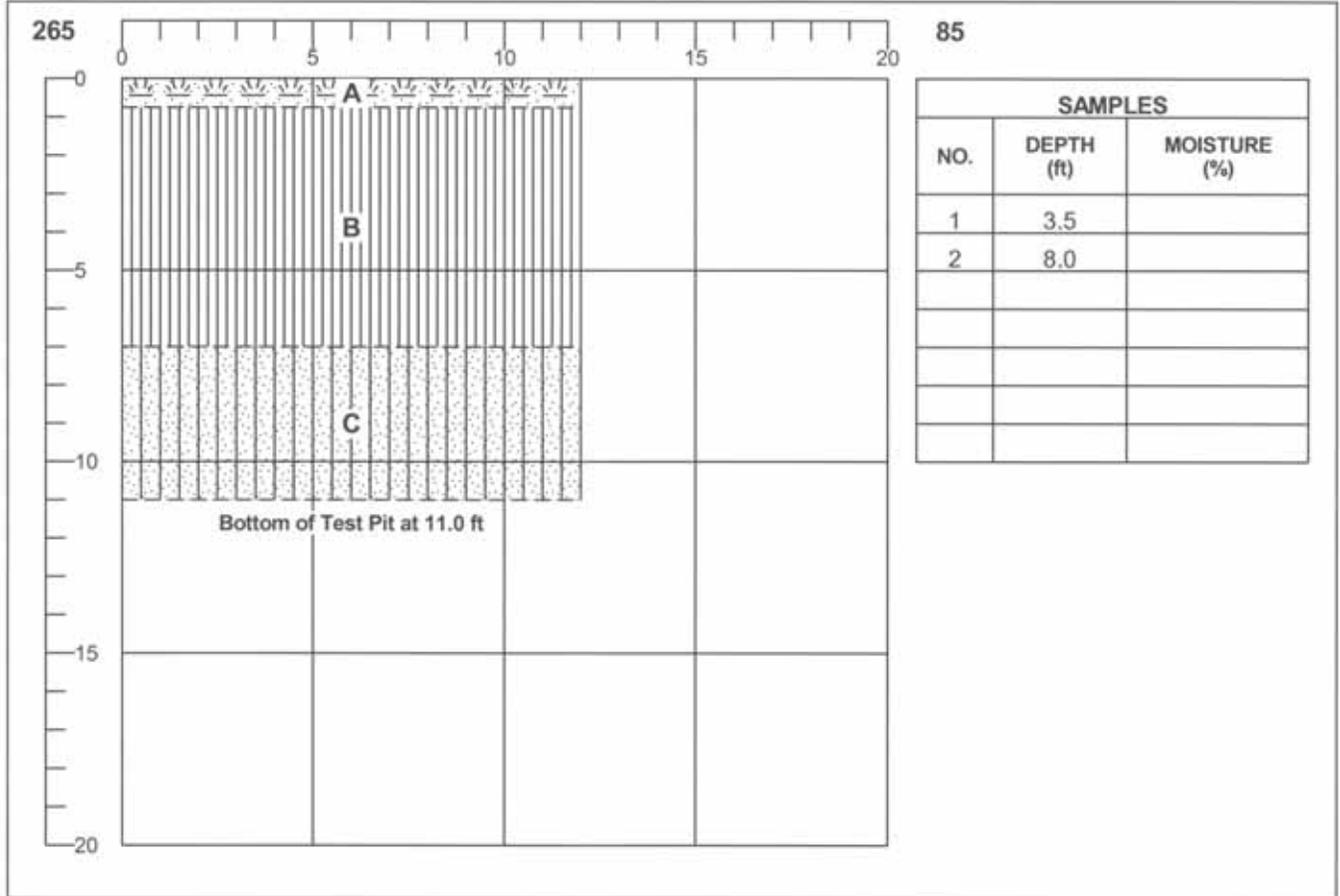
LOG OF TEST PIT TP-4

Temp 40 °F Weather Cloudy Engineer AMJ/SJW Operator _____
 Equipment Deere 160LC Contractor Custom Date 11/04/05
 Elevation 224.0 ft Datum AMSL Job 053-1672
 Location Near House

LITHOLOGIC DESCRIPTIONS AND EXCAVATION NOTES	
A	0.0 - 0.8 ft: Sandy TOPSOIL
B	0.8 - 7.0 ft: Hard, mottled pale orange/light gray/dark yellowish orange, nonstratified but with "blocky" structure composed of faceted defined prisms, SILT, damp. (ML/SP) (GLACIOLACUSTRINE DEPOSIT)
C	7.0 - 11.0 ft: Dense, medium gray, nonstratified, silty fine SAND, organic odor, damp. (SM) (GLACIOLACUSTRINE DEPOSIT)

TIME	DEPTH OF HOLE (ft)	DEPTH TO W/L (ft)	DEPTH TO SEEPAGE (ft)
16:32	0.0		
16:35	4.0		
16:40	11.0		
16:55	0.0

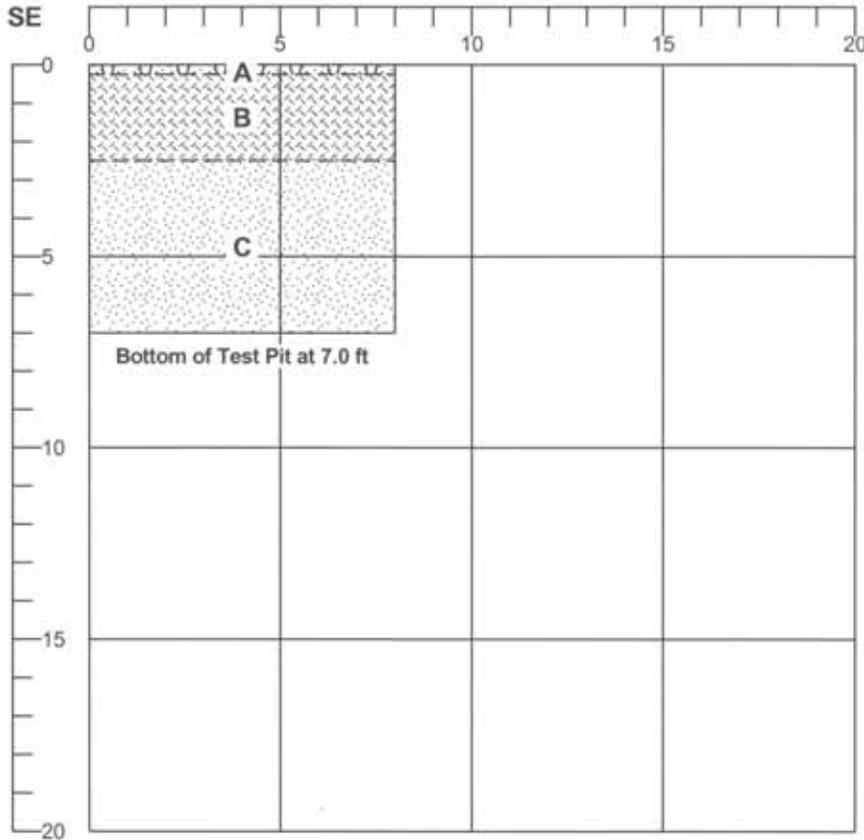
LOG OF TEST PIT TP-5

Temp 42 °F Weather Cloudy Engineer C. Allen Operator Pat
 Equipment Komatsu WB 140 Contractor Kelly's Excavating Date 12/05/05
 Elevation ~210 Datum AMSL Job 053-1672
 Location S End of Property

SAMPLES		
NO.	DEPTH (ft)	MOISTURE (%)
1	1.5	
2	4.0

In the south-western portion of the site, along the southern property line, two hand auger borings (HA-1 and HA-2) and one test pit (TP-5) were completed. The test pit and hand auger borings encountered a silty sand and silt with varying amounts of gravel which was interpreted as colluvium (soil transported down a slope through a combination of gravity and surface water). Underlying the colluvium, advance outwash sands were generally encountered. However, we observed a thin (0.3 feet) layer of peat below the colluvium in HA-1 which was then underlain by the advance outwash.

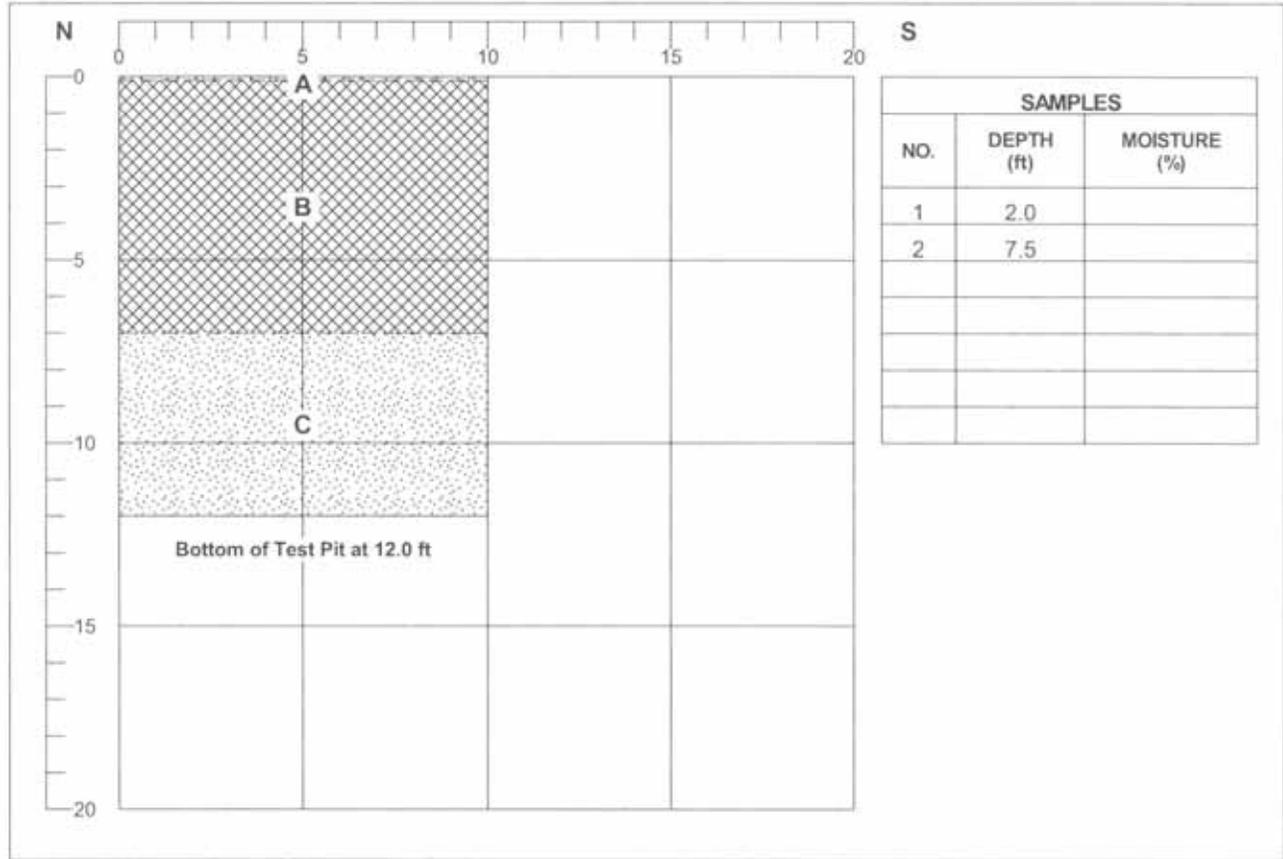
SAMPLES		
NO.	DEPTH (ft)	MOISTURE (%)
1	2.0	
2	7.5

LITHOLOGIC DESCRIPTIONS AND EXCAVATION NOTES	
A	0.0 - 0.1 ft: SOD/TOPSOIL
B	0.1 - 7.0 ft: Loose to compact, brown to olive brown to orangish brown, mottled, SILT, little fine to coarse sand, little gravel, trace angular cobbles (quarry spalls), trace organics (sticks, wood chips, logs to 8 inch diameter and roots), moist. (FILL) (ML)
C	7.0 - 12.0 ft: Compact, orangish brown to gray, nonstratified, fine to coarse SAND, little gravel, little silt, interbedded with SILT, trace sand, trace organics and fine to medium SAND, trace silt, moist. (SW-SP-ML) (ADVANCE OUTWASH)

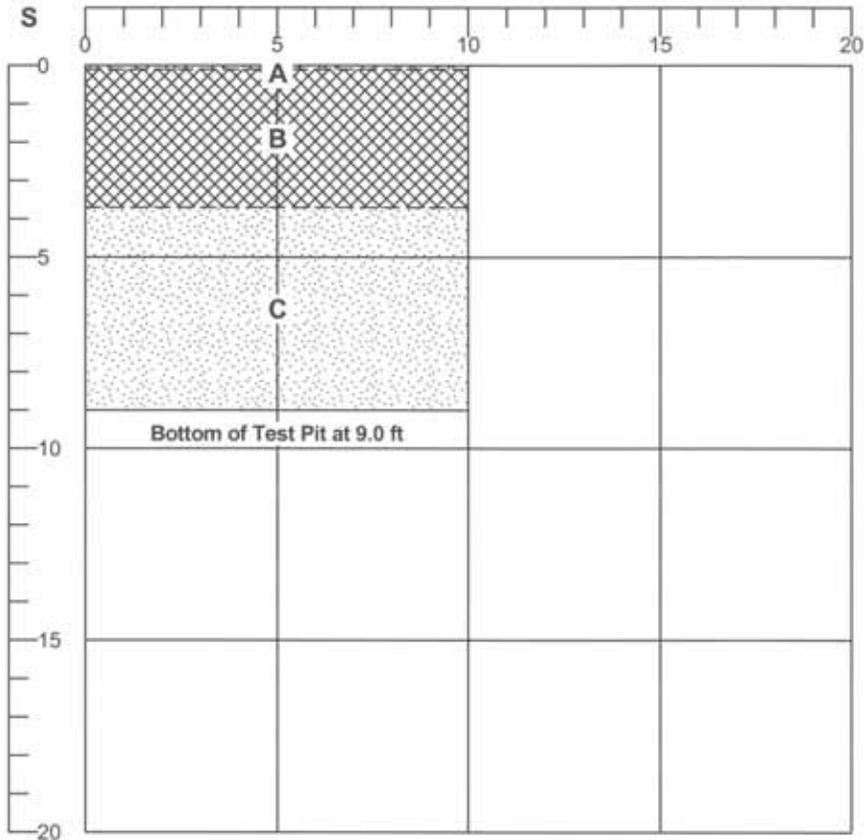
LOG OF TEST PIT TP-7

Temp 41 °F Weather Cloudy Engineer C. Allen Operator Pat
 Equipment Komatsu WB 140 Contractor Kelly's Excavating Date 12/05/05
 Elevation -182 Datum AMSL Job 053-1672
 Location ROW on 111th Ave. NE

SAMPLES		
NO.	DEPTH (ft)	MOISTURE (%)
1	2.0	
2	4.0

A total of four test pits (TP-6 through TP-9) were excavated along the western edge of the 111th Avenue NE Right-of-Way. The test pits encountered fill soils consisting of loose to dense sand with varying amounts of silt, gravel, cobbles, organics and construction debris. The fill soils extended to the bottom of the excavation for TP-9 at a depth of 8 feet. In test pit TP-8 Golder observed gray sand with some silty clay and little organics as sticks and logs to 10 inch diameter from a depth of 5 feet to 15 feet. We were unable to confirm whether this was fill or native soils. Test pits TP-6 and TP-7 encountered outwash sand underlying the fill, at depth of 7 feet and 3.7 feet, and extending to the bottom of each test pit.

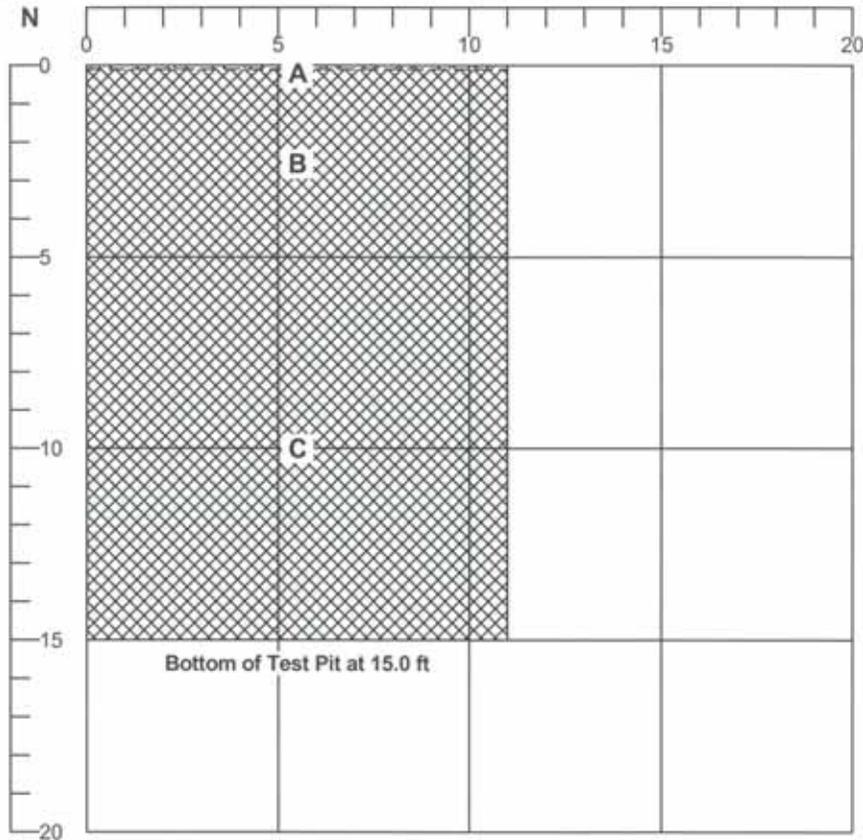
LOG OF TEST PIT TP-8

Temp 40 °F Weather Cloudy Engineer C. Allen Operator Pat
 Equipment Komatsu WB 140 Contractor Kelly's Excavating Date 12/05/05
 Elevation -172 Datum AMSL Job 053-1672
 Location ROW on 111th Ave. NE

SAMPLES		
NO.	DEPTH (ft)	MOISTURE (%)
1	3.0	
2	15.0

LITHOLOGIC DESCRIPTIONS AND EXCAVATION NOTES	
A	0.0 - 0.1 ft: SOD/TOPSOIL
B	0.1 - 5.0 ft: Loose to compact, brown to olive brown to gray, mottled, nonstratified, silty fine to coarse SAND, some gravel, little angular cobbles (quarry spalls), trace wood, trace pea gravel, moist. (FILL) (SM)
C	5.0 - 15.0 ft: Loose to compact, gray, nonstratified, fine to coarse SAND, some silty clay, little organics (sticks, logs to 10 inch diameter), little gravel in zones, moist. (POSSIBLE FILL?) (SW-SM)

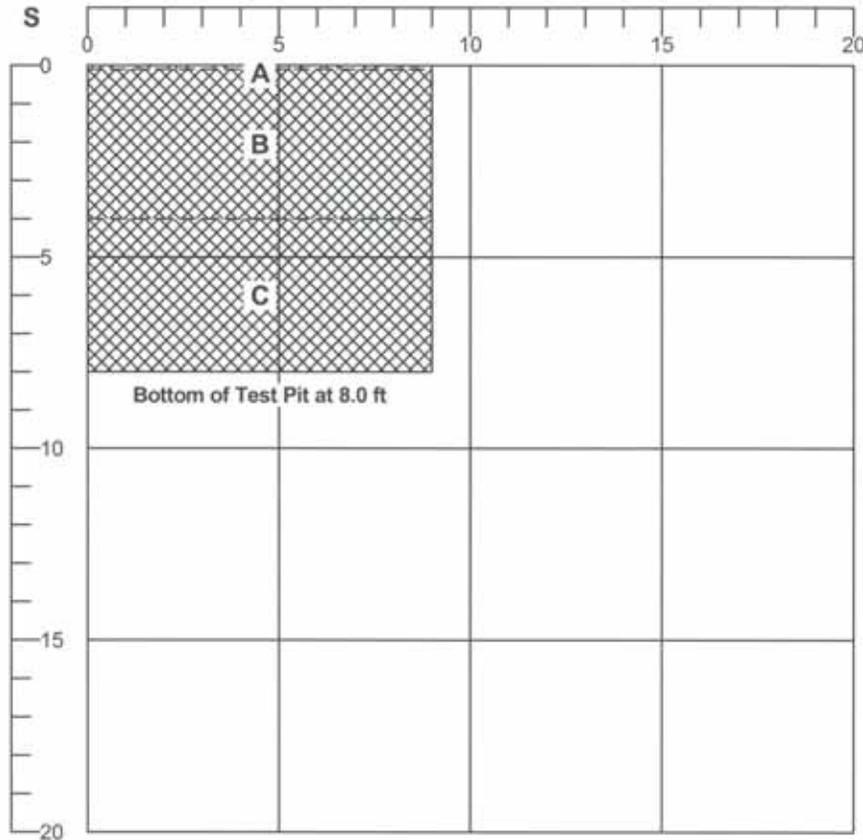
LOG OF TEST PIT TP-9

Temp 40 °F Weather Cloudy Engineer C. Allen Operator Pat
 Equipment Komatsu WB 140 Contractor Kelly's Excavating Date 12/05/05
 Elevation ~167 Datum AMSL Job 053-1672
 Location ROW on 111th Ave. NE

SAMPLES		
NO.	DEPTH (ft)	MOISTURE (%)
1	3.0	
2	7.0
