POTALA VILLAGE SUBSTANTIAL DEVELOPMENT PERMIT SHR11-00002

TOPOGRAPHIC SURVEY FOR:
POTALA VILLAGE
KIRKLAND, LLC
NW 1/4, SW 1/4, SEC. 8, T.25N., R.5E., W.M.
DRAWN BY: DATE: DRAWING FILE NAME: SCALE: JOB NO.
DJB 4-28-11 ksa2-top-DWG 1" = 20' 10-482

**RESIDENTIAL LEVEL
 2ND FLOOR PLAN**
 SCALE 1/32" = 1'-0"

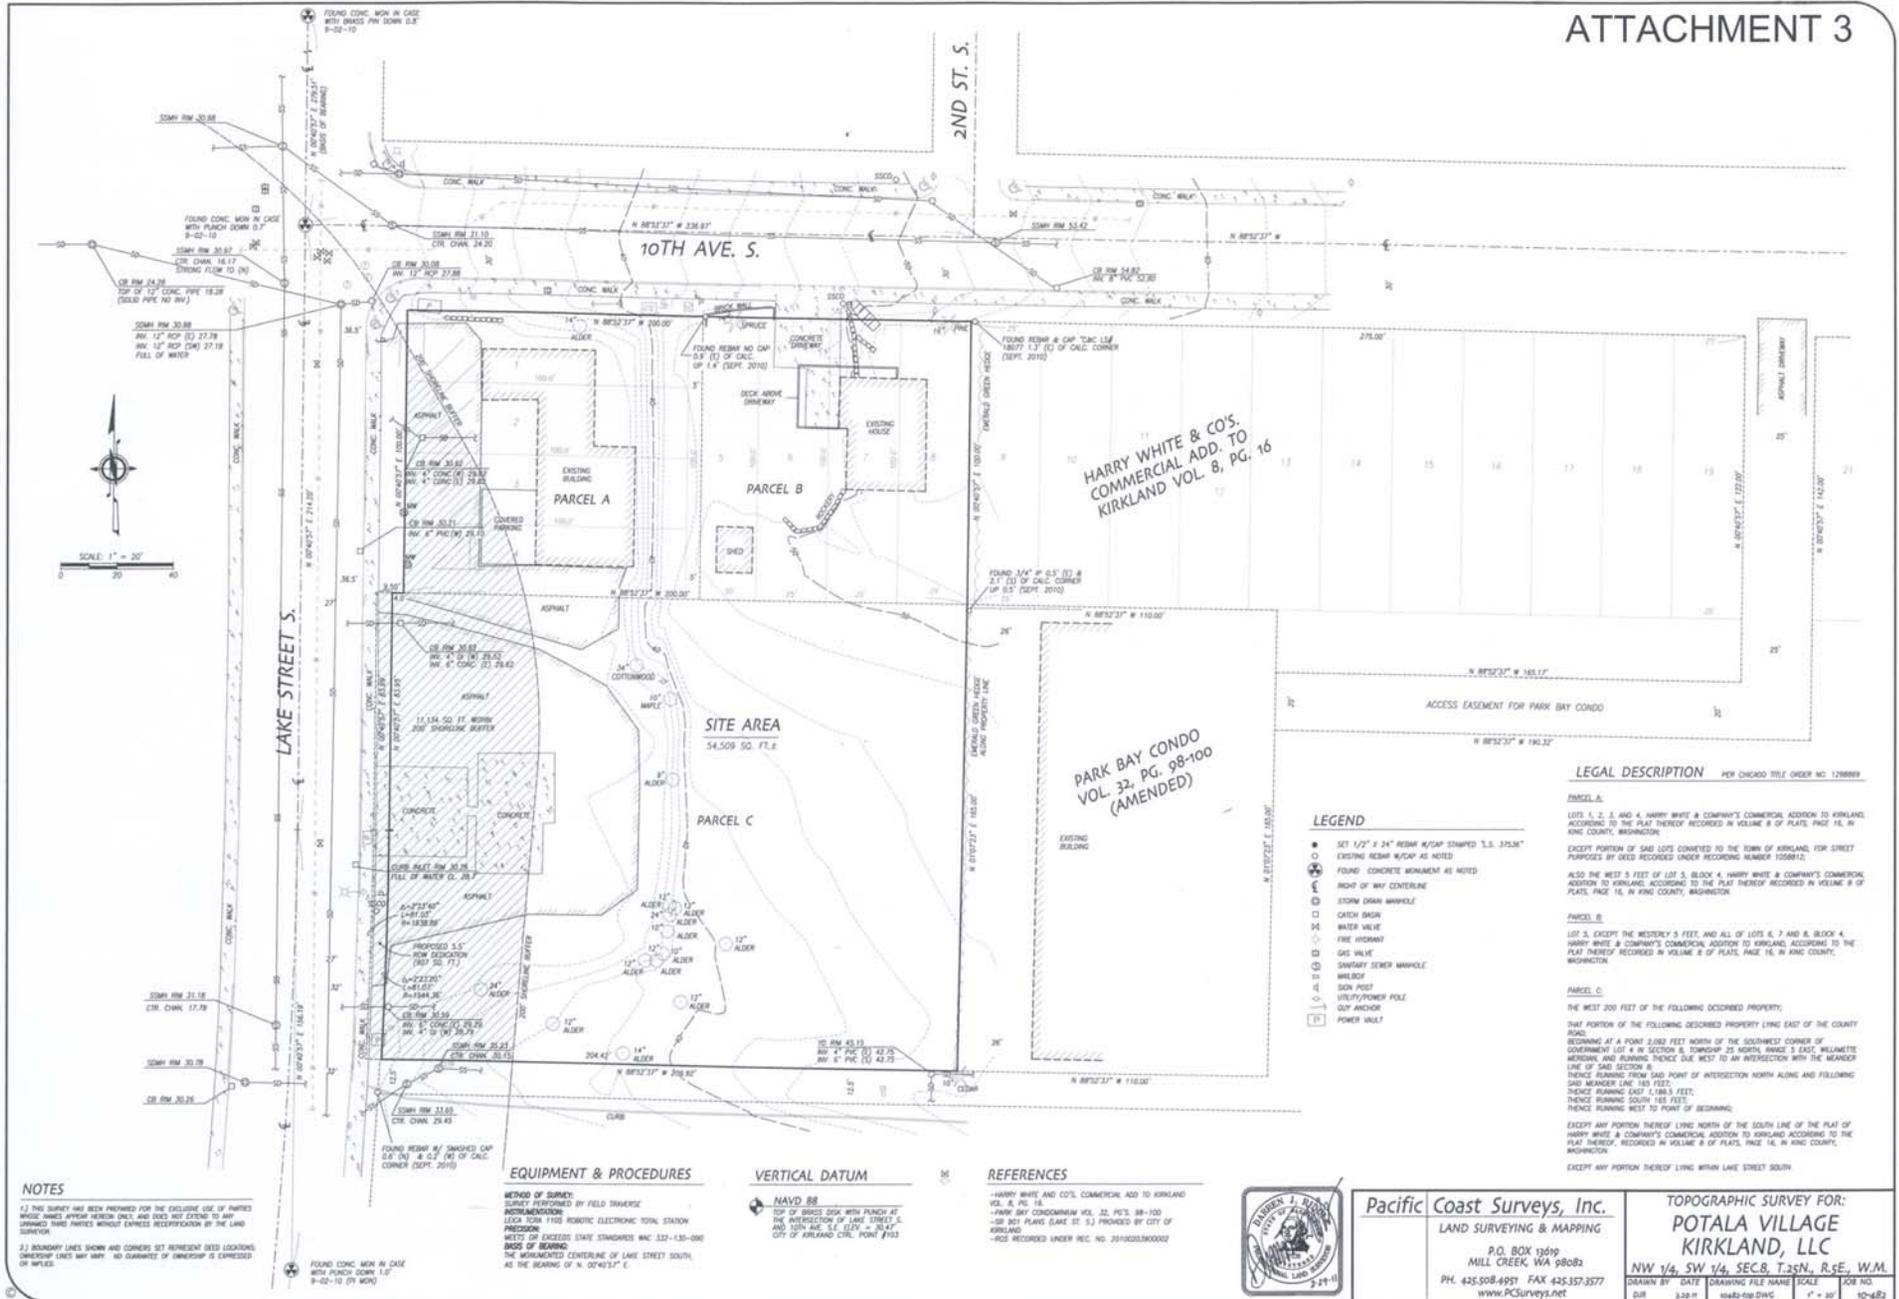
METHOD OF SURVEY:
SURVEY PERFORMED BY FIELD TRAVERSE
INSTRUMENTATION:
LEICA TOTAL STATION 1150 ROBOTIC ELECTRONIC TOTAL STATION
PRISM
WEETS OR EXCESS STATE STANDARDS IAC 132-135-006
BASE OF BEARING:
THE MONUMENTED CENTERLINE OF LAKE STREET SOUTH,
AS THE BEARING OF N. 00°40'37" E.

NAVD 88
TOP OF BENCH MARK WITH PUNCH AT
INTERSECTION OF LAKE STREET S.
AND 10TH AVE. S. (ELEV. = 254.4)
CITY OF ARLAND CIVIL POINT #193

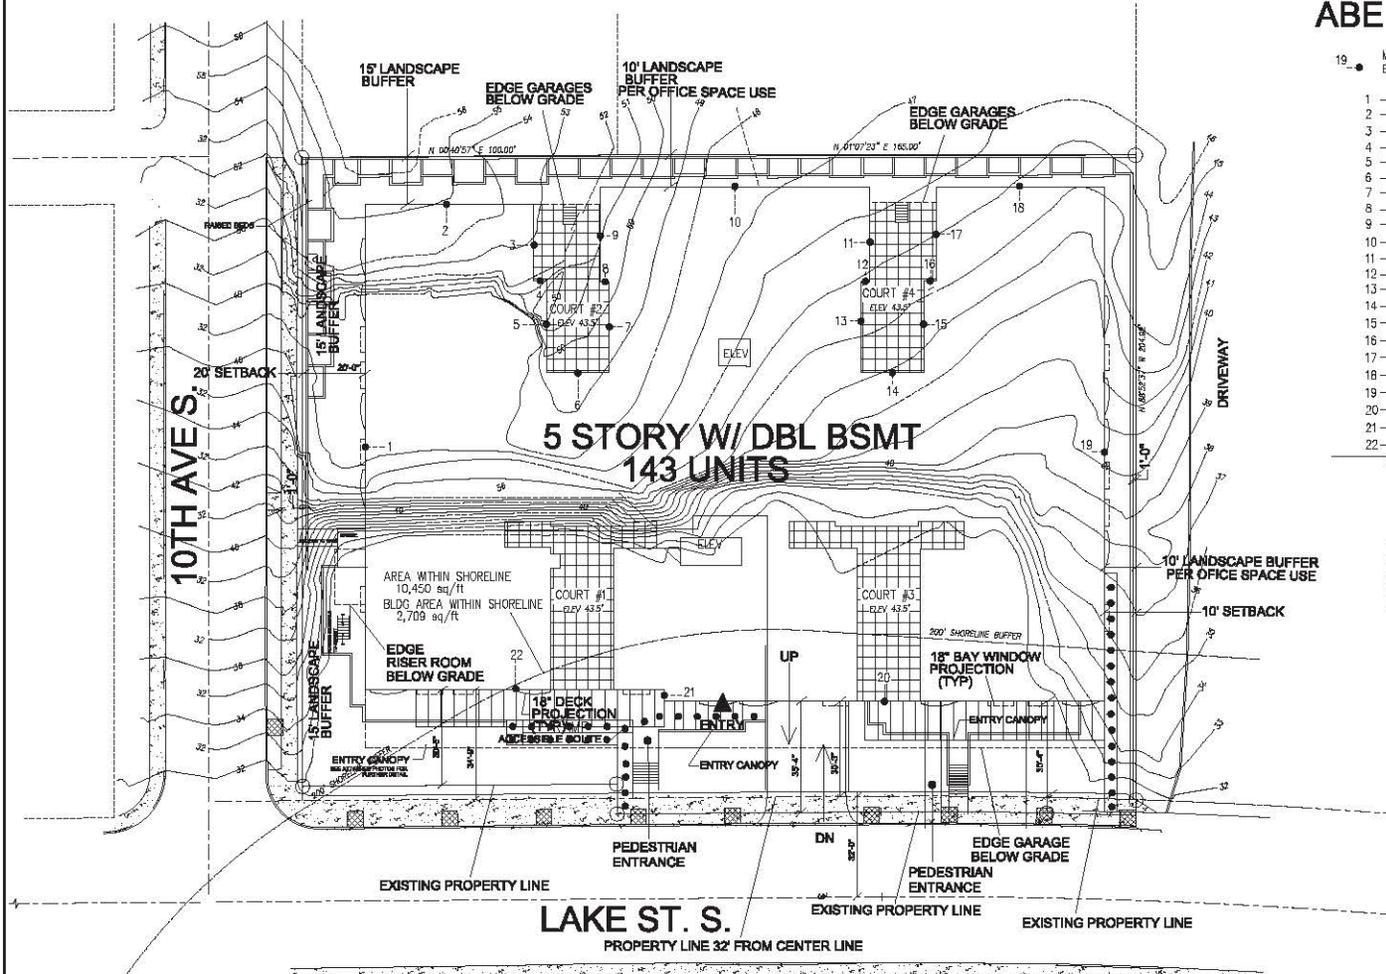
SITE PLAN
 ABE CALCULATIONS
 SCALE 1/8" = 1'-0"

COMMON OPEN SPACE 13,035 SQ/FT
 COURTYARD

TRASH CONTAINMENT IS IN THE BUILDING

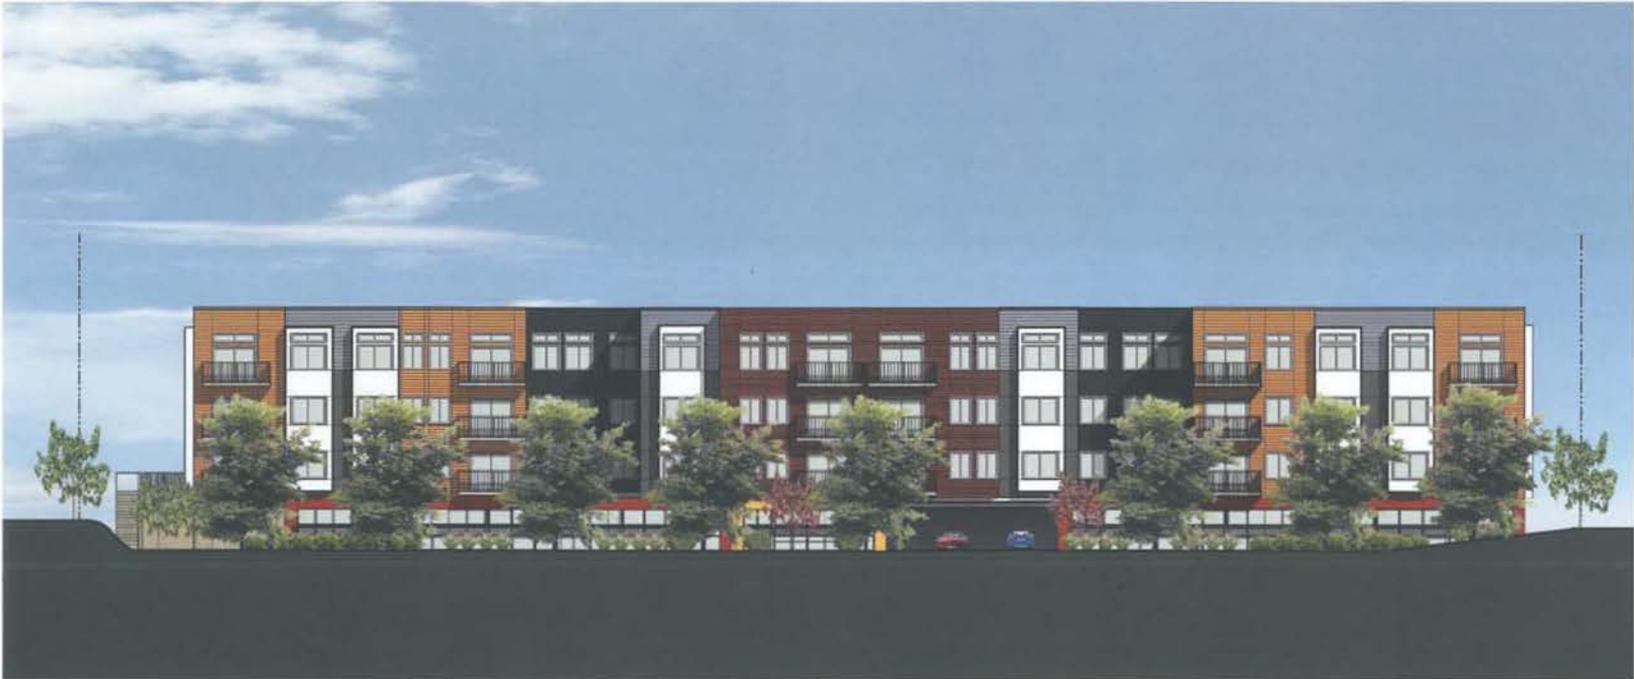
LAKE STREET ELEVATION

SCALE 3/32" = 1'-0"

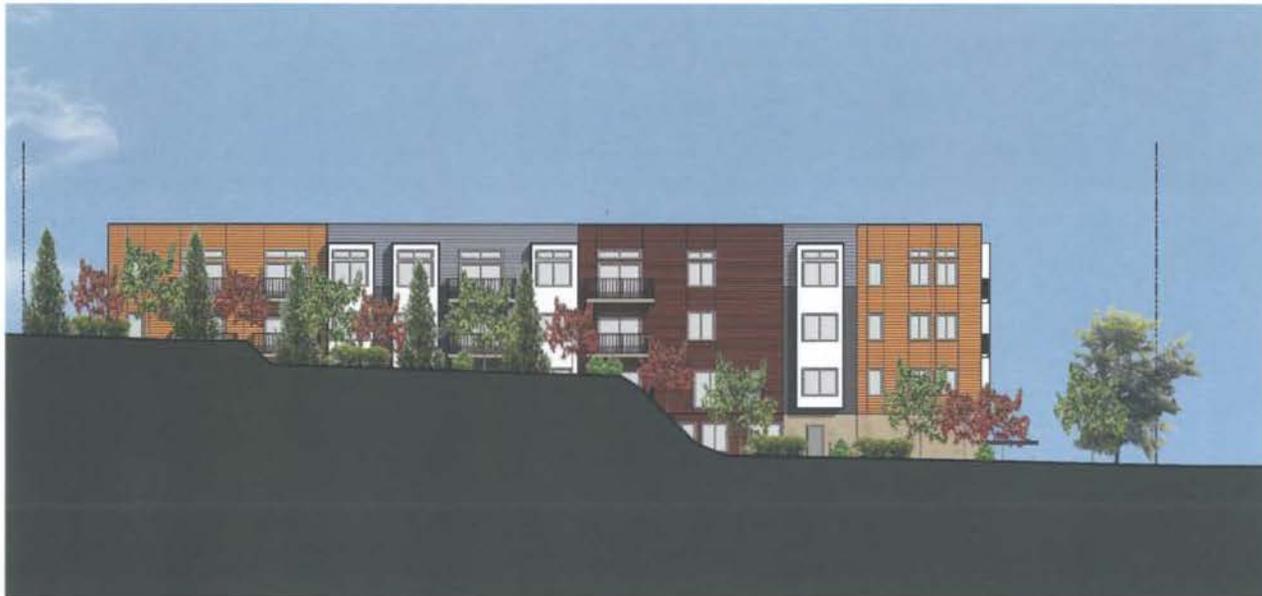
10TH AVE. ELEVATION

SCALE 3/32" = 1'-0"

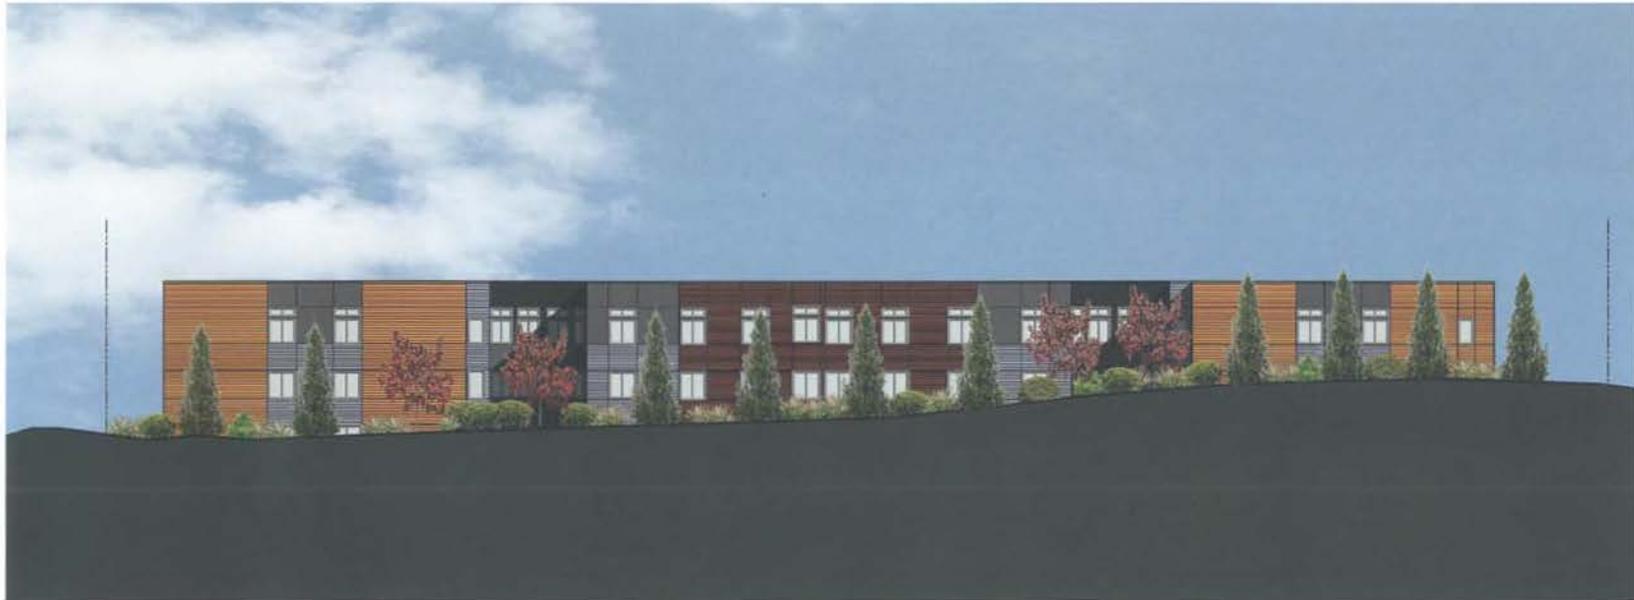
EAST ELEVATION

SCALE: 3/32" = 1'-0"

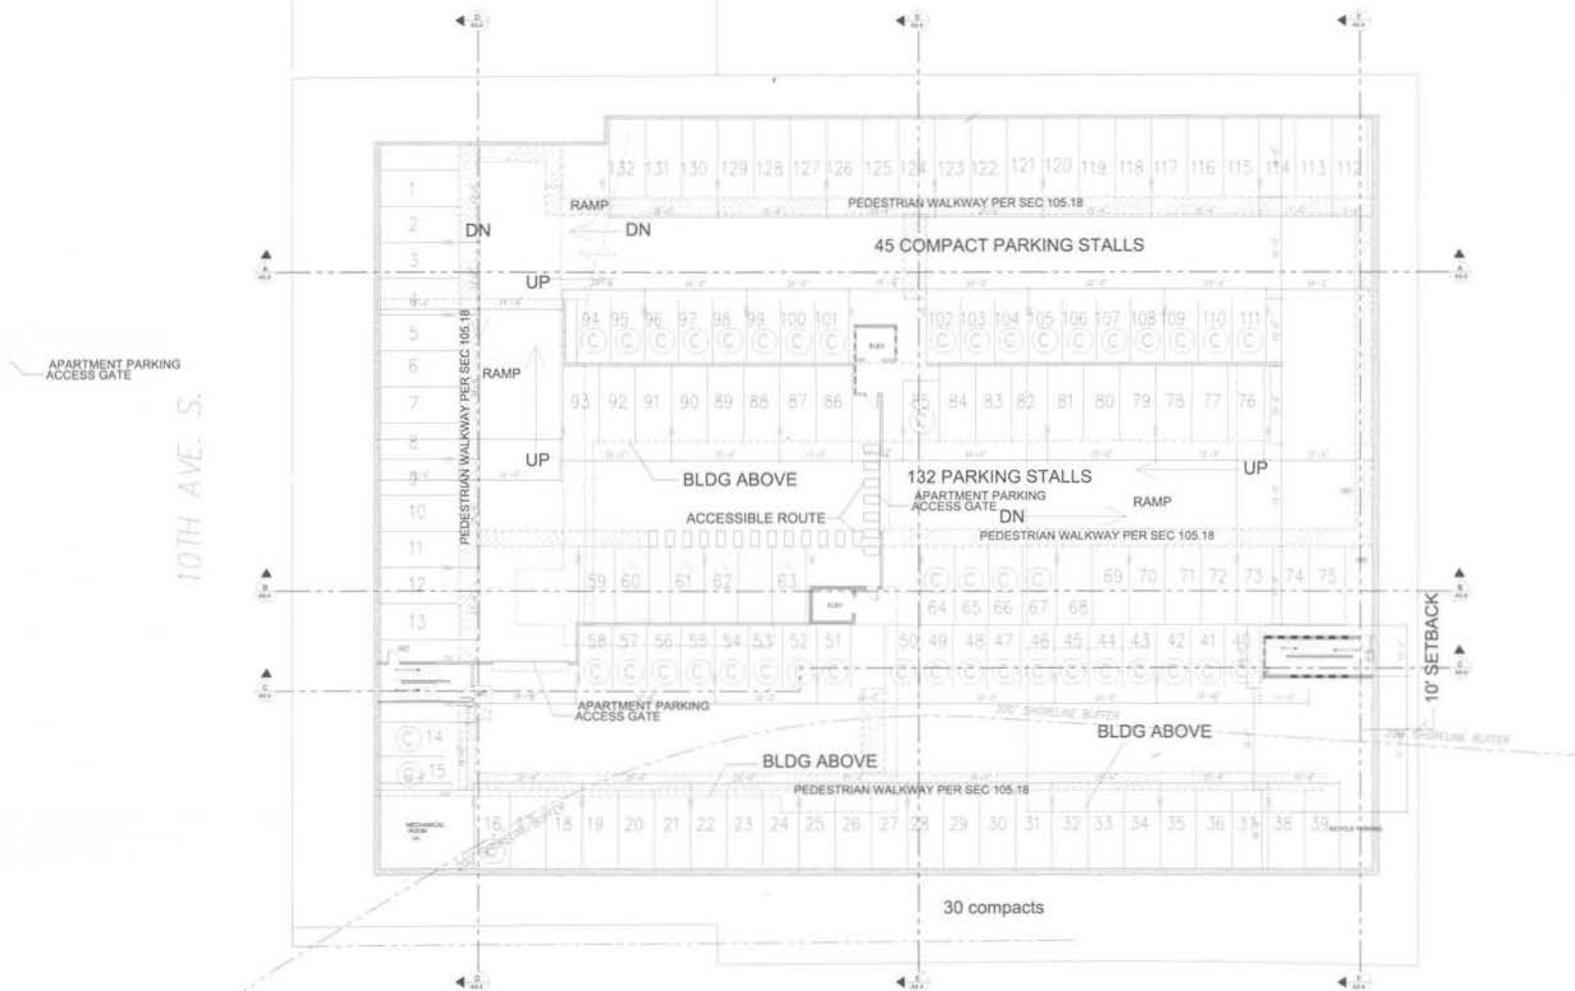
BASEMENT PARKING
 LEVEL #1 FLOOR PLAN
 SCALE 3/32" = 1'-0"

FLOOR AREA BREAKDOWN
 624 SQ/FT COMMON AREA
 41,329 SQ/FT RESIDENTIAL PARKING AREA
 41,953 SQ/FT TOTAL FLOOR AREA

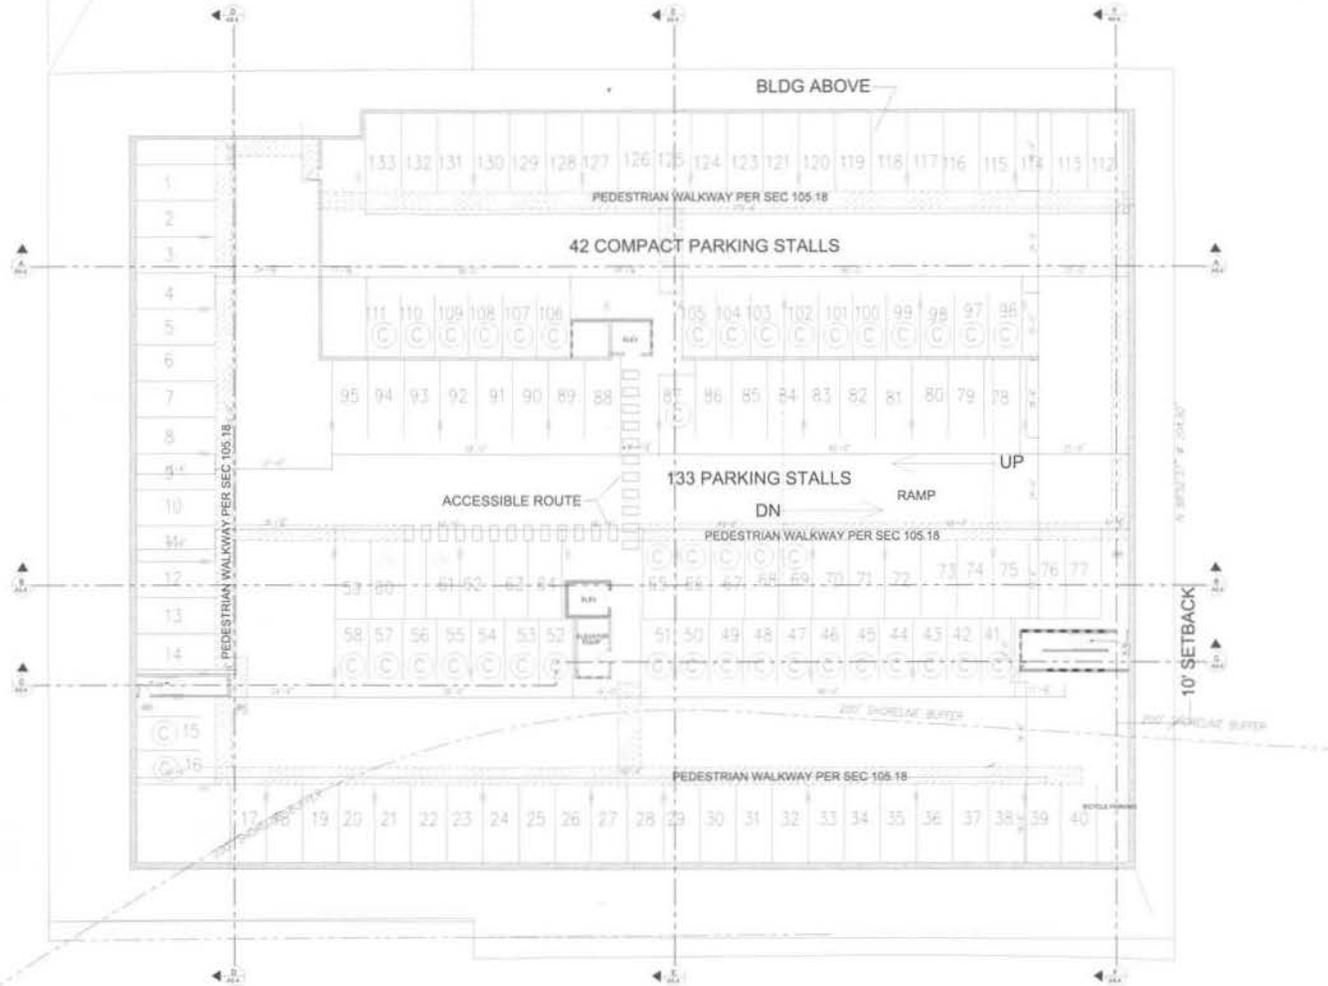
FLOOR AREA BREAKDOWN
 968 SQ/FT COMMON AREA
 40,985 SQ/FT RESIDENTIAL PARKING AREA
 41,953 SQ/FT TOTAL FLOOR AREA

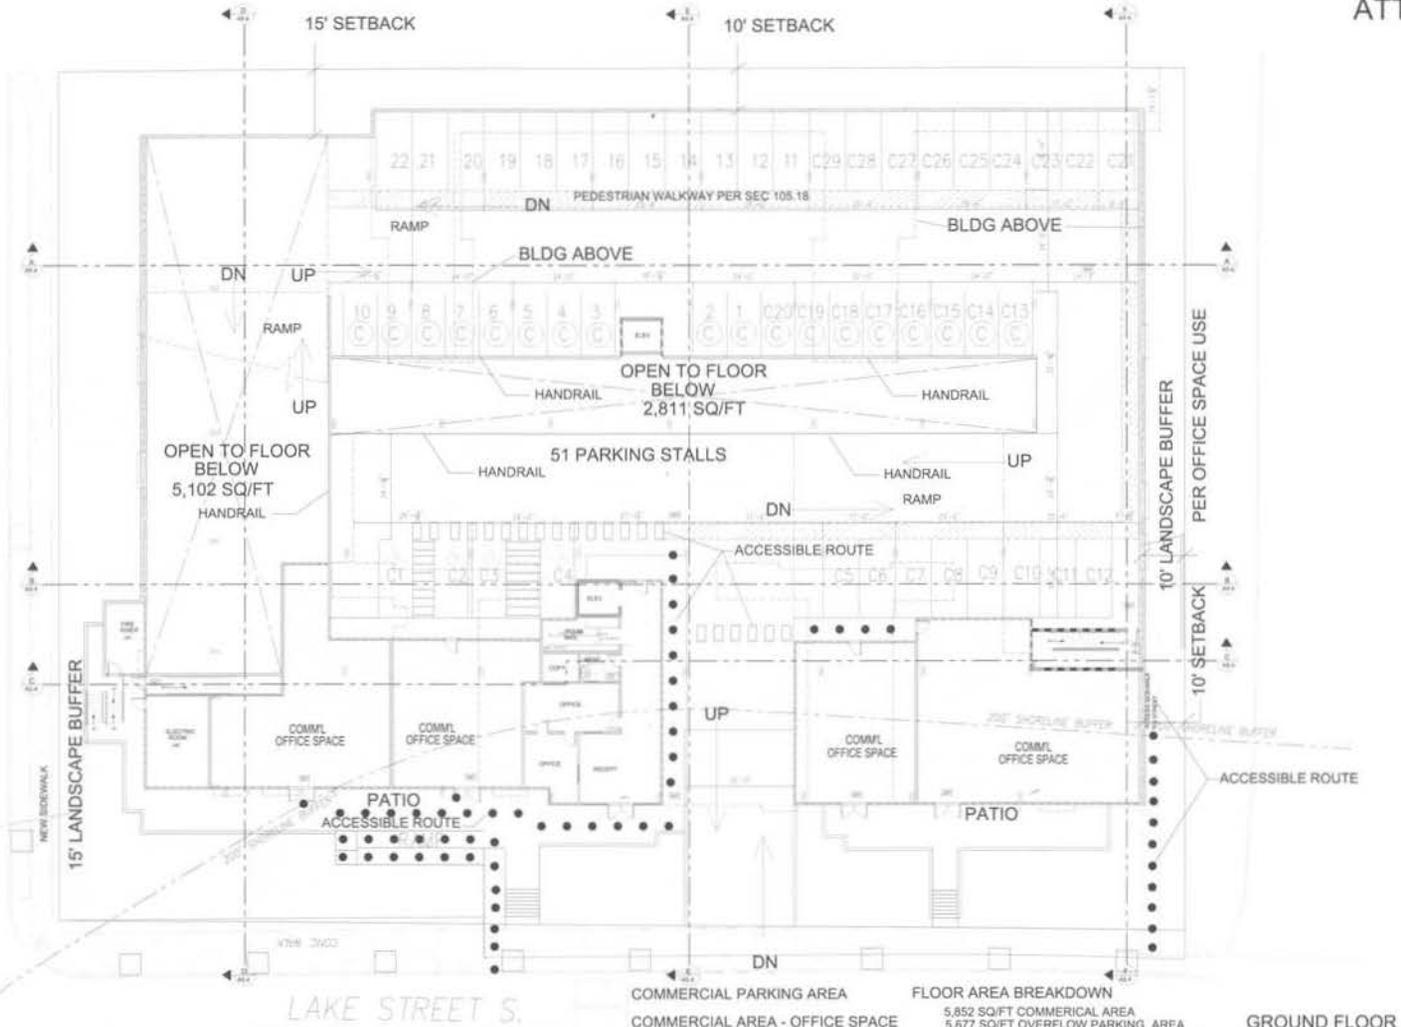
PARKING REQUIREMENTS

37 COMPACT STALLS PROVIDED	3,000 SQ/FT MEDICAL OFFICE @ 1 PER 200 SQ/FT = 15 PARKING STALLS REQ	29 STALLS PROVIDED
15 HANDICAP STALLS PROVIDED	2,862 SQ/FT OFFICE @ 1 PER 300 SQ/FT = 10 PARKING STALLS REQ	34 STALLS PROVIDED
221 STANDARD STALLS PROVIDED	334 SQ/FT ELECTRIC ROOM @ 1 PER 300 SQ/FT = 2 PARKING STALLS REQ	41 STALLS PROVIDED
	TOTAL COMMERCIAL PARKING = 27 PARKING STALLS REQ	34 STALLS PROVIDED
	143 APARTMENT UNITS @ 1.7 STALLS = 244 PARKING STALLS REQ	41 STALLS PROVIDED
	GUEST PARKING STALLS PROVIDED	318 TOTAL PARKING STALLS PROVIDED

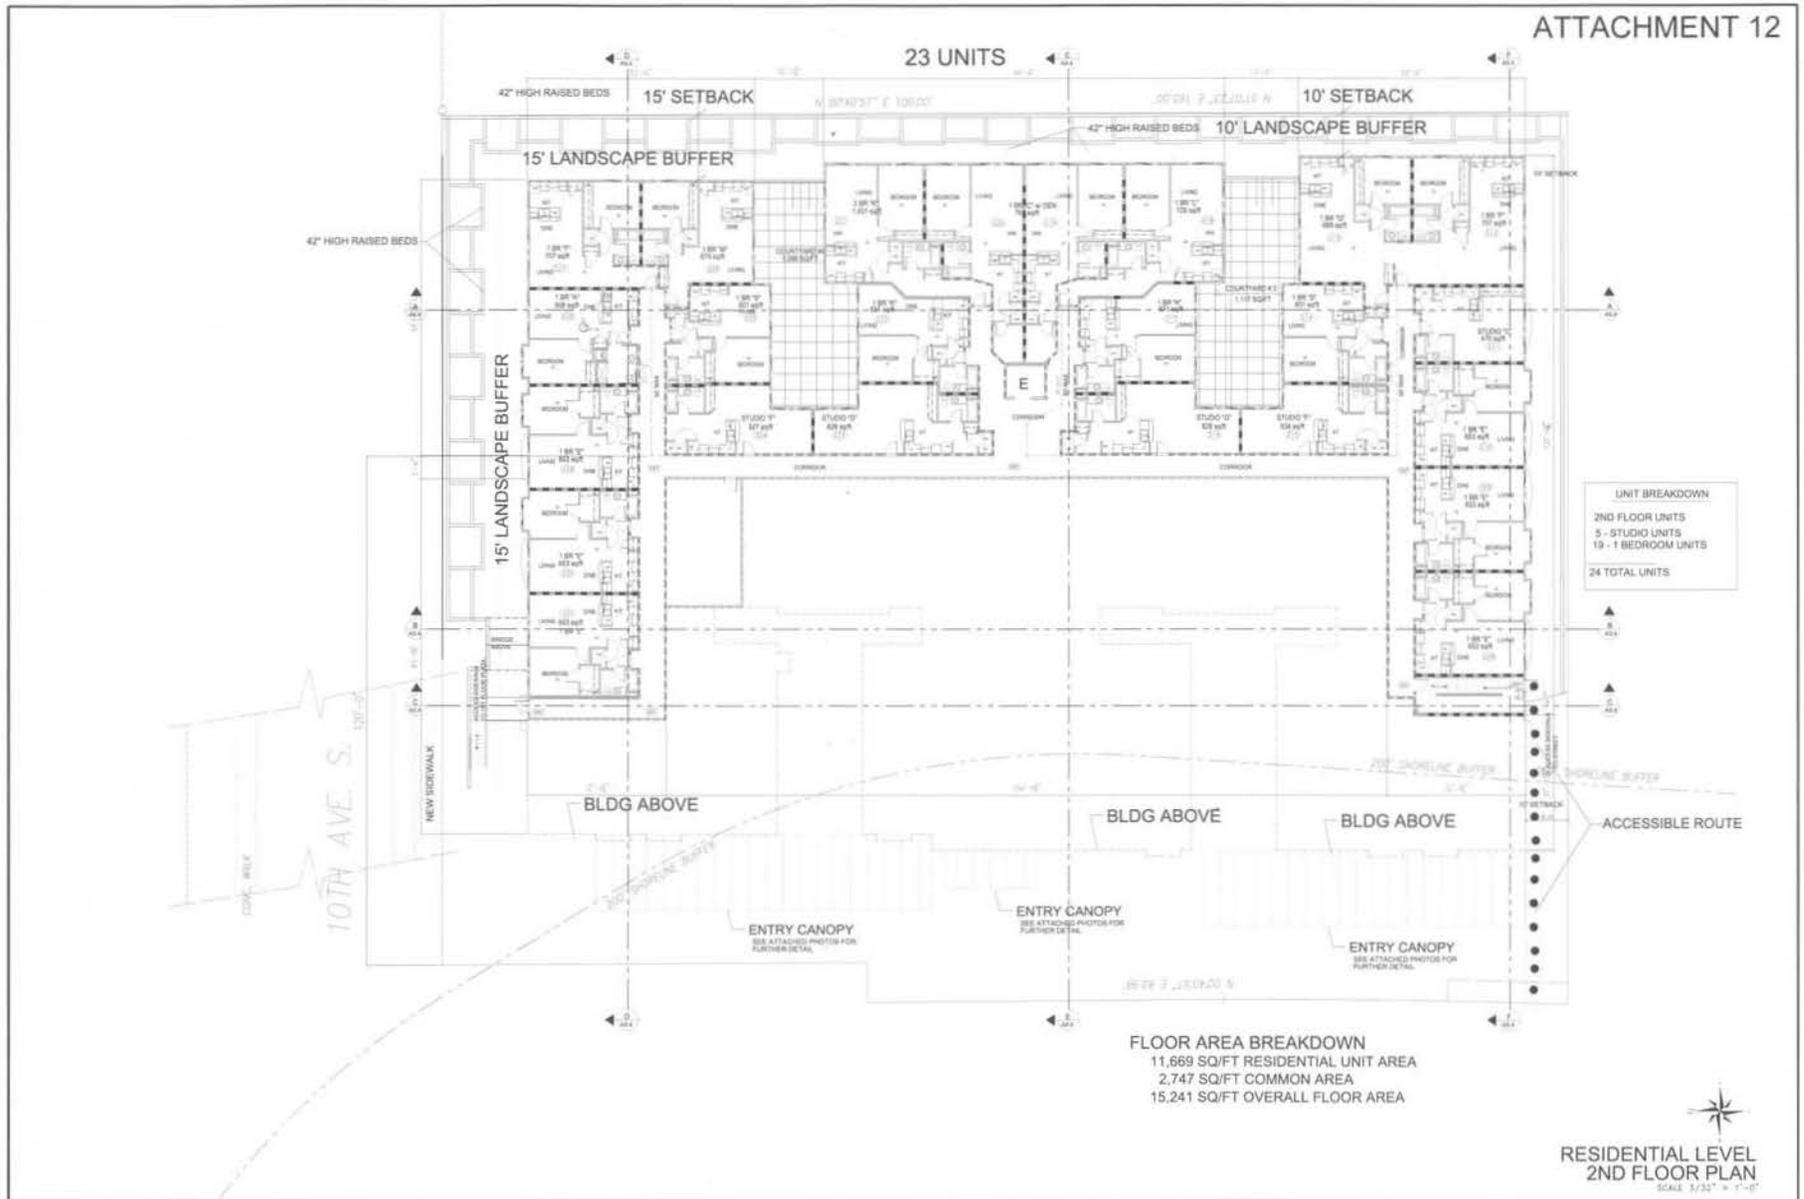
UNIT BREAKDOWN
 2ND FLOOR UNITS
 5 - STUDIO UNITS
 19 - 1 BEDROOM UNITS
 24 TOTAL UNITS

FLOOR AREA BREAKDOWN
 11,669 SQ/FT RESIDENTIAL UNIT AREA
 2,747 SQ/FT COMMON AREA
 15,241 SQ/FT OVERALL FLOOR AREA

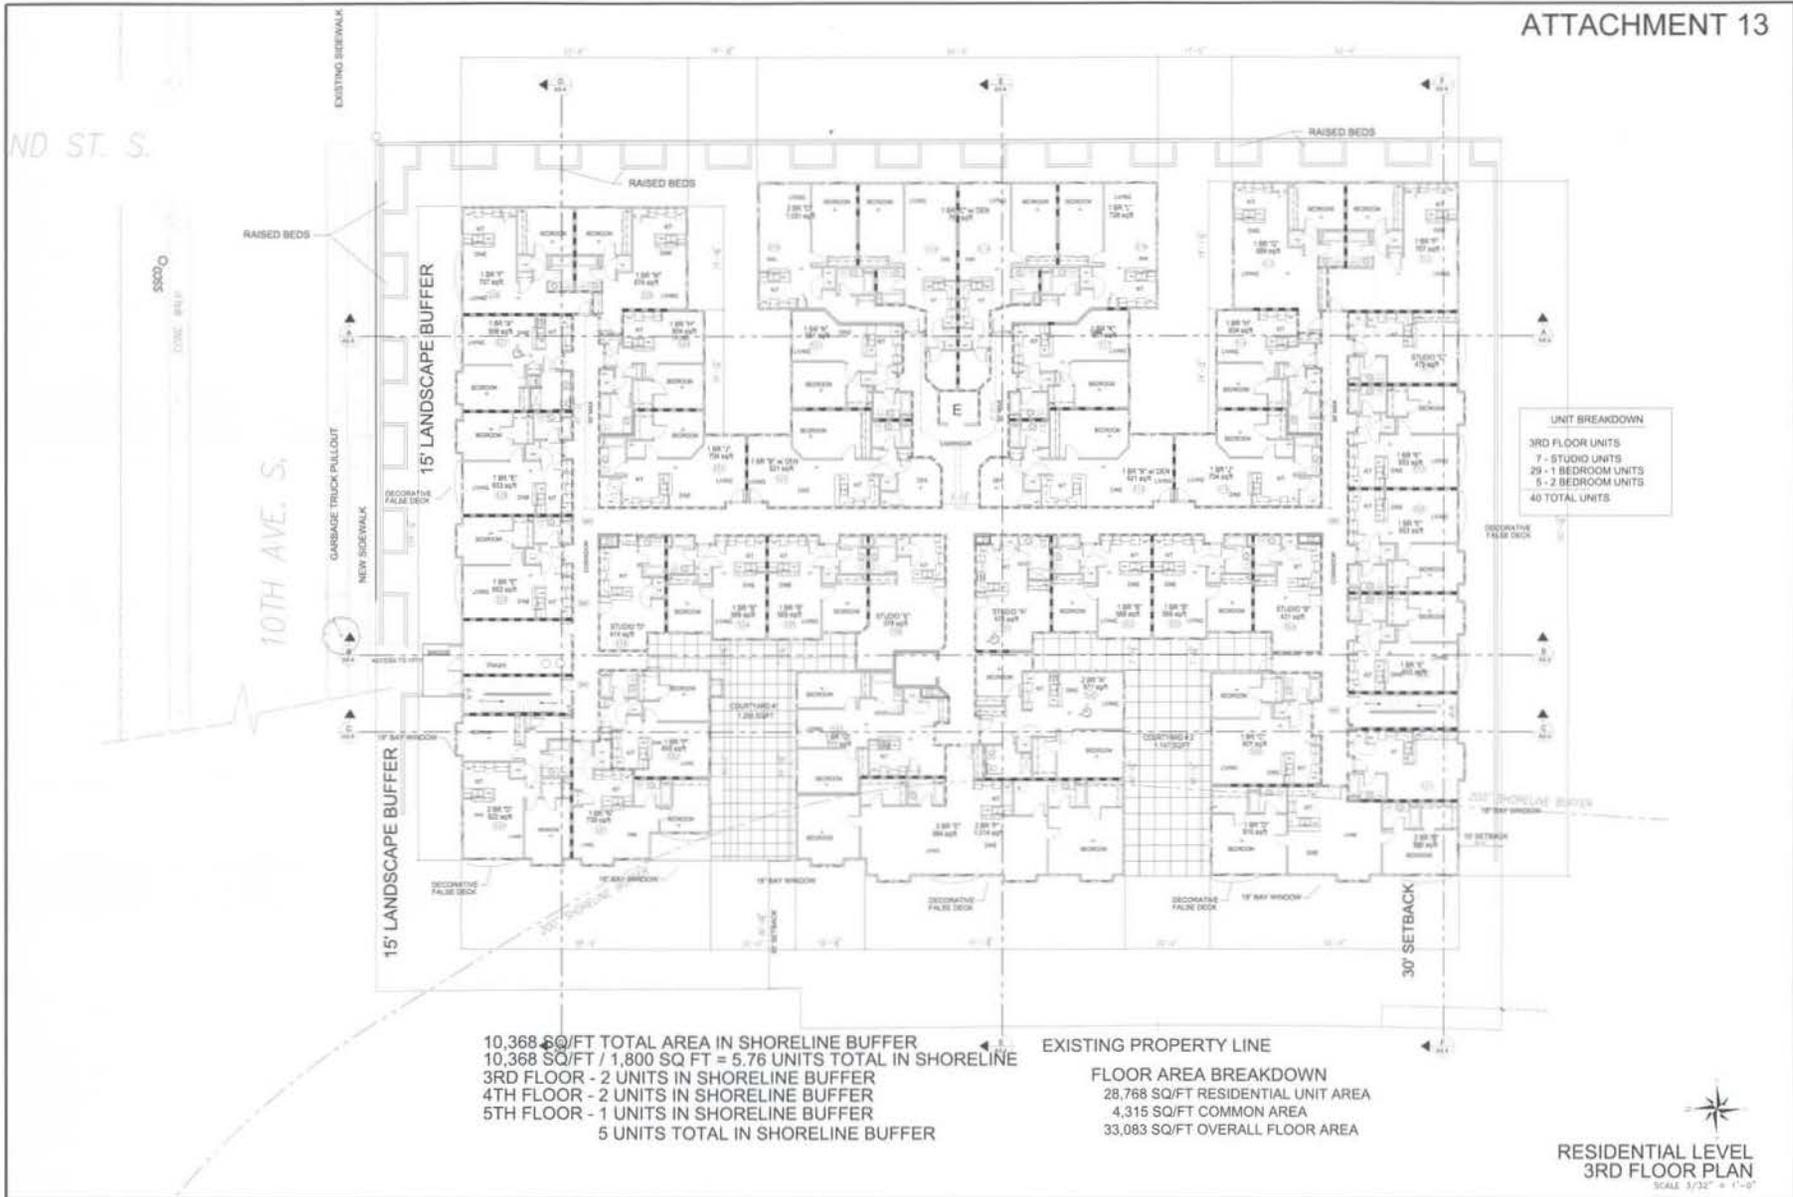
RESIDENTIAL LEVEL
 3RD FLOOR PLAN
 SCALE 3/32" = 1'-0"

UNIT BREAKDOWN
 3RD FLOOR UNITS
 7 - STUDIO UNITS
 29 - 1 BEDROOM UNITS
 5 - 2 BEDROOM UNITS
 40 TOTAL UNITS

10,368 SQ/FT TOTAL AREA IN SHORELINE BUFFER
 10,368 SQ/FT / 1,800 SQ FT = 5.76 UNITS TOTAL IN SHORELINE
 3RD FLOOR - 2 UNITS IN SHORELINE BUFFER
 4TH FLOOR - 2 UNITS IN SHORELINE BUFFER
 5TH FLOOR - 1 UNITS IN SHORELINE BUFFER
 5 UNITS TOTAL IN SHORELINE BUFFER

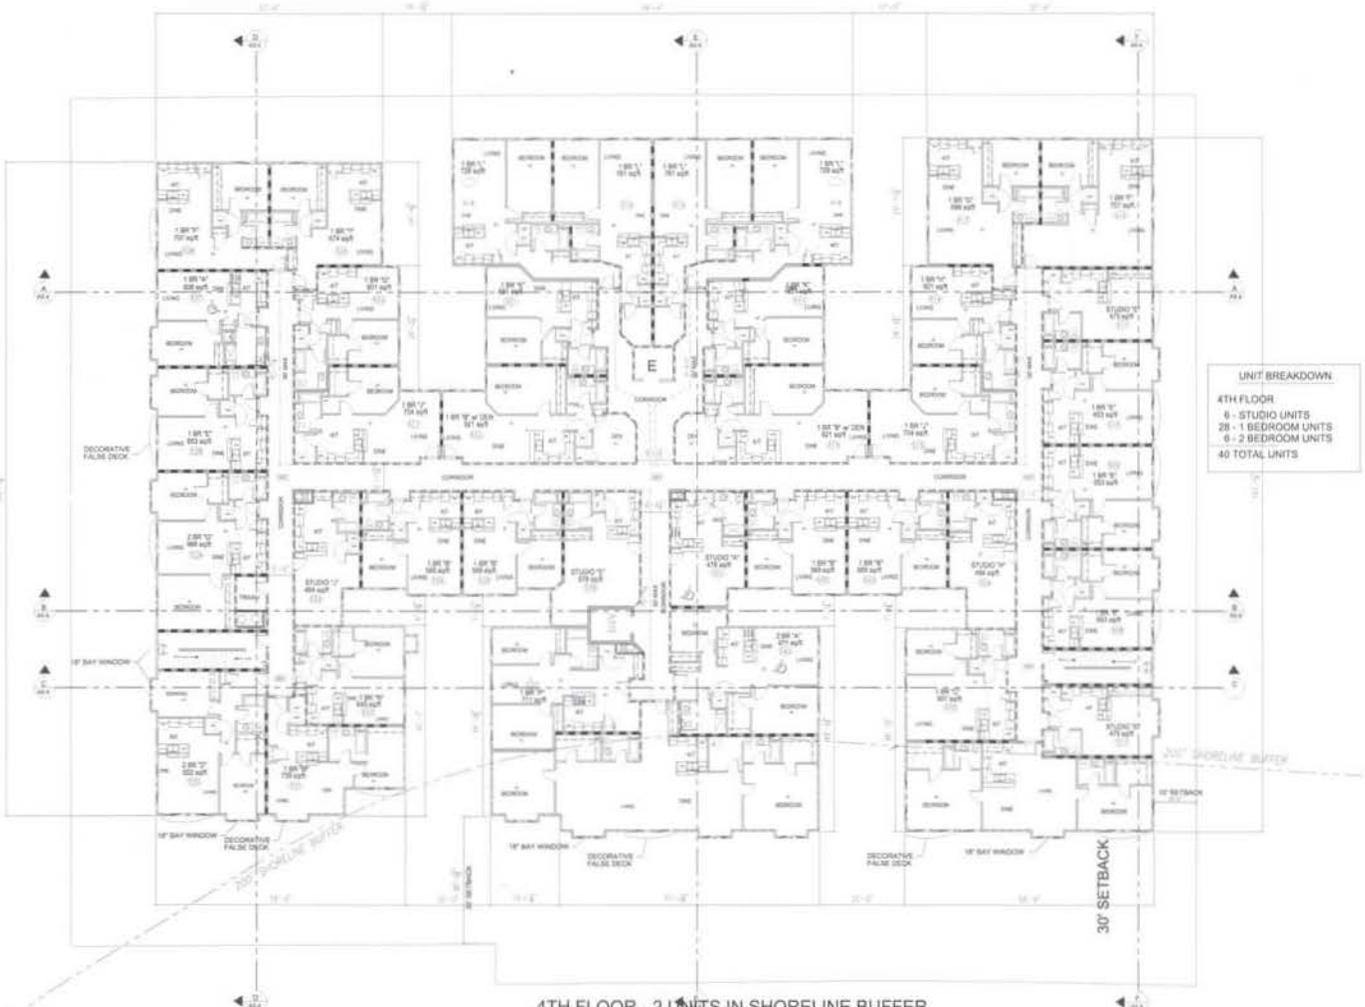
RESIDENTIAL LEVEL
 4TH FLOOR PLAN
 SCALE 3/32" = 1'-0"

UNIT BREAKDOWN
 4TH FLOOR
 6 - STUDIO UNITS
 28 - 1 BEDROOM UNITS
 6 - 2 BEDROOM UNITS
 40 TOTAL UNITS

4TH FLOOR - 2 UNITS IN SHORELINE BUFFER
 FLOOR AREA BREAKDOWN
 29,193 SQ/FT RESIDENTIAL UNIT AREA
 3,890 SQ/FT COMMON AREA
 33,083 SQ/FT OVERALL FLOOR AREA

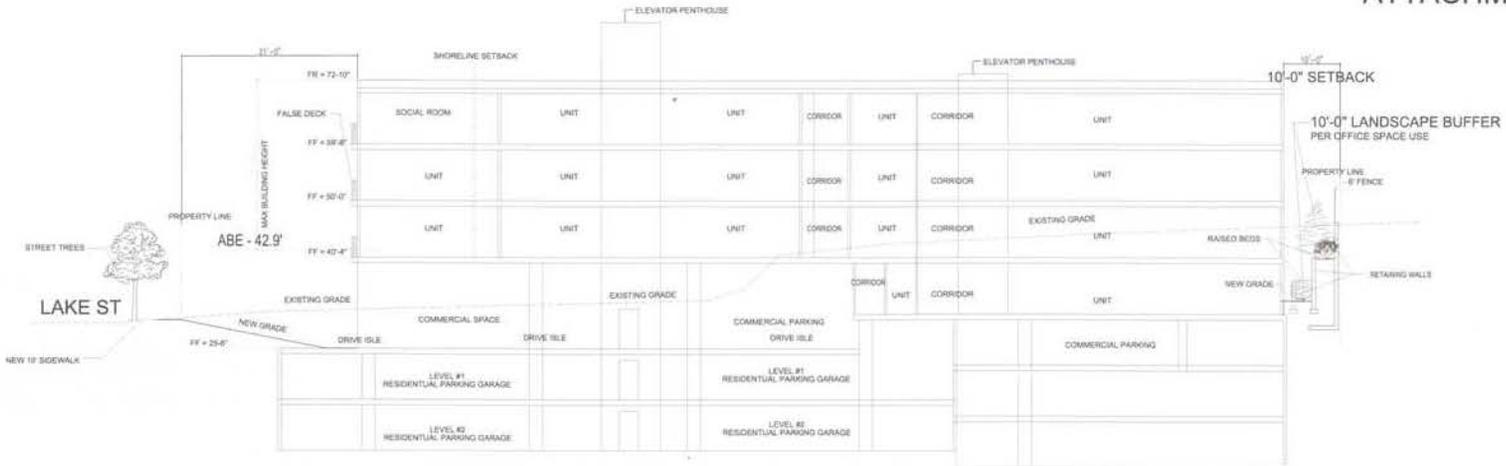
SECTION "E-E"

SECTIONS CUTS
SCALE 1/8" = 1'-0"

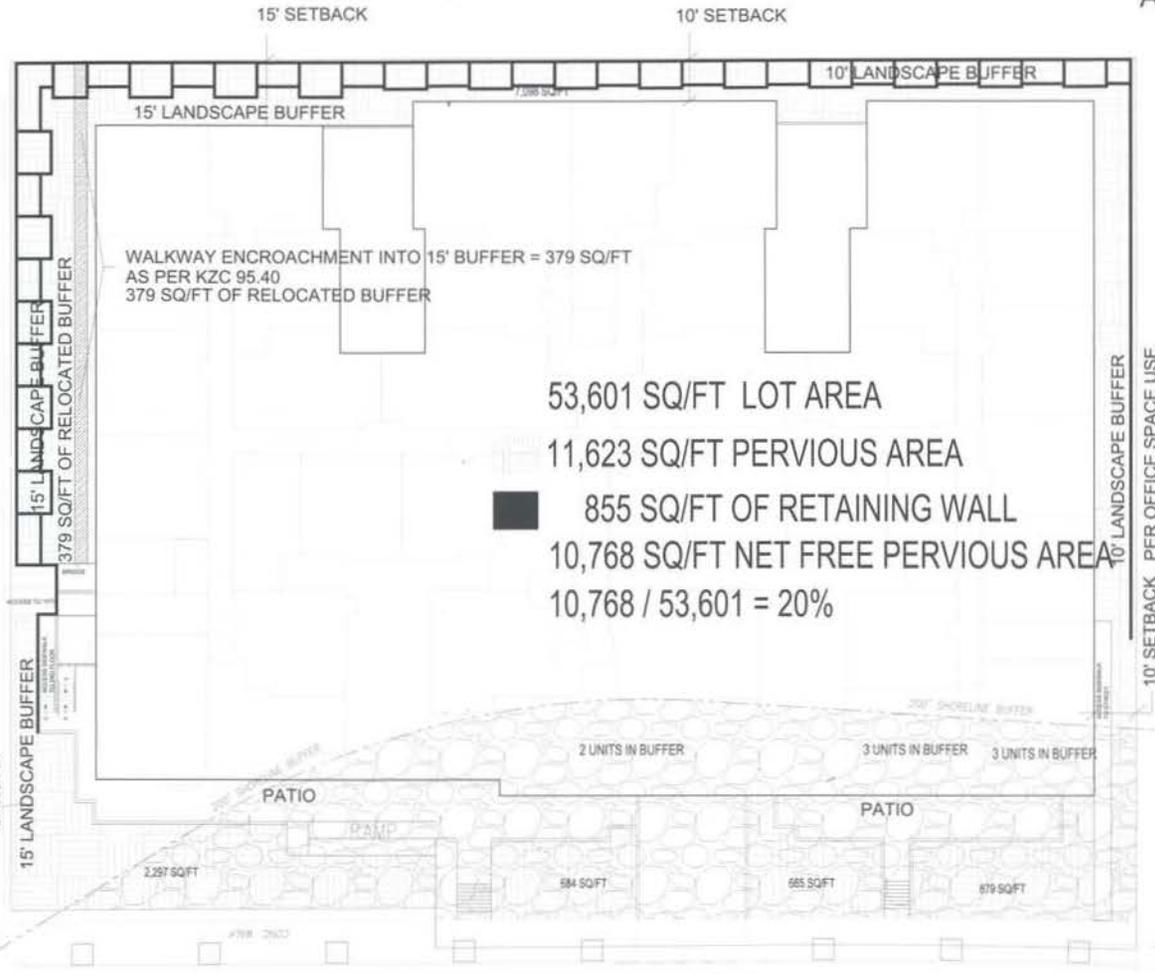
OPEN AREA PLAN
 SHORELINE BUFFER CALC PLAN
 SCALE 3/32" = 1'-0"

10,368 SQ/FT TOTAL AREA IN SHORELINE BUFFER
 10,368 SQ/FT / 1,800 SQ FT = 5.76 UNITS TOTAL IN SHORELINE
 3RD FLOOR - 2 UNITS IN SHORELINE BUFFER
 4TH FLOOR - 2 UNITS IN SHORELINE BUFFER
 5TH FLOOR - 1 UNITS IN SHORELINE BUFFER
 5 UNITS TOTAL IN SHORELINE BUFFER
