As requested, The Riley Group, Inc. (RGI) has reviewed the preliminary plans for the proposed Watershed Cottages development at 4559 112<sup>th</sup> Avenue Northeast. RGI previously completed a Geotechnical Engineering Report and Low Impact Development/ Infiltration Feasibility Study at the property in support of development of the site by the current owner.

**WATERSHED COTTAGES**  
**PRELIMINARY PLANS**

Blueprint 112th		Figure 1
RGI Project Number 2018-122	Site Vicinity Map	Date Drawn: 05/2018
Address: 4559 112th Avenue Northeast, Kirkland, Washington 98033

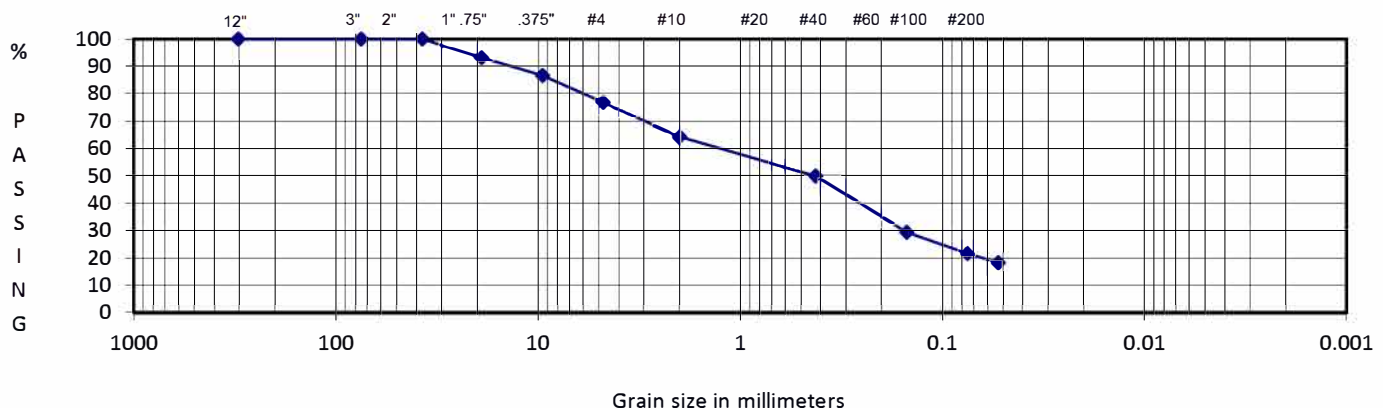
PROJECT TITLE	Blueprint 112th - Hydro		SAMPLE ID/TYPE	TP1	Soil	
PROJECT NO.	2018-122			SAMPLE DEPTH	3'	
TECH/TEST DATE	LC 5/24				DATE RECEIVED	5/21/2018
<b>WATER CONTENT (Delivered Moisture)</b>			Total Weight Of Sample Used For Sieve Corrected For Hygroscopic Moisture			
Wt Wet Soil & Tare (gm)	(w1)	620.1	Weight Of Sample (gm)		554.9	
Wt Dry Soil & Tare (gm)	(w2)	554.9	Tare Weight (gm)		15.7	
Weight of Tare (gm)	(w3)	15.7	(W6)	Total Dry Weight (gm) 539.2

DESCRIPTION Silty SAND with some gravel.

USCS SM

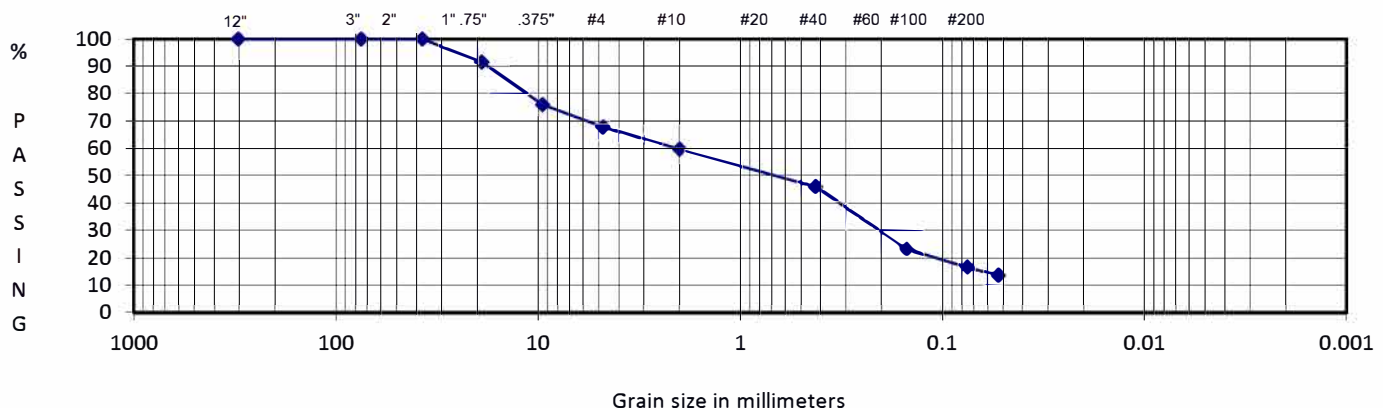
PROJECT TITLE	Blueprint 112th - Hydro	SAMPLE ID/TYPE	TP3	Soil
PROJECT NO.	2018-122	SAMPLE DEPTH	3'	
TECH/TEST DATE	LC 5/24	DATE RECEIVED	5/21/2018	
<b>WATER CONTENT (Delivered Moisture)</b>		Total Weight Of Sample Used For Sieve Corrected For Hygroscopic Moisture		
Wt Wet Soil & Tare (gm)	(w1)	854.0	Weight Of Sample (gm)	773.0
Wt Dry Soil & Tare (gm)	(w2)	773.0	Tare Weight (gm)	15.7
Weight of Tare (gm)	(w3)	15.7	(W6) Total Dry Weight (gm)	757.3

DESCRIPTION Silty gravelly SAND.

USCS SM

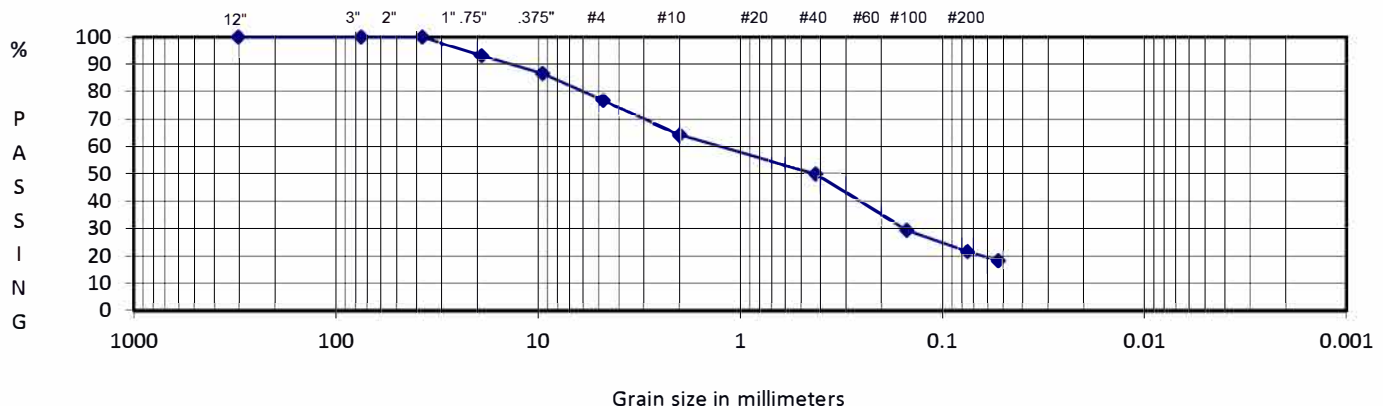
0.375"	87.4	71.70	13.30	86.70	fine gravel
D10 (mm)		#4	140.5	124.80	23.15	76.85	coarse sand
D30 (mm)		#10	208.0	192.30	35.66	64.34	medium sand
D60 (mm)		#20					medium sand
Cu		#40	285.5	269.80	50.04	49.96	fine sand
Cc		#60					fine sand

#100	396.7	381.00	70.66	29.34	fine sand
		#200	438.2	422.50	78.36	21.64	fine sand
		#270	456.5	440.80	81.75	18.25	fine sand

DESCRIPTION Silty SAND with some gravel.

USCS SM
