CERTIFICATE CONCERNING DESIGN AND CONSTRUCTION OF ELECTRONIC SPEED MEASURING DEVICES

The ASE program includes the use of the AutoPatrol 3D radar fixed speed safety camera systems at the following locations within the City of Kirkland:

Speed Validation Report Client: Kirkland, WA

| VERRA MOBILITY PREVENTIVE MAINTENANCE CHECKLIST | | |

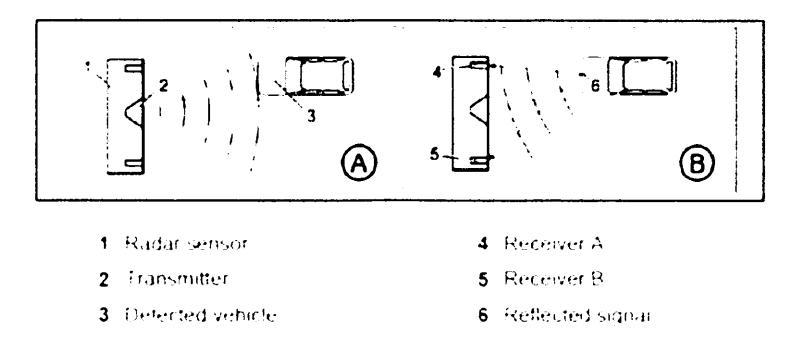
The tracking radar utilizes the Doppler Effect for speed determination. If an electromagnetic wave is emitted at a moving object, then the wave is reflected back from the moving object. The frequency of the wave received back by the radar shifts based on the speed of the moving object and its direction of travel. The tracking radar continuously determines this frequency shift of each object to calculate the object's speed. The tracking radar consists of two receiving antennas integrated into a single radar sensor. This configuration allows the radar to measure the distance and angle of the vehicle relative to the position of the radar sensor. Illustration A and B show the measurement principle in simplified form. The radar sensor emits a radar beam (illustration A). The radar beam is reflected by the vehicle (illustration B). The two receivers receive the reflected radar beam. The radar sensor evaluates the return frequency, as well as the phase difference of the reflected radar beam from both of the receivers. With the aid of these values the radar sensor calculates the vehicle position.

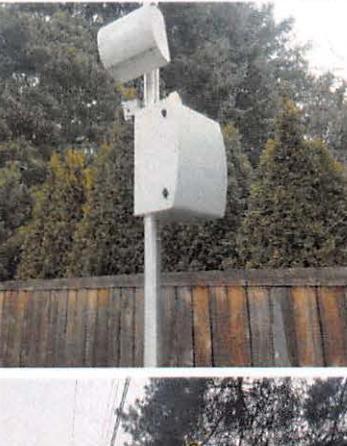
5.1. Enclosure:

| 3.1. Pole: | Pass |
|---|---|
| 3.3. Enclosure: Confirm straps are tight and secure against pole. Tighten if loose. | Pass |

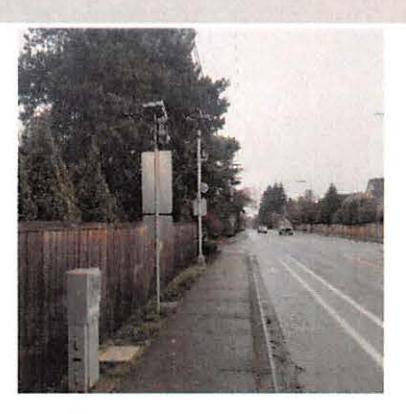
5.2. Pole:

| 3.1. Pole: | Pass |
|---|---|
| Check sturdiness. Check hurricane collar and confirm screws are tight. | |

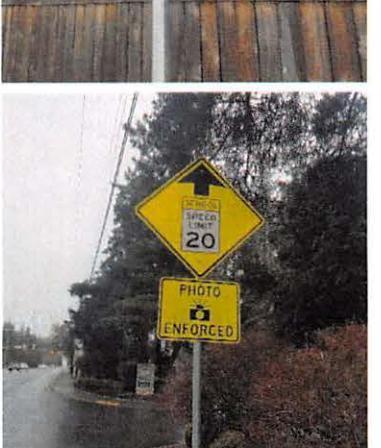
5.3. Photo Enforcement Sign(s):

5. Take (and attach) photo of enclosure, pole, and photo enforcement sign(s) for presence and damage.

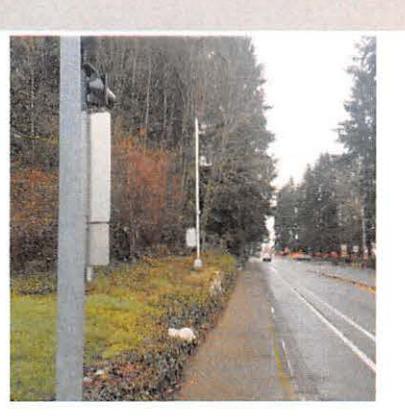
5.2. Pole:

| 3.1. Pole: Check sturdiness. Check hurricane collar and confirm screws are tight. | Pass |
