Appendix C

Corridor Profile Details

JUANITA DRIVE Corridor Study

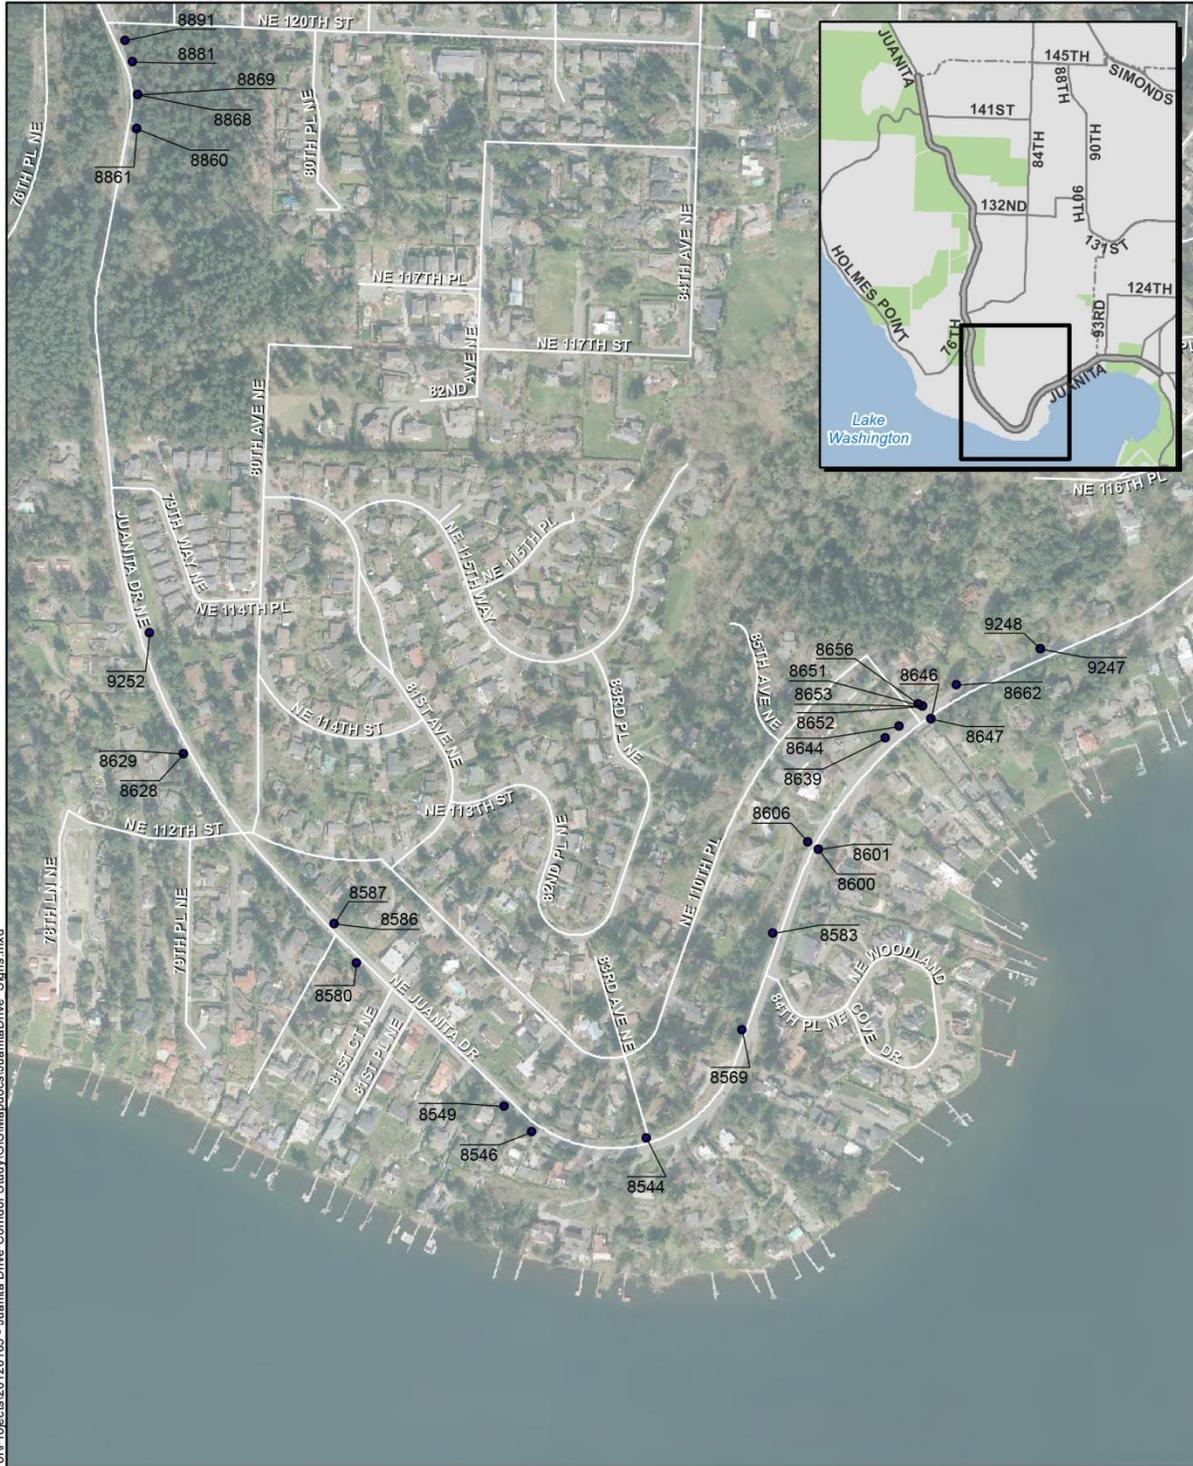
Juanita Drive Corridor Study
Signs Map
Sheet 3 of 4

- Signs

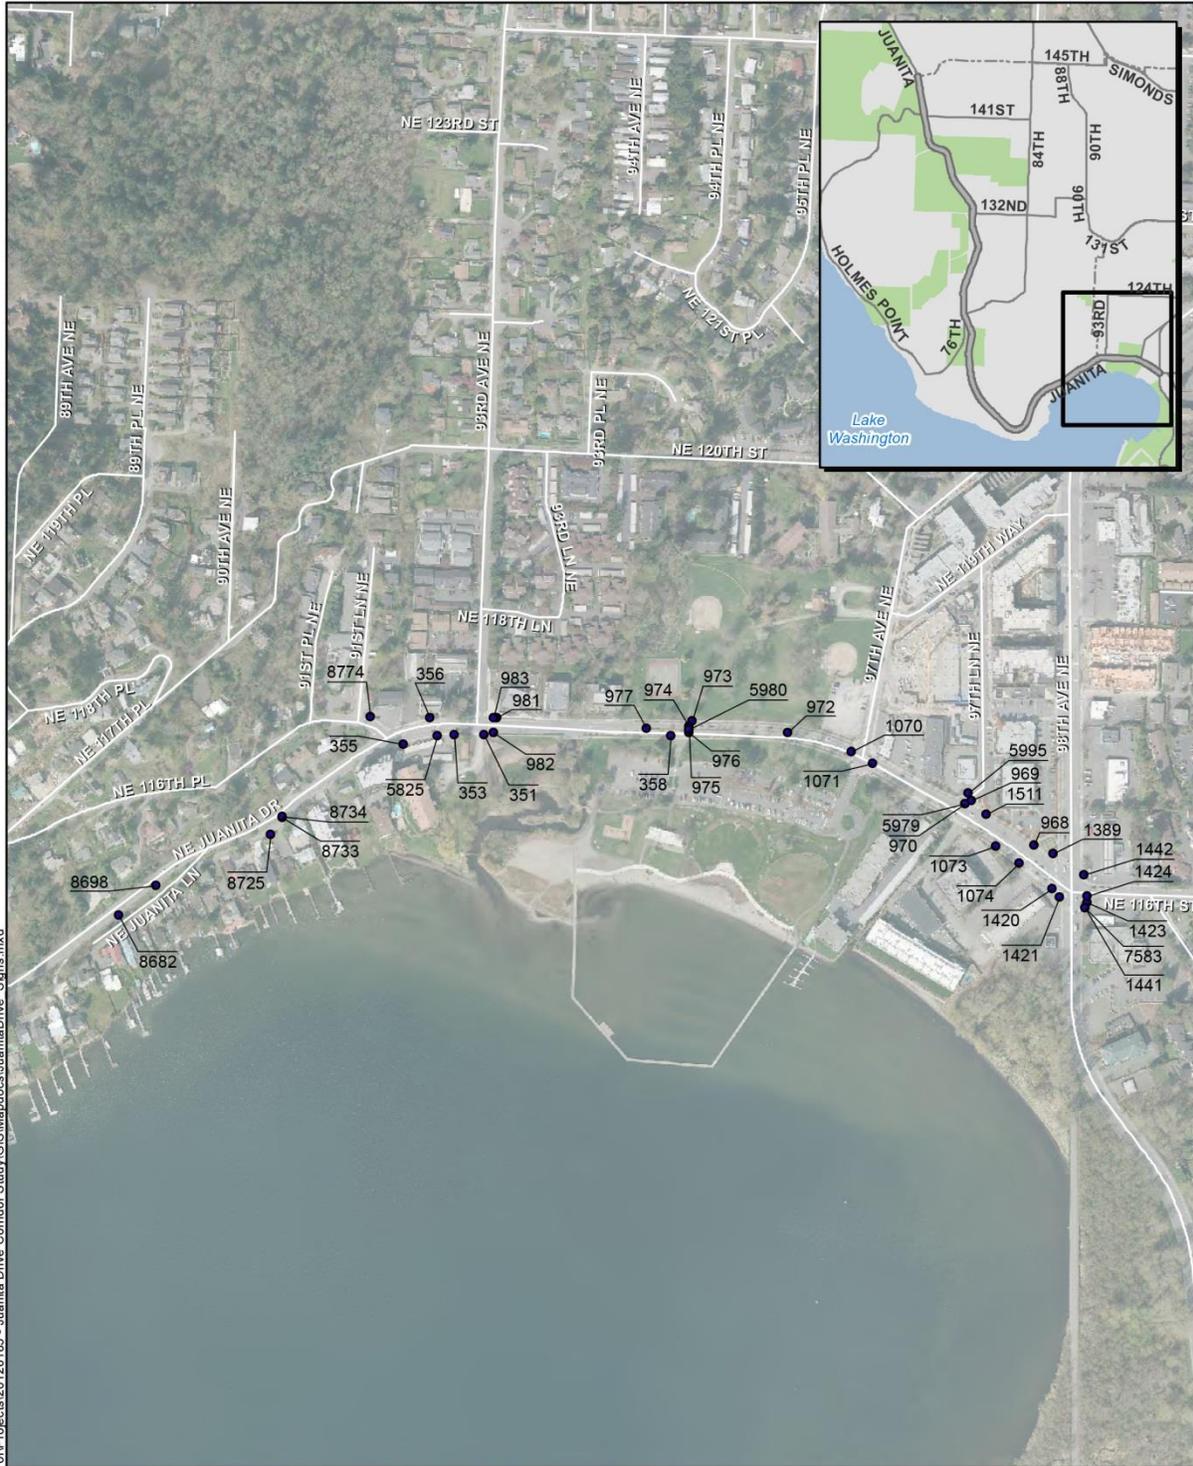
Sheet 4 of 4

Juanita Drive Corridor Study
Signs Map
