COMPARING WIDTHS

To understand how bridge-width might affect user experience and traffic flow on the Totem Lake Connector, Kirkland's staff measured the widths of several bicycle and pedestrian facilities in the area. Each of the photos below was shot at 50 millimeters, 23 paces from the subject, at eye-level.

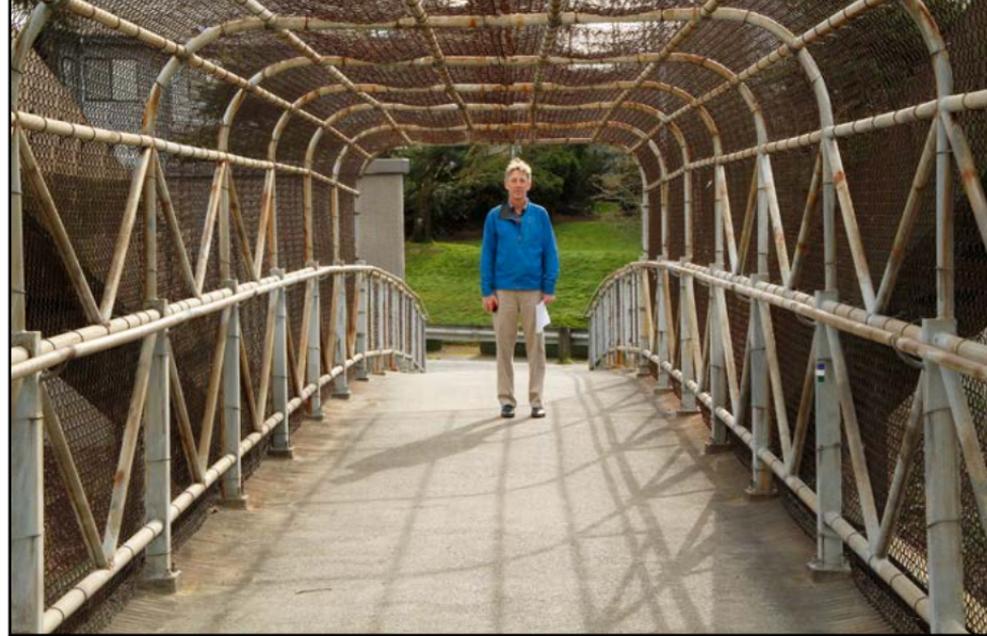
FACILITY: 80th Street bicycle & pedestrian bridge; **WIDTH:** 8 feet

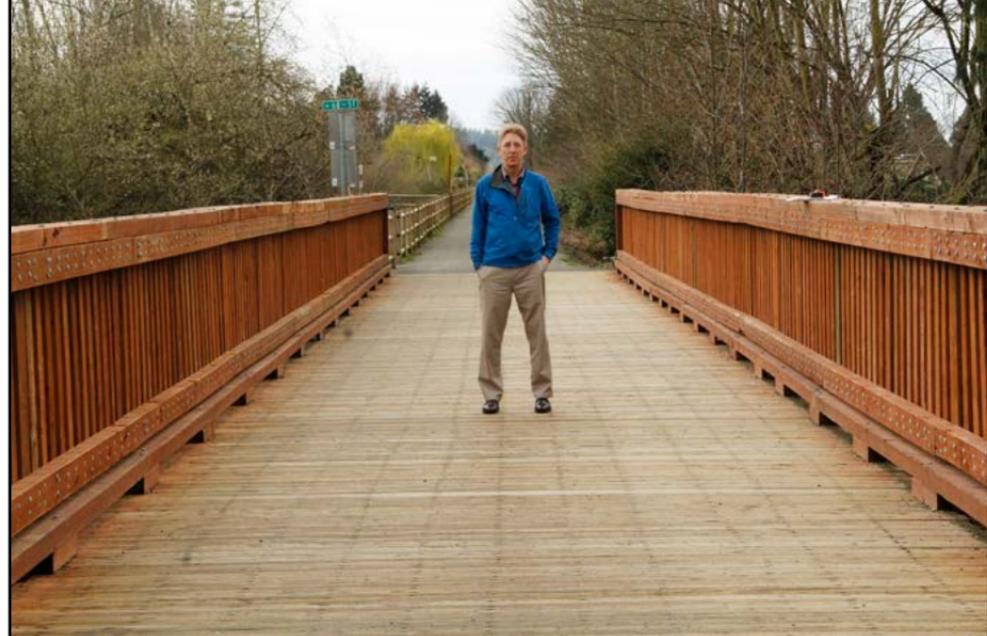
FACILITY: CKC bridge over Northeast 68th Street; **WIDTH:** 12 feet

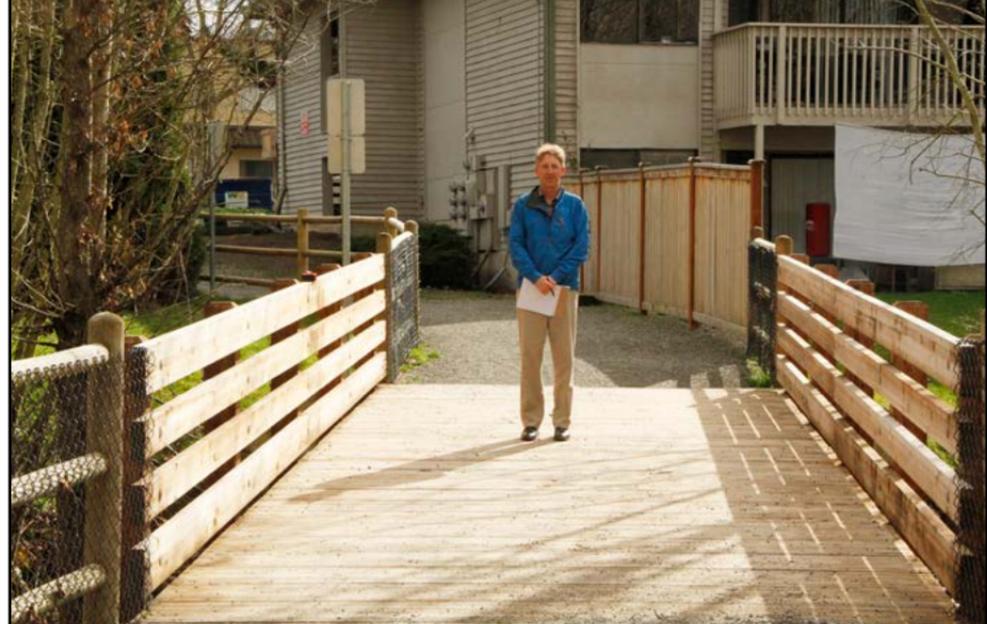
FACILITY: CKC bridge to Houghton; **WIDTH:** 10 feet

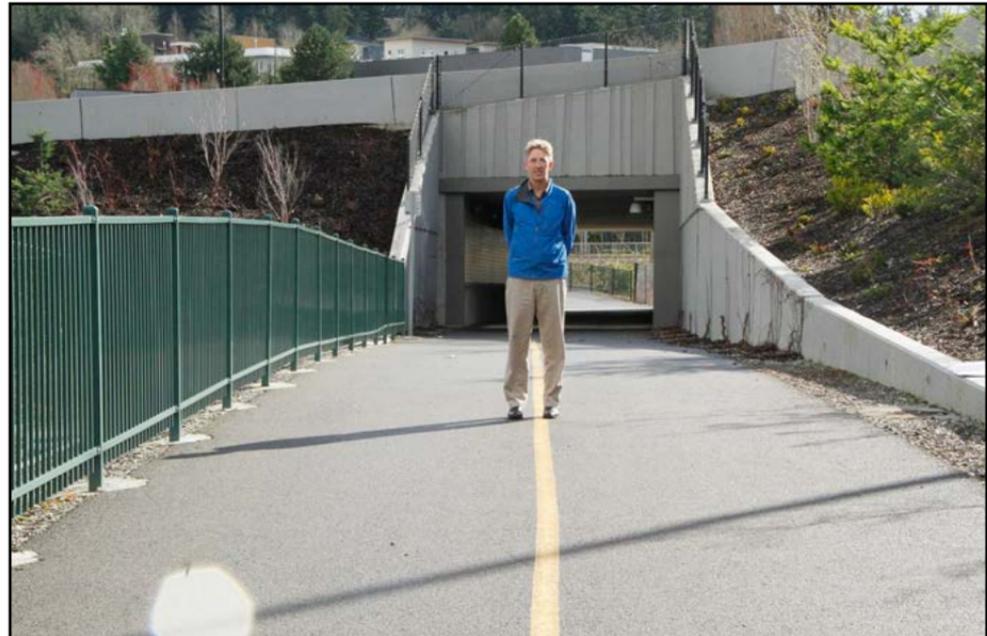
FACILITY: 520 trail, near Northup Way, facing east; **WIDTH:** 14 feet

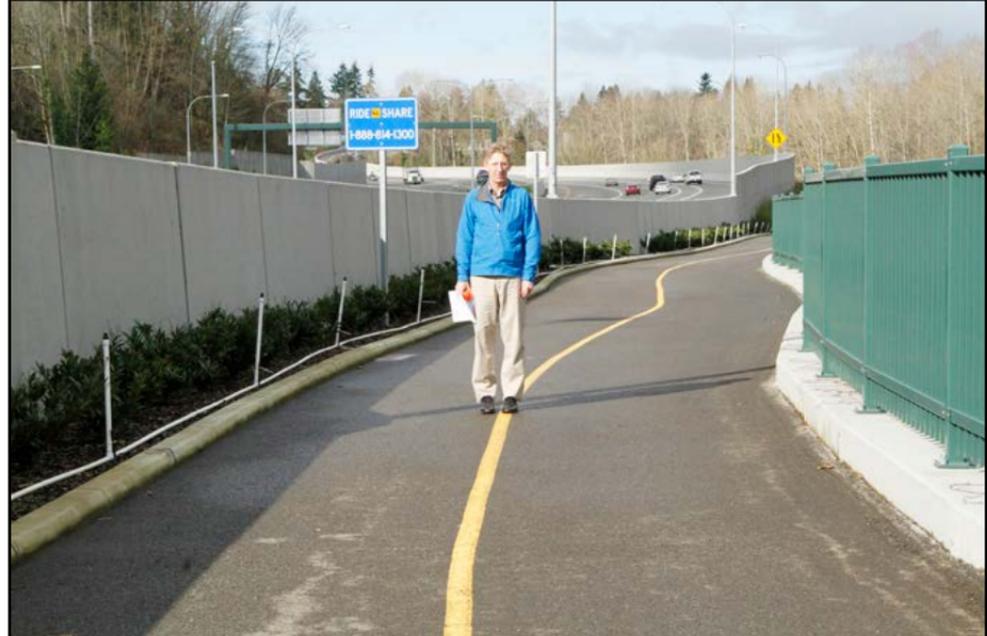
FACILITY: 520 trail, near Northup Way, facing west; **WIDTH:** 12 feet

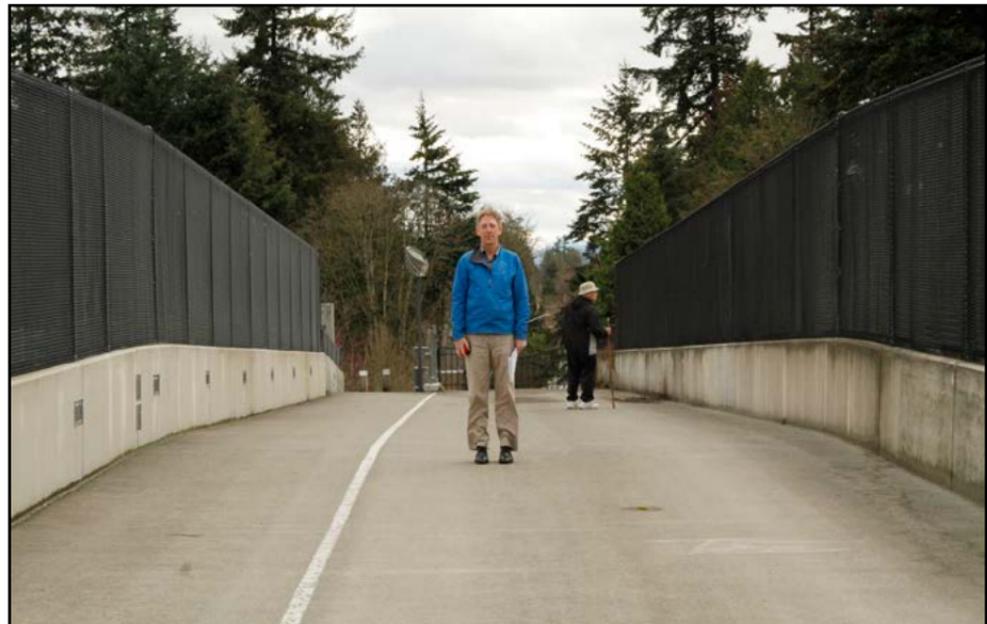
FACILITY: 100th Street bridge; **WIDTH:** 18 feet

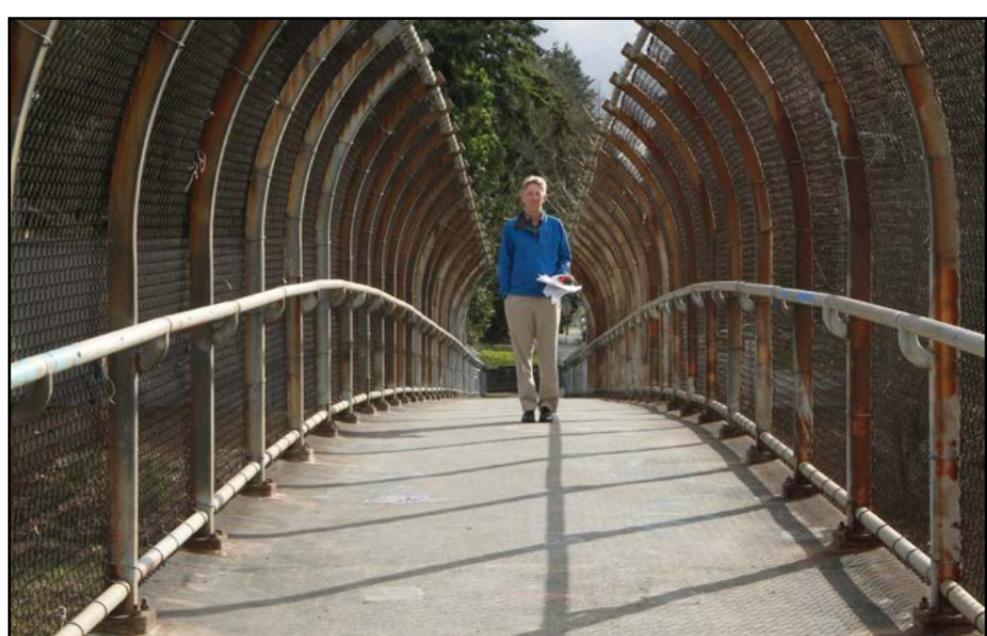
FACILITY: 60th Street pedestrian bridge, **WIDTH:** 8 feet
