**CITY OF KIRKLAND**  
**PARKS AND COMMUNITY SERVICES**  
123 Fifth Avenue, Kirkland, WA 98033  
425-587-3000

**Subject:** **Consideration of Synthetic Turf Feasibility Study at Crestwoods Park – Field #4 and 132nd Square Park – Field #1**

## **132nd Square Park Stormwater Alternatives**

## Infield Synthetic Turf Conversion Study

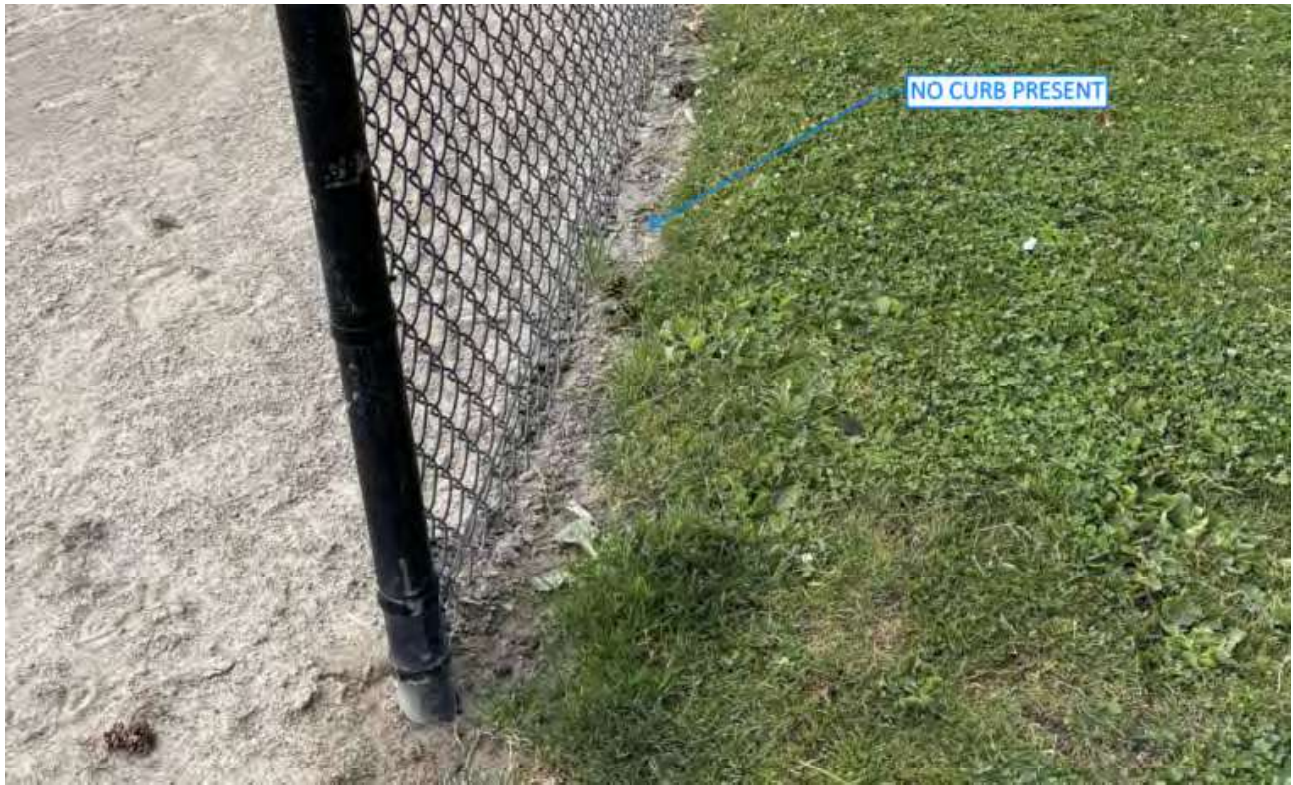
*Image 2, typical fenceline condition*

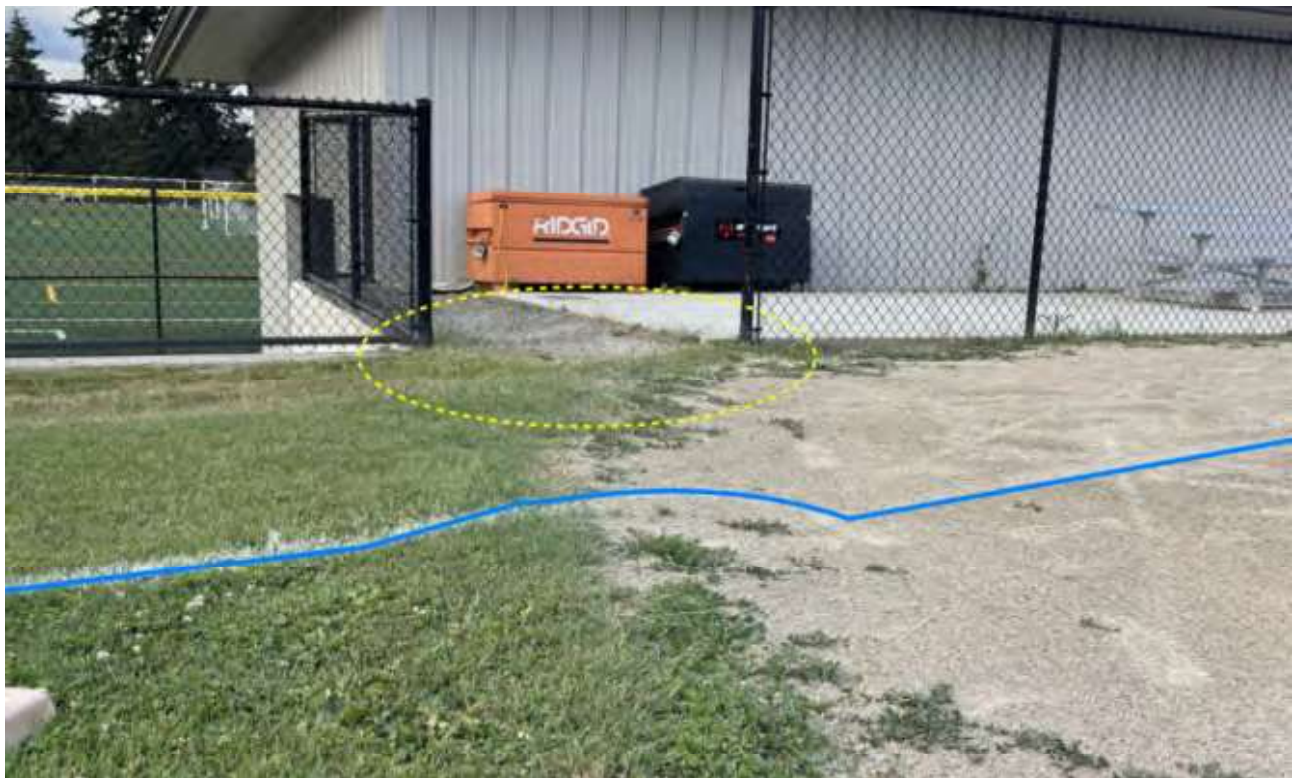
*Image 3, Grade Irregularities*

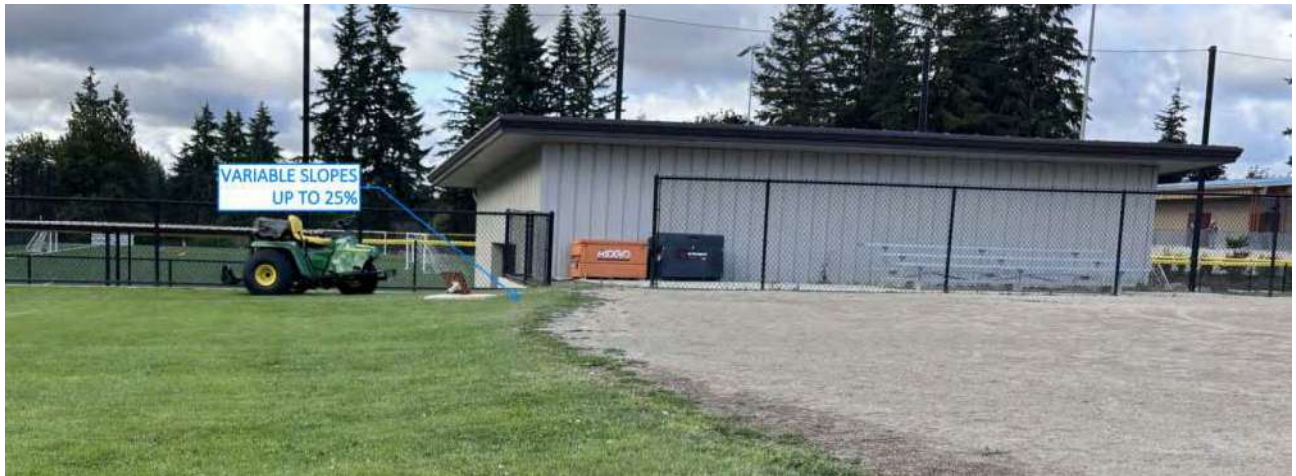
*Image 4, 3<sup>rd</sup> Base Line / Foul Territory Grade Irregularities*

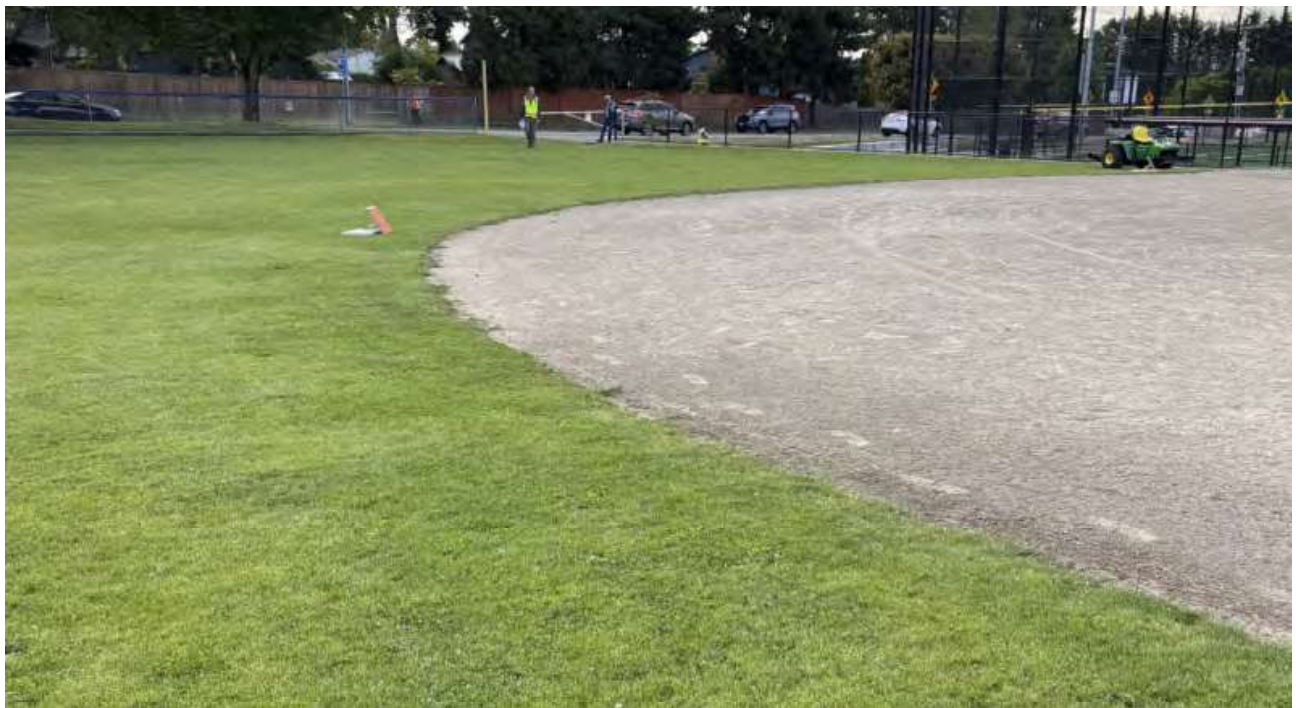
*Image 6, Relatively even transitions between the foul lines*

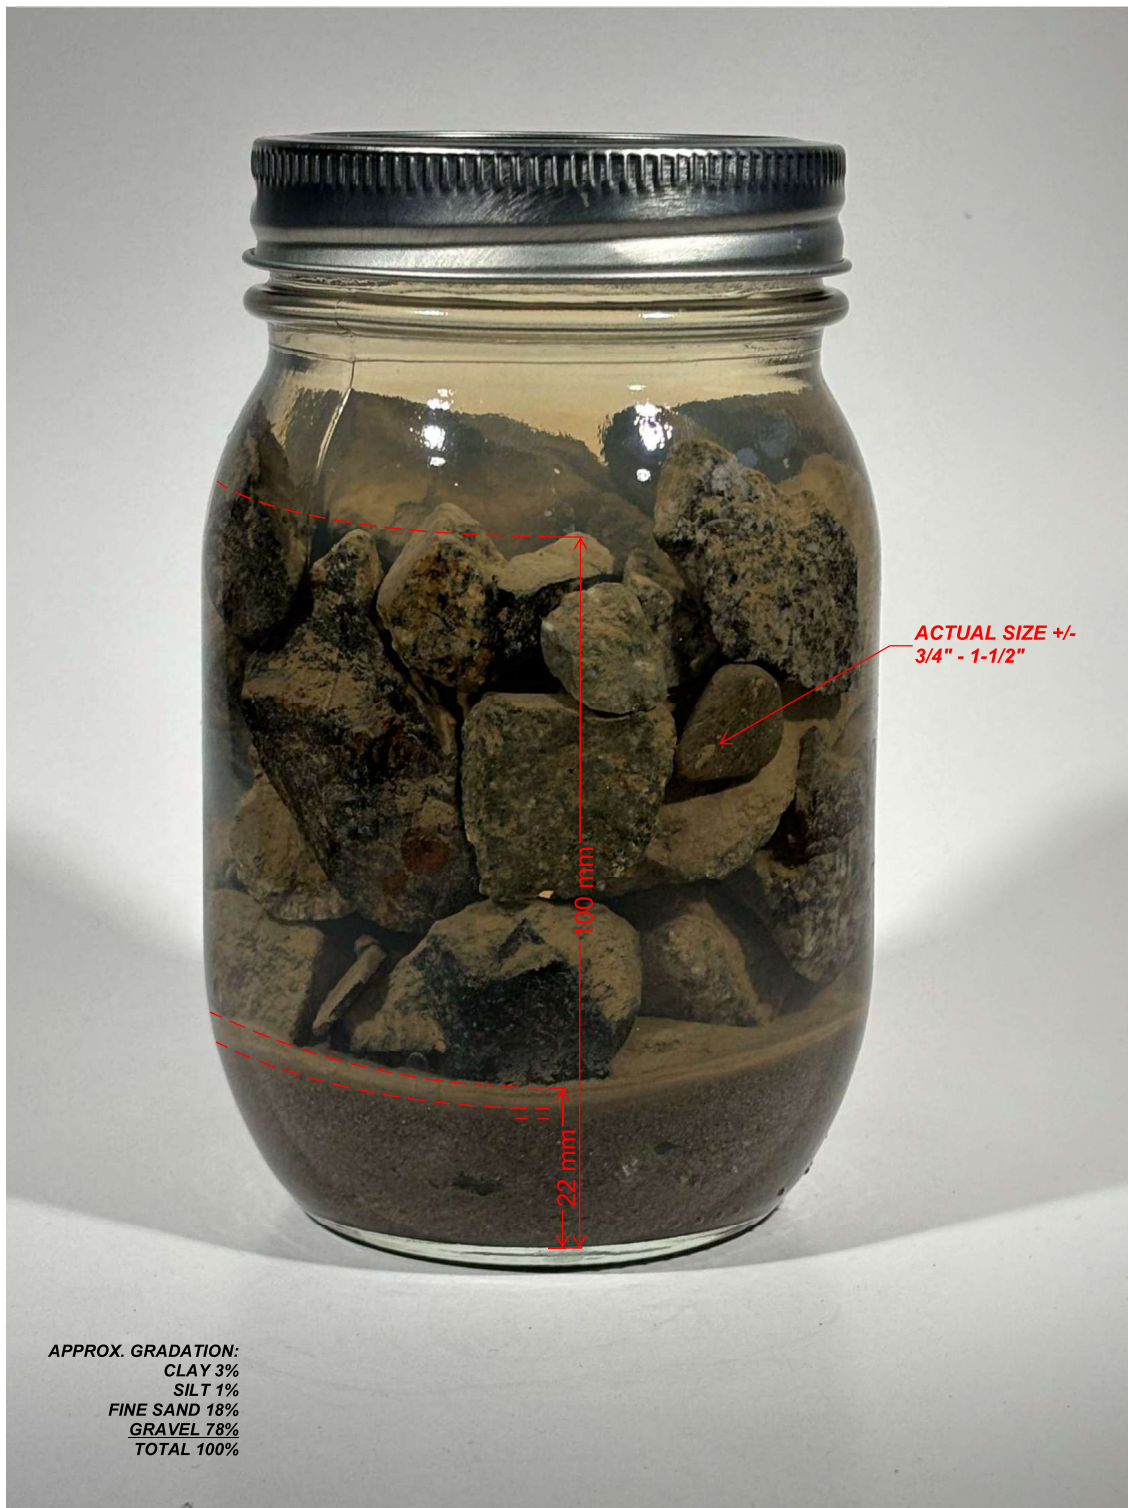
APPROX. GRADATION:  
CLAY 3%  
SILT 1%  
FINE SAND 18%  
GRAVEL 78%  
TOTAL 100%

CRESTWOODS PARK FIELD 4  
SECTION MATERIALS SETTLEMENT TESTING  
DRAINAGE AGGREGATE SAMPLE JUNE 18, 2025

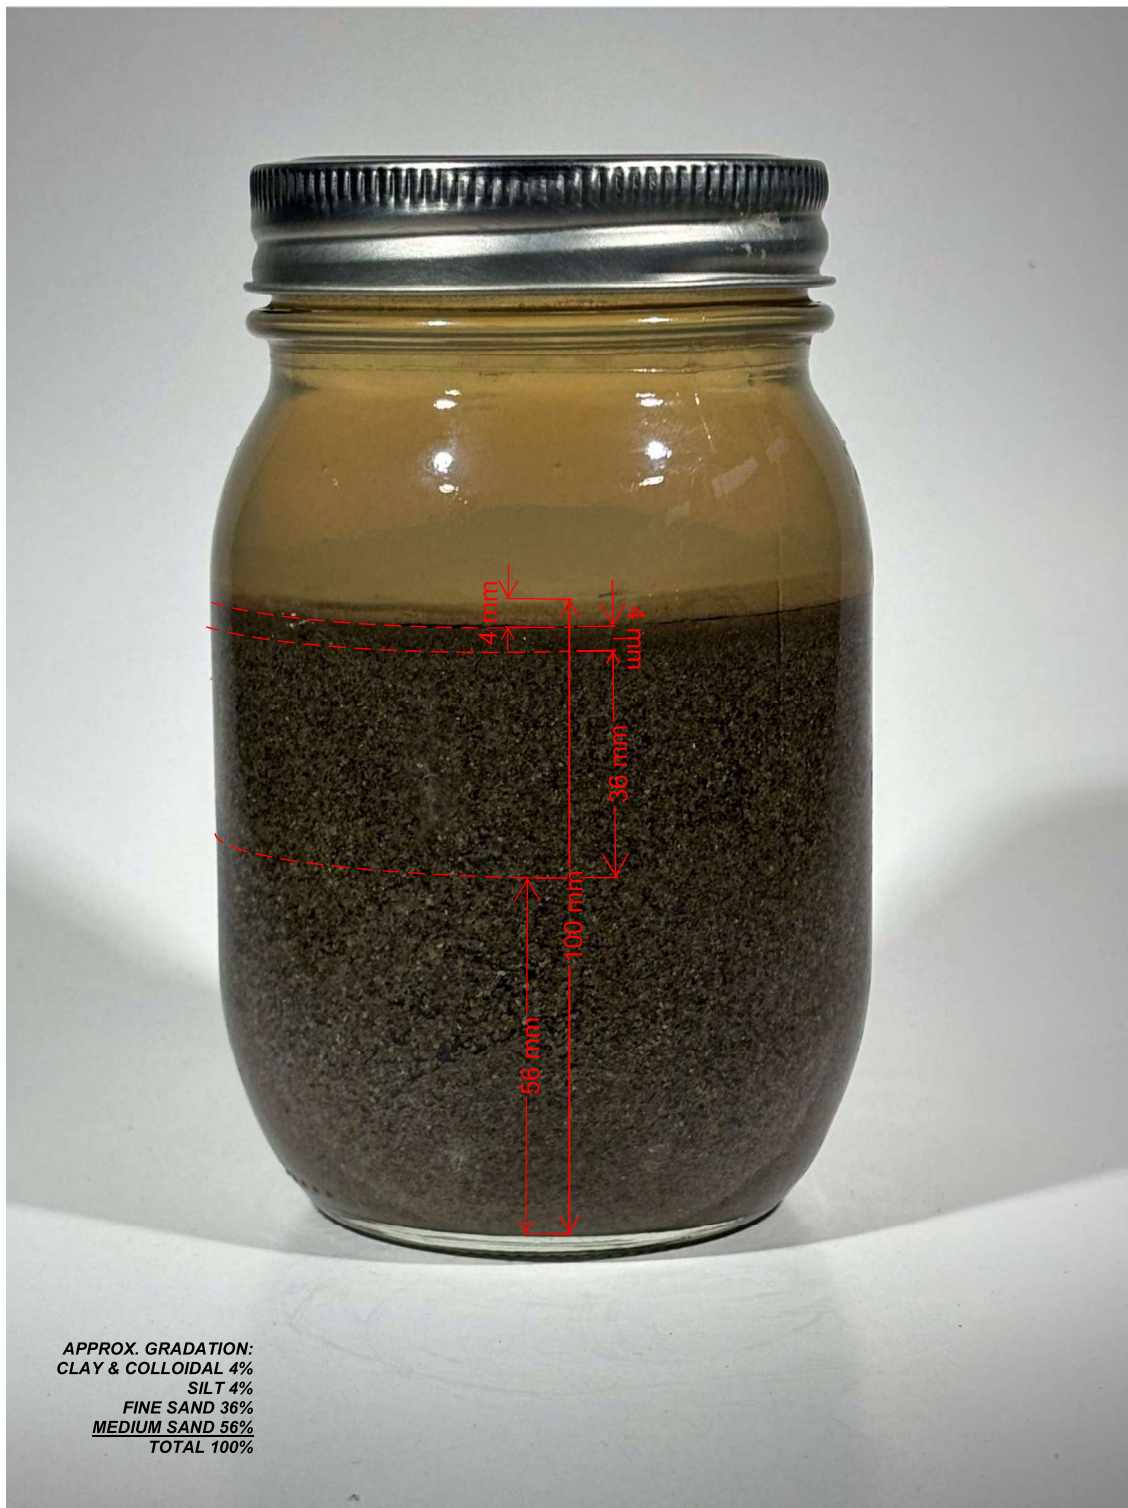
CRESTWOODS PARK FIELD 4  
SECTION MATERIALS SETTLEMENT TESTING  
BASE SAND SAMPLE JUNE 18, 2025

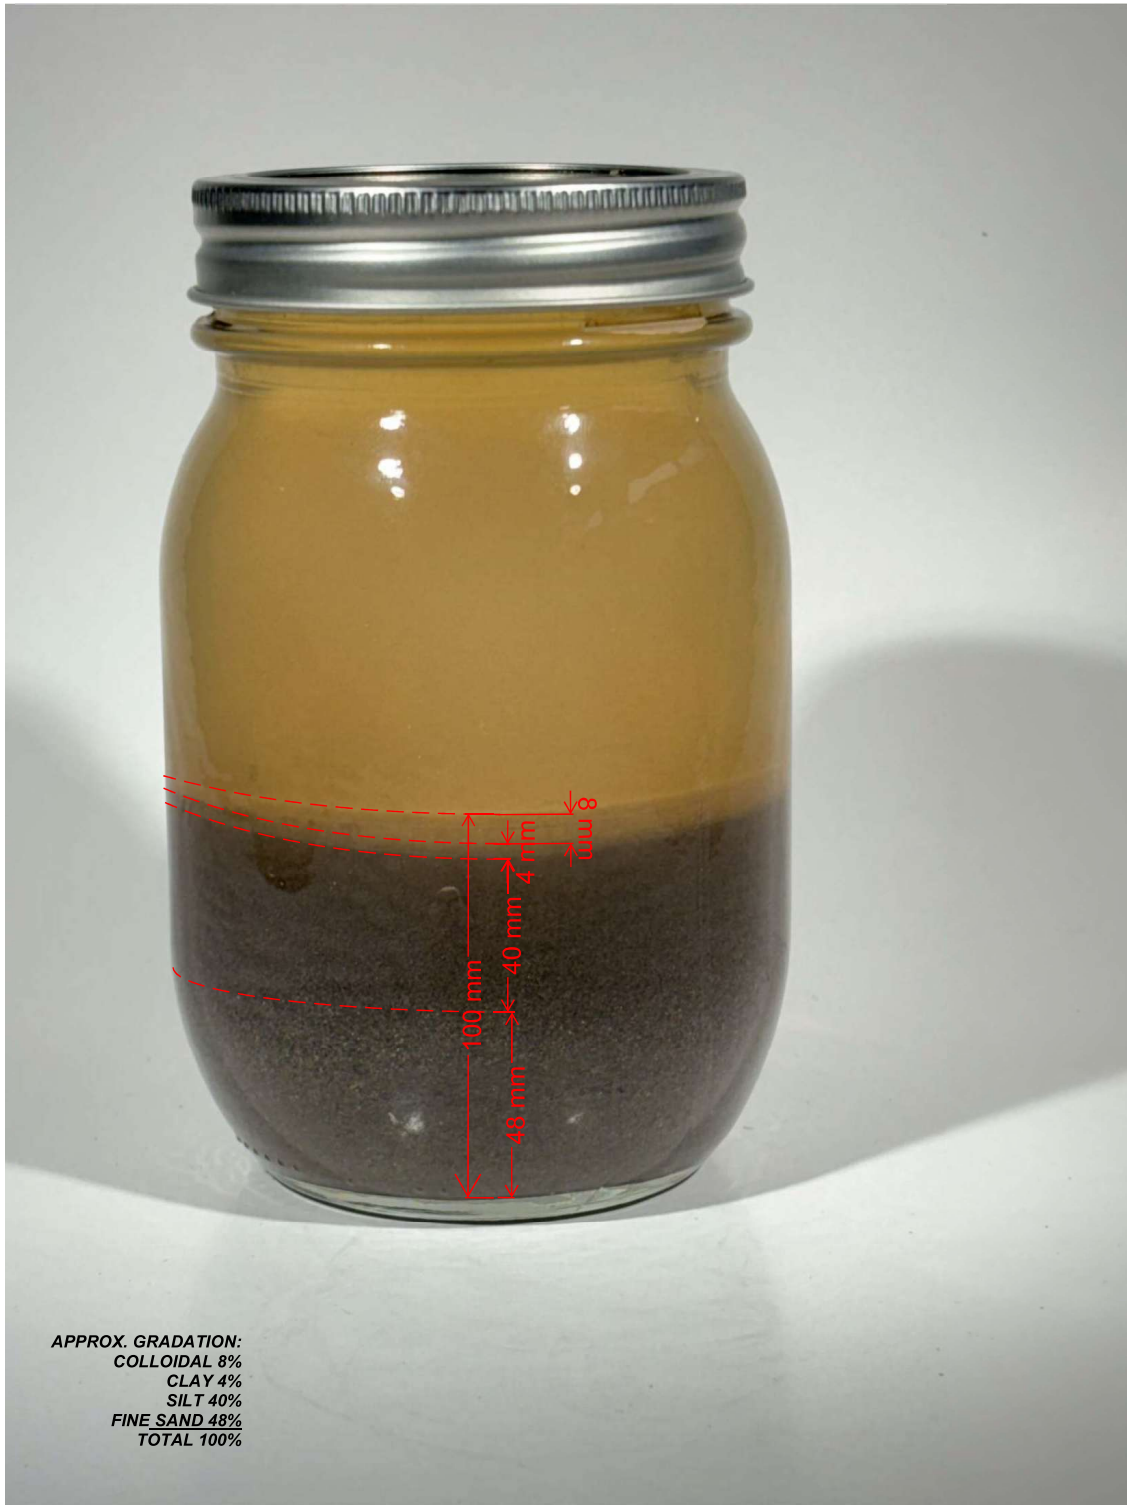
CRESTWOODS PARK FIELD 4  
SECTION MATERIALS SETTLEMENT TESTING  
INFIELD TOP MIX SAMPLE JUNE 18, 2025

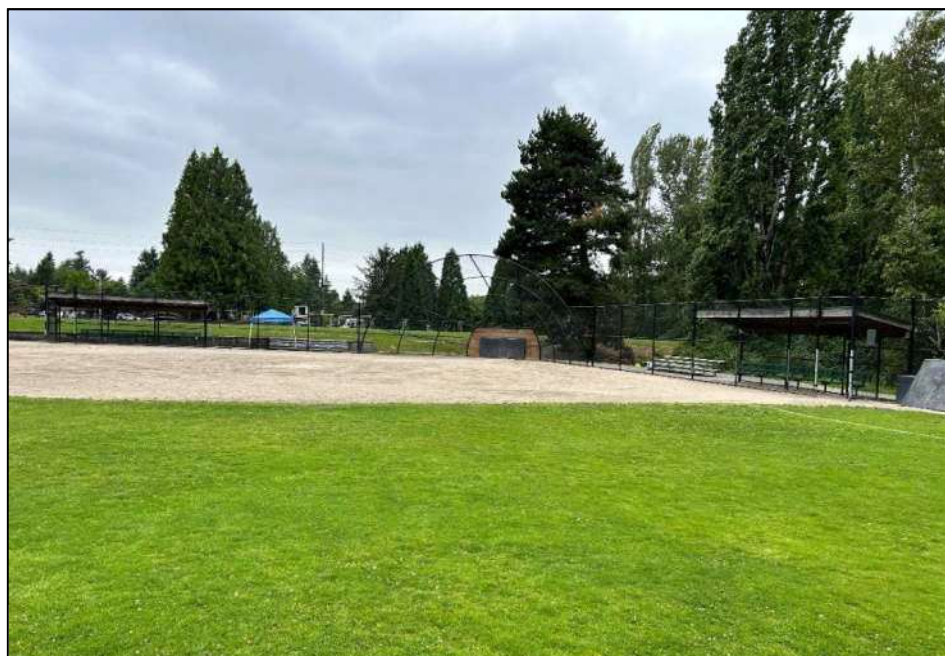
Photo 1. View of the infield and outfield at Ballfield 4 (June 12, 2025).

The Crestwoods Park Ballfield 4 includes a flat sand/silt infield and mowed grass outfield that is heavily managed/maintained (Photo 1). The outfield is routinely mowed, fertilized, irrigated, and overseeded two to three times a year. The infield is top-dressed with sand once a year and has an underdrain system. Pesticides are applied as needed at the beginning and end of each growing season.

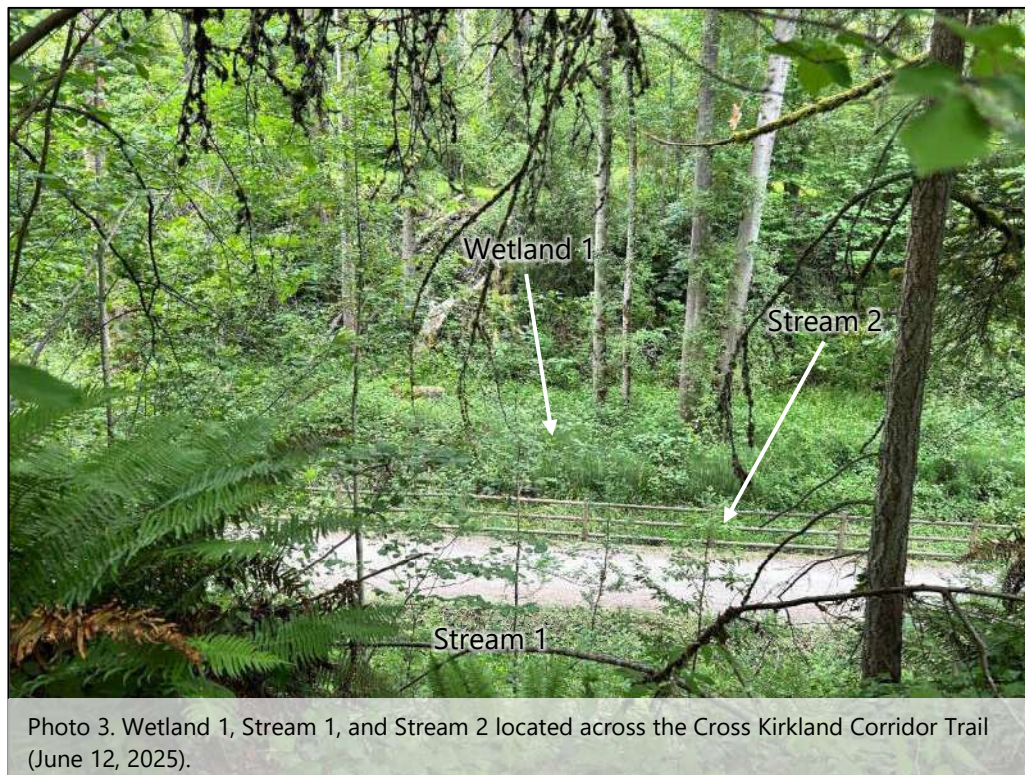
Photo 3. Wetland 1, Stream 1, and Stream 2 located across the Cross Kirkland Corridor Trail (June 12, 2025).

Wetland 1 is a palustrine, forested, depressional wetland dominated by black cottonwood (*Populus balsamifera*), slough sedge (*Carex obnupta*), reed canarygrass (*Phalaris arundinacea*), and Himalayan blackberry (*Rubus armeniacus*). Most of the wetland extends beyond the study area to the north, south, and east. The wetland is located at the base of a slope and immediately east of the Cross Kirkland Corridor Trail. Wetland 1 is estimated to be a Category II wetland, which would have a 75-foot buffer with a low habitat score, which would be dependent on the final wetland rating (KZC 90.55.1). Preliminary wetland rating forms are included in Appendix A.

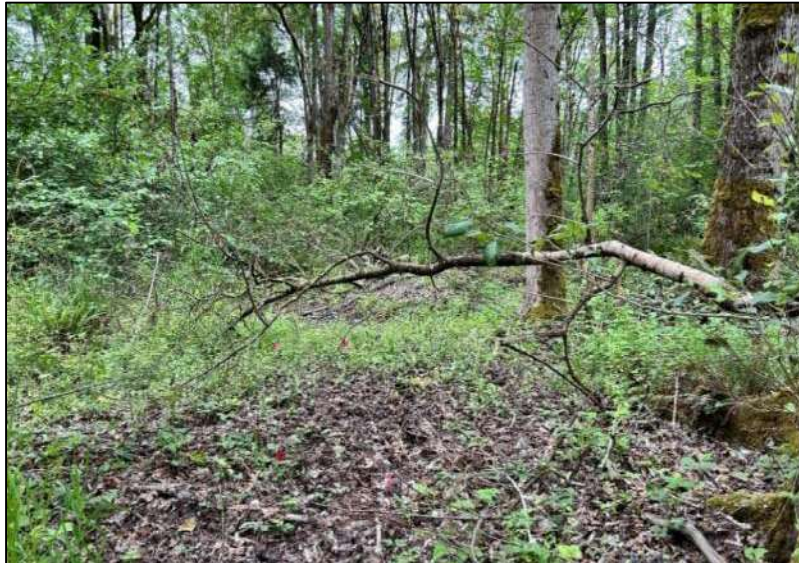
Photo 4. Wetland 2 (June 12, 2025).

Wetland 2 is a palustrine, forested, slope wetland located in the northeast corner of the study area (Photo 4). The wetland is dominated by black cottonwood, willow (*Salix sp.*), soft rush (*Juncus effusus*), creeping buttercup (*Ranunculus repens*), lady fern (*Athyrium filix-femina*), American mannagrass

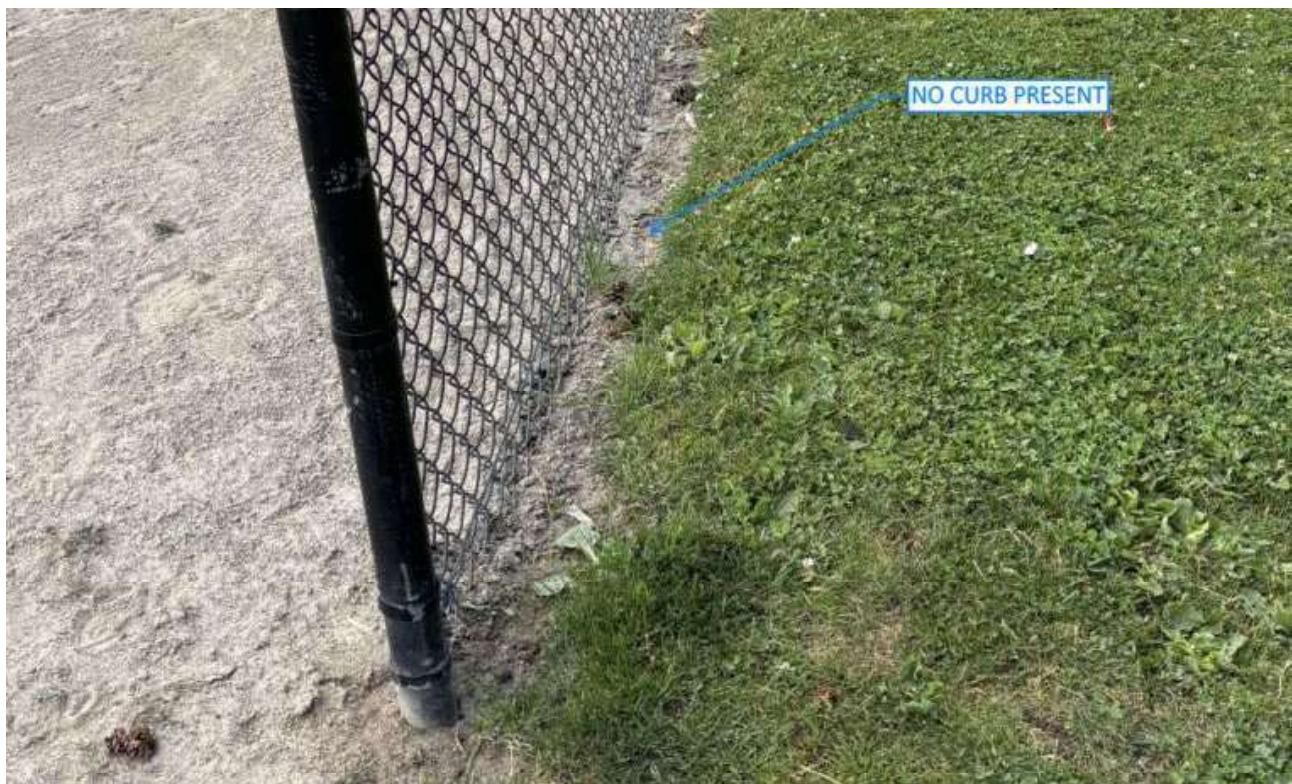
*Image 2, typical fenceline condition*

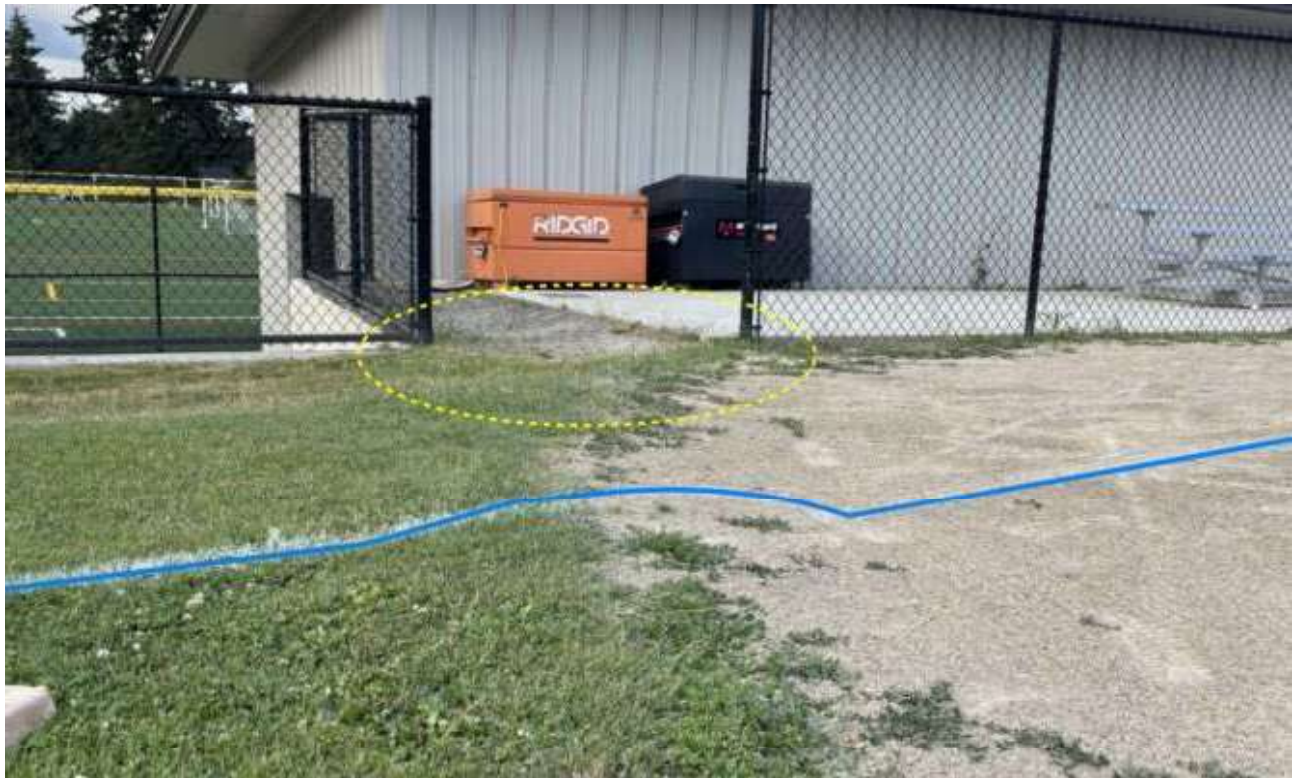
*Image 3, Grade Irregularities*

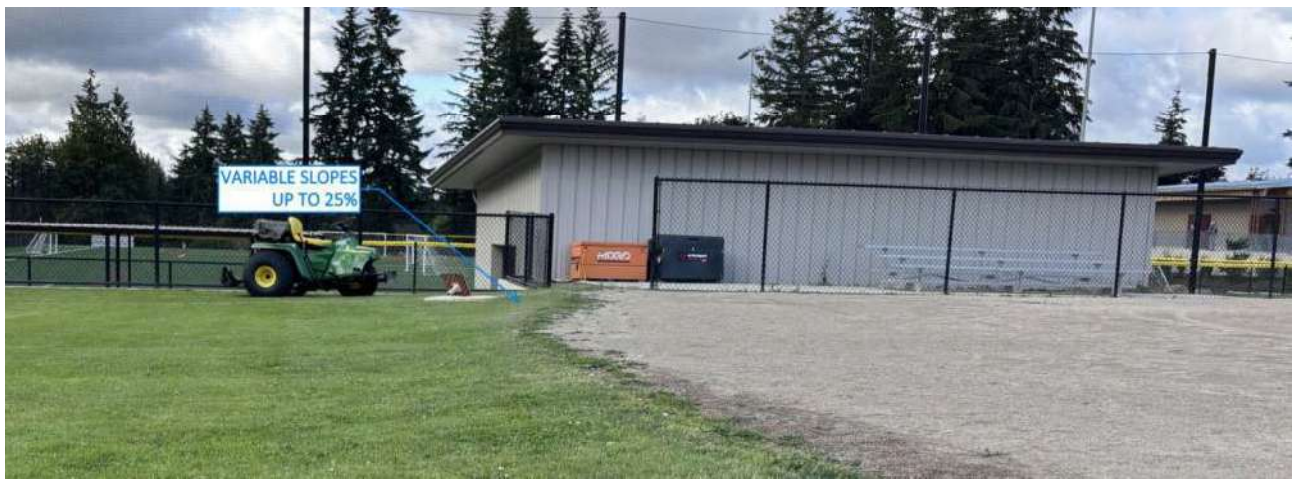
*Image 4, 3<sup>rd</sup> Base Line / Foul Territory Grade Irregularities*

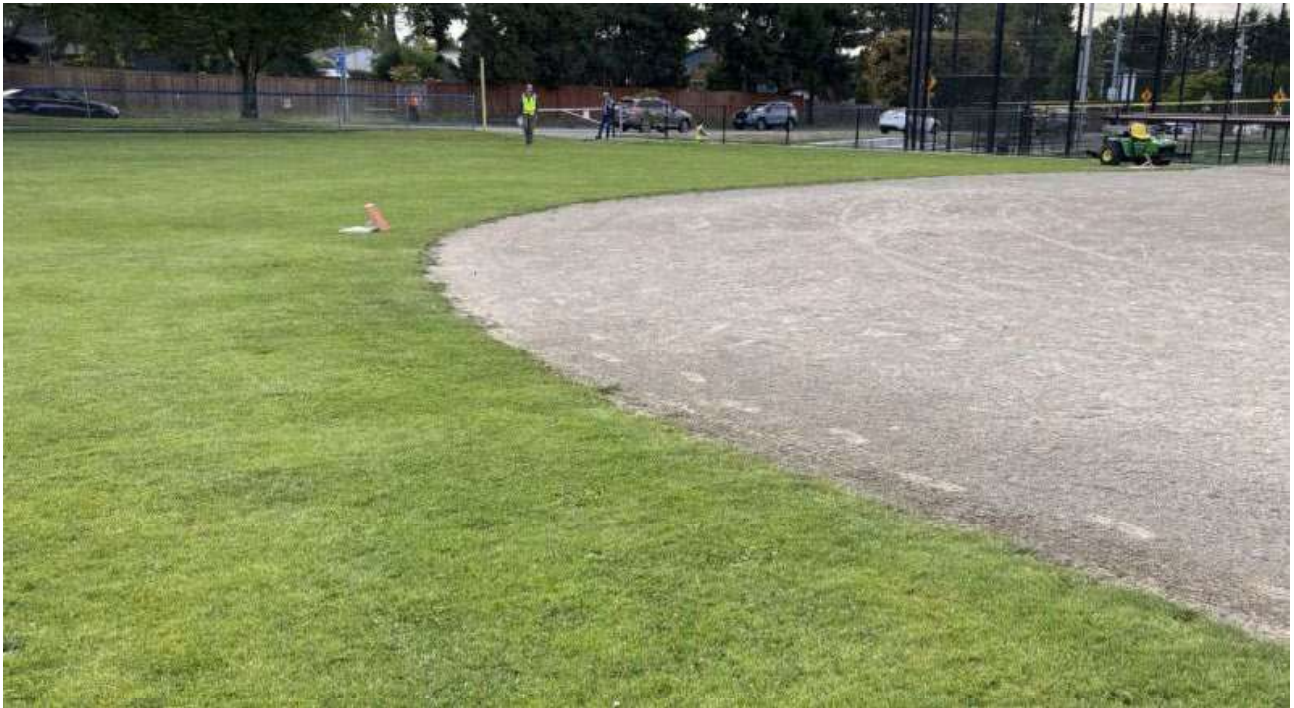
*Image 6, Relatively even transitions between the foul lines*

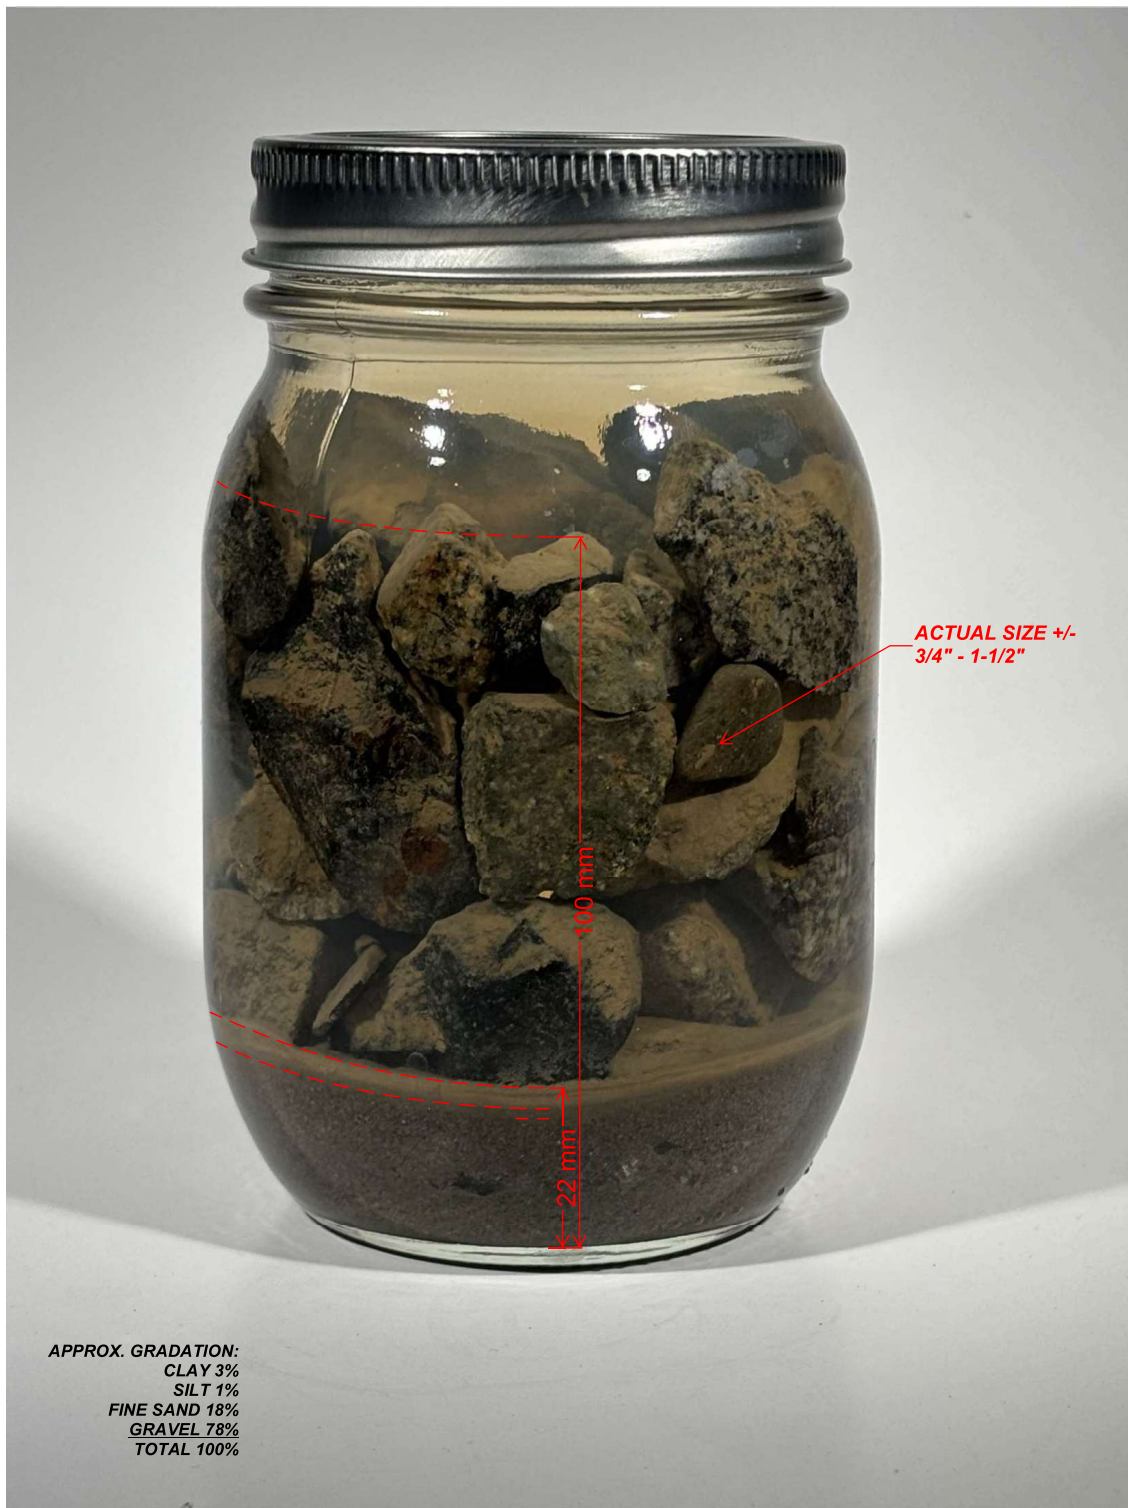
APPROX. GRADATION:  
CLAY 3%  
SILT 1%  
FINE SAND 18%  
GRAVEL 78%  
TOTAL 100%

CRESTWOODS PARK FIELD 4  
SECTION MATERIALS SETTLEMENT TESTING  
DRAINAGE AGGREGATE SAMPLE JUNE 18, 2025

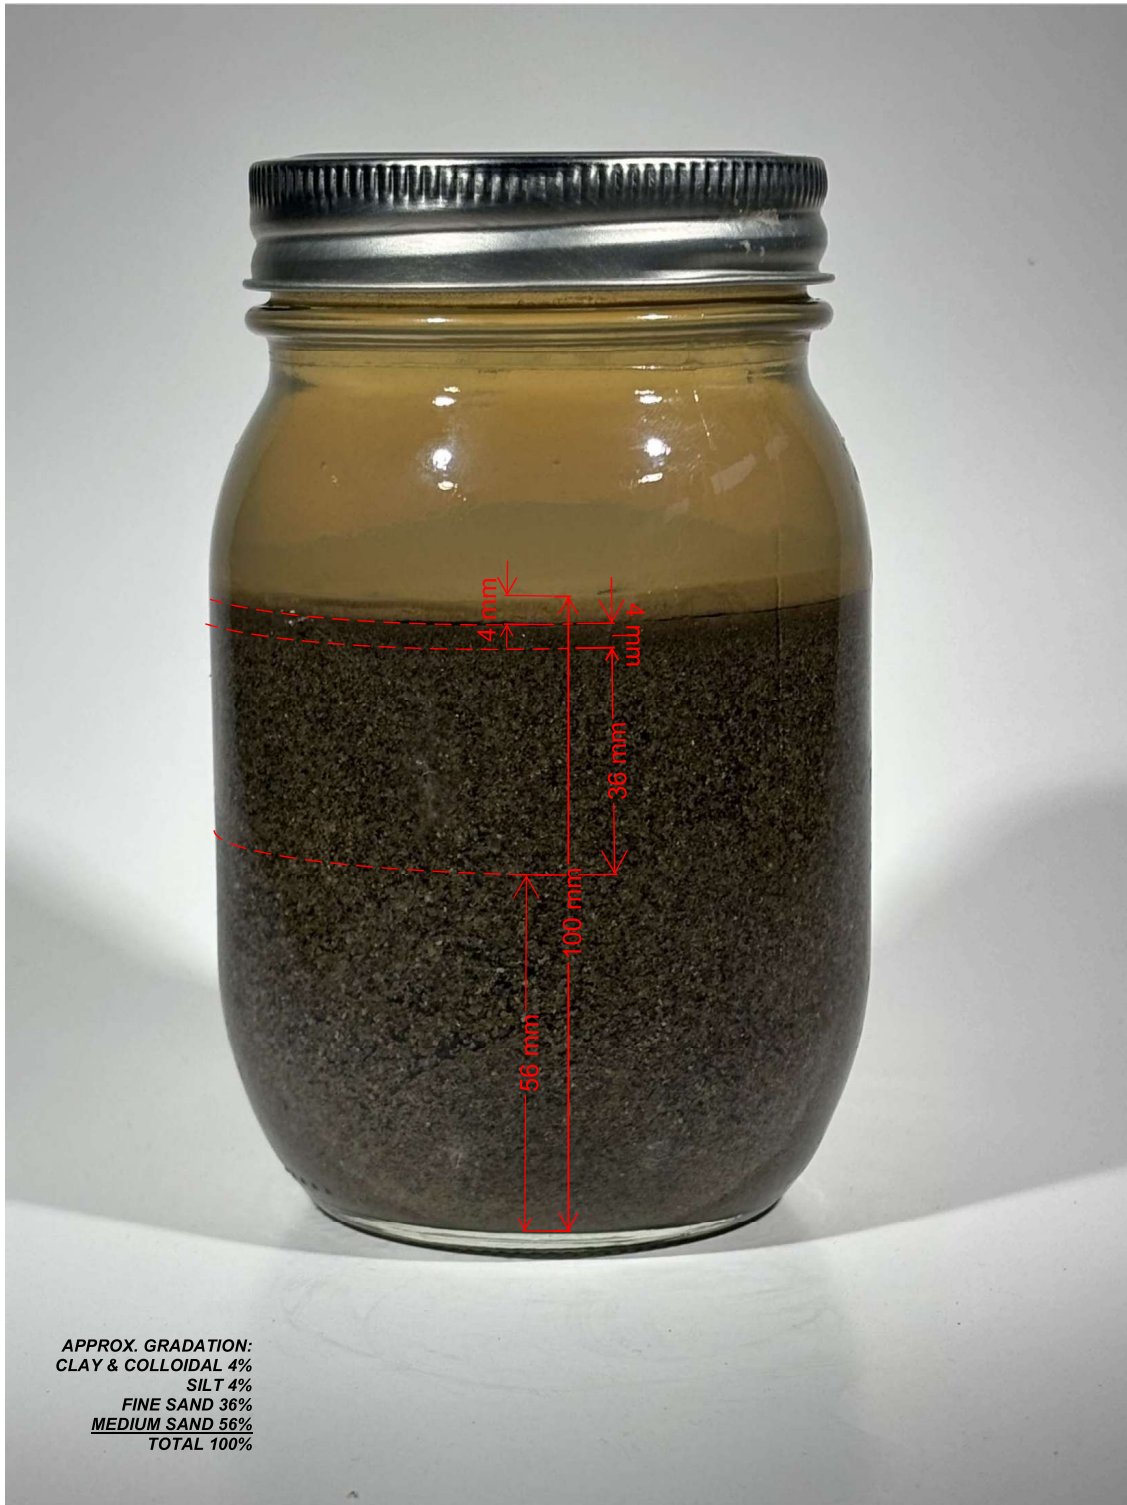
CRESTWOODS PARK FIELD 4  
SECTION MATERIALS SETTLEMENT TESTING  
BASE SAND SAMPLE JUNE 18, 2025

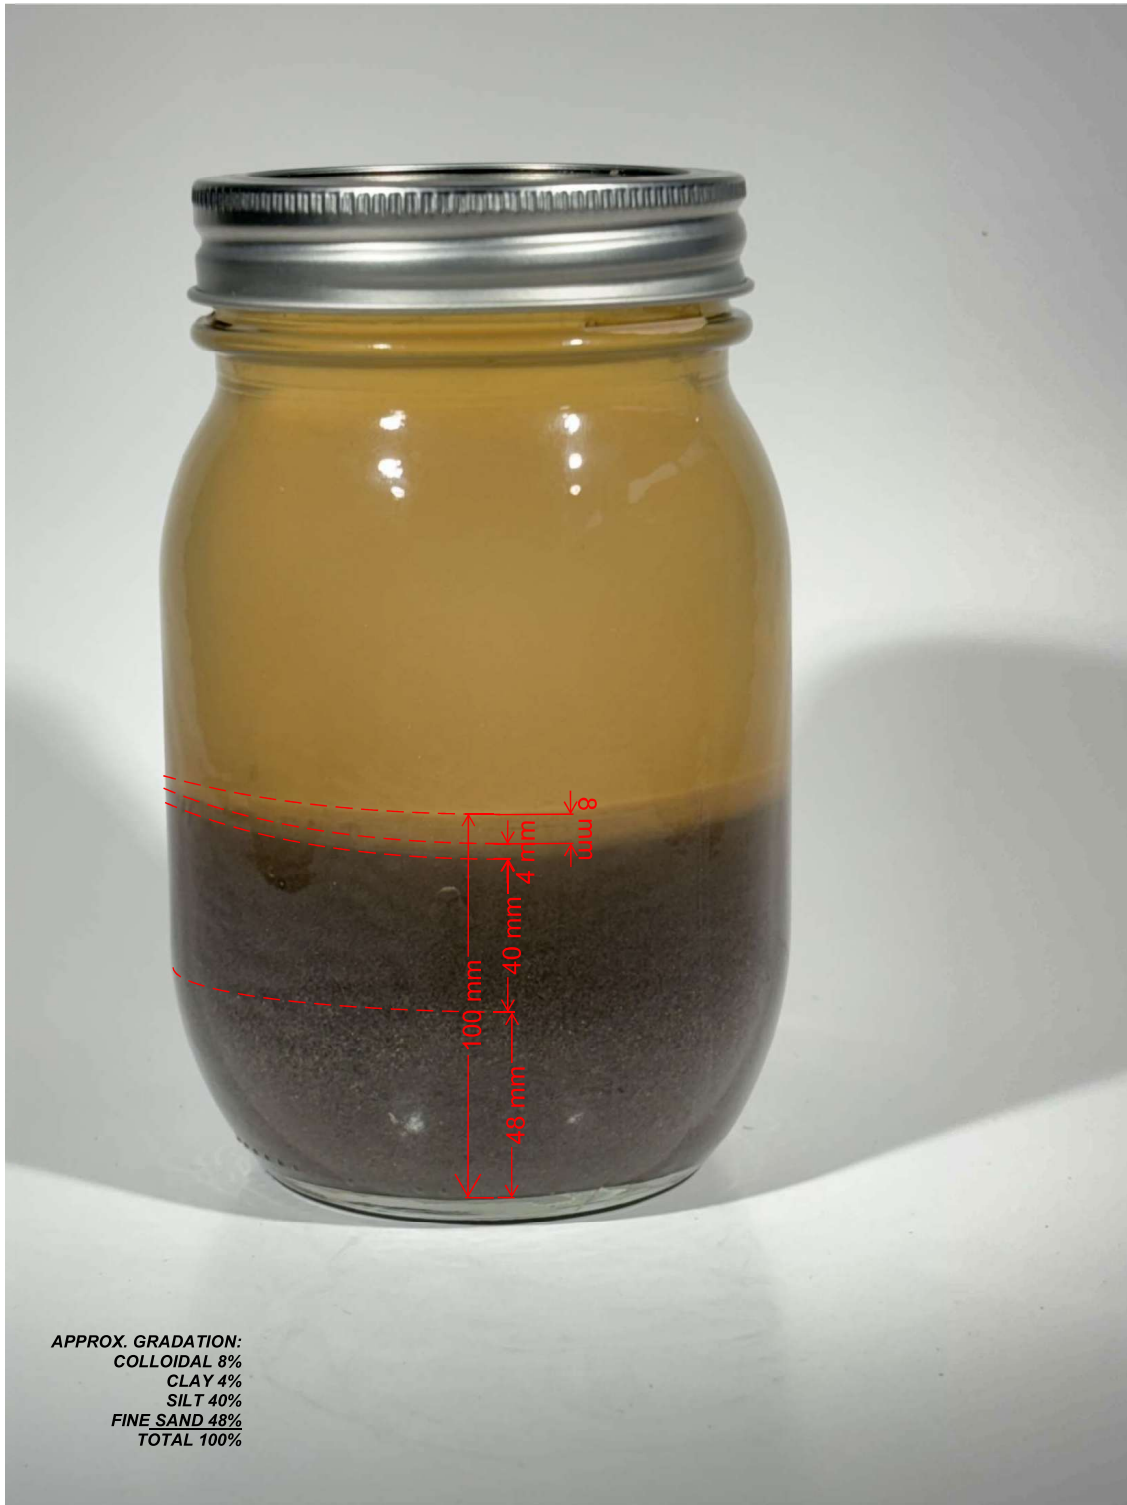
CRESTWOODS PARK FIELD 4  
SECTION MATERIALS SETTLEMENT TESTING  
INFIELD TOP MIX SAMPLE JUNE 18, 2025
