**CERTIFICATE CONCERNING DESIGN AND CONSTRUCTION OF ELECTRONIC  
SPEED MEASURING DEVICES**

# Calibration Report

**Speed Validation Report**  
**Client: Kirkland, WA**

Preventive Maintenance Checklist

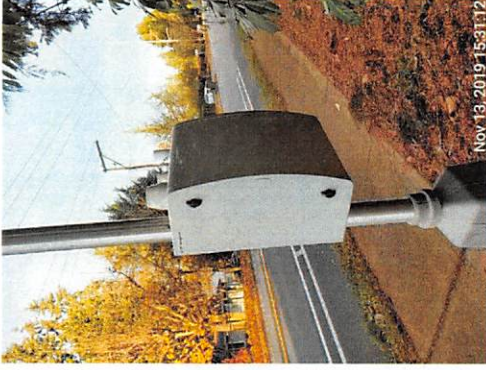
Clean enclosure

Item	Status	Note/Action
1.1 Clean dirt, grime, and graffiti off enclosure and clean glass.		
Clean Glass: If glass is cracked on the enclosure, immediately stop work and contact your manager or the ATS Field Service Manager via phone call to report the issue.	<input checked="" type="checkbox"/>	
Clean graffiti: If cleaning is expected to take more than 15 minutes, immediately stop work and contact your manager or the ATS Field Service Manager via phone call to report the issue.	<input type="checkbox"/> (NA)	
Clean Enclosure: If enclosure moves while cleaning glass, immediately stop work and contact your manager or the ATS Field Service Manager via phone call to report the issue.	<input checked="" type="checkbox"/>

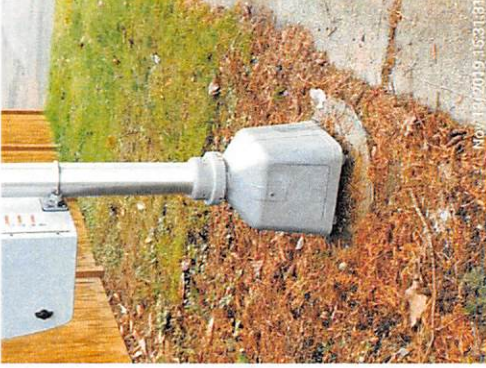
Pole close up

1.3 Inspect poles, bases, enclosures. If any repair work is necessary that will take longer than 15 minutes to complete, immediately stop work and contact your manager or the ATS Field Service Manager via phone call to report the issue.		
Ensure pole is sturdy. Check hurricane collar and ensure screws are tight.	<input checked="" type="checkbox"/>	
Ensure base does not have any cracks. Ensure bolts are tight inside the base and also the latch bolt.	<input type="checkbox"/> (NA)	
Ensure enclosure is well strapped to the pole and is not loose. Tighten if loose.	<input checked="" type="checkbox"/>
