Appendix G

Summary of Annexation Area Stream Survey

Stream Walk Photo Logs

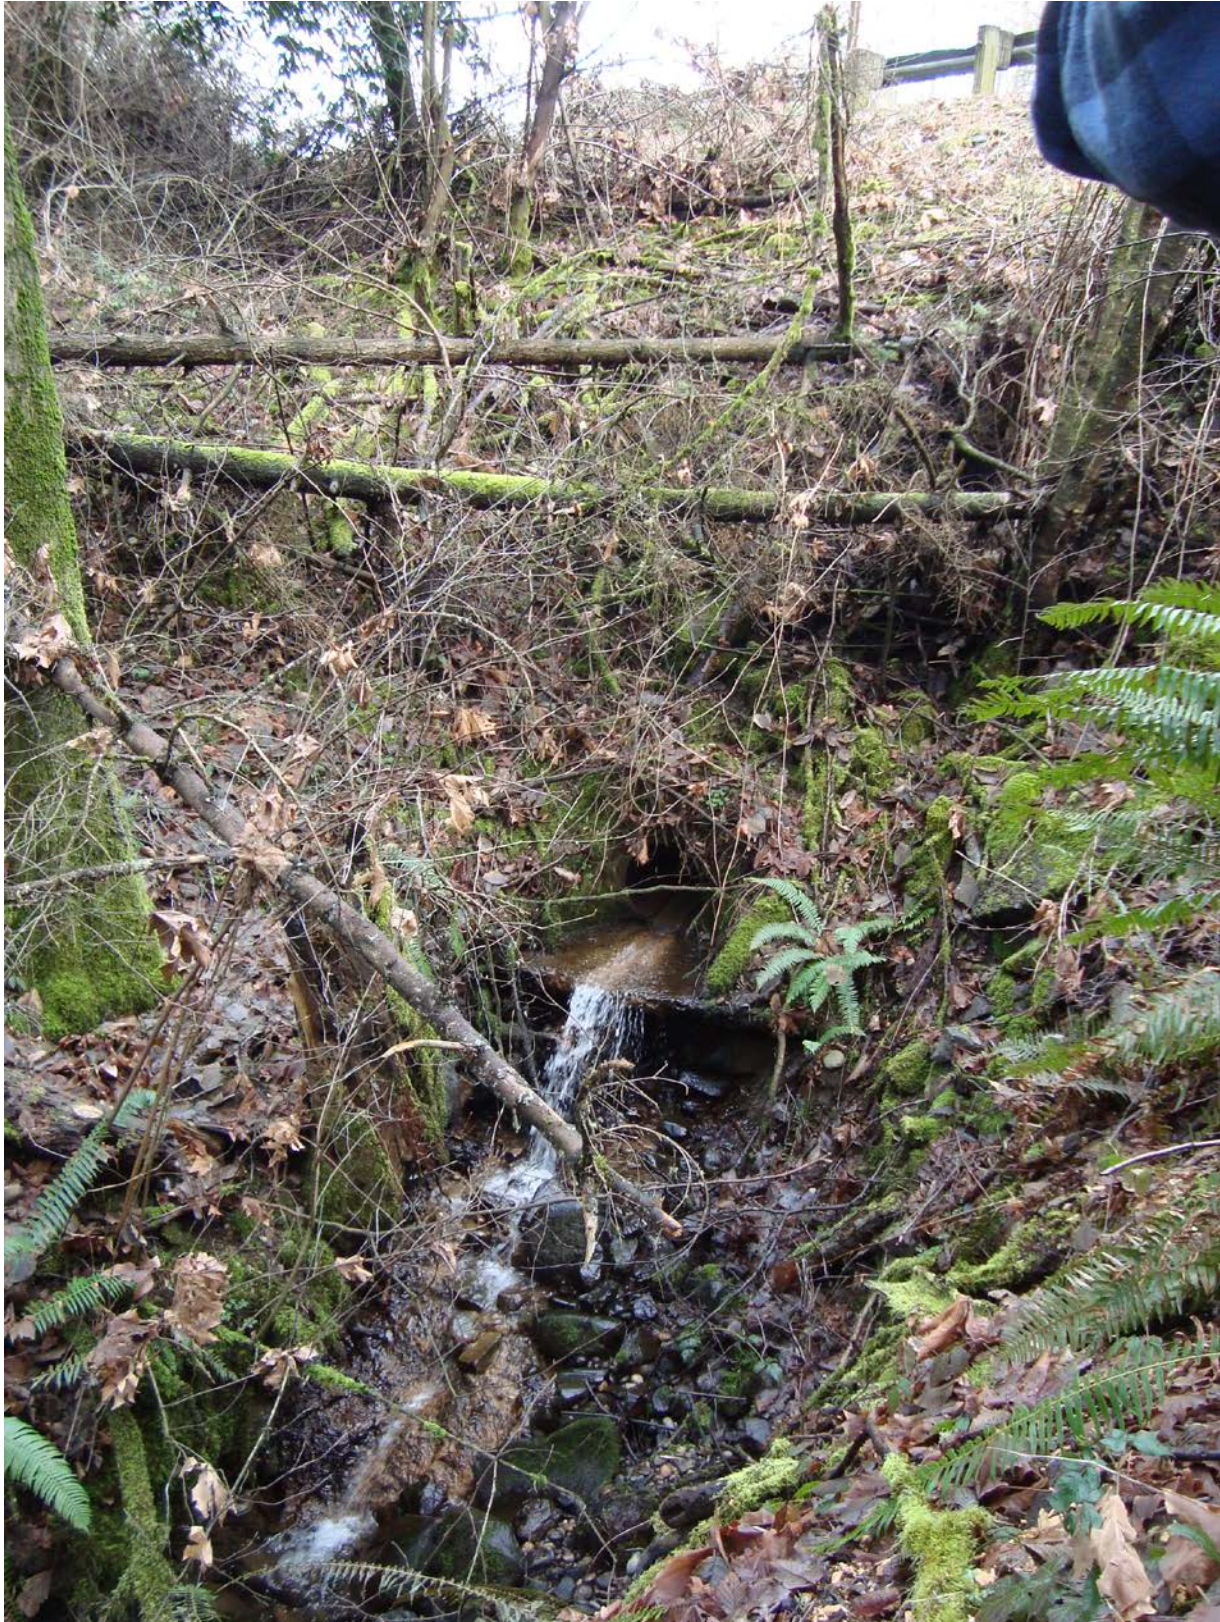
Photo #7. Champagne Creek crossing under Juanita Drive

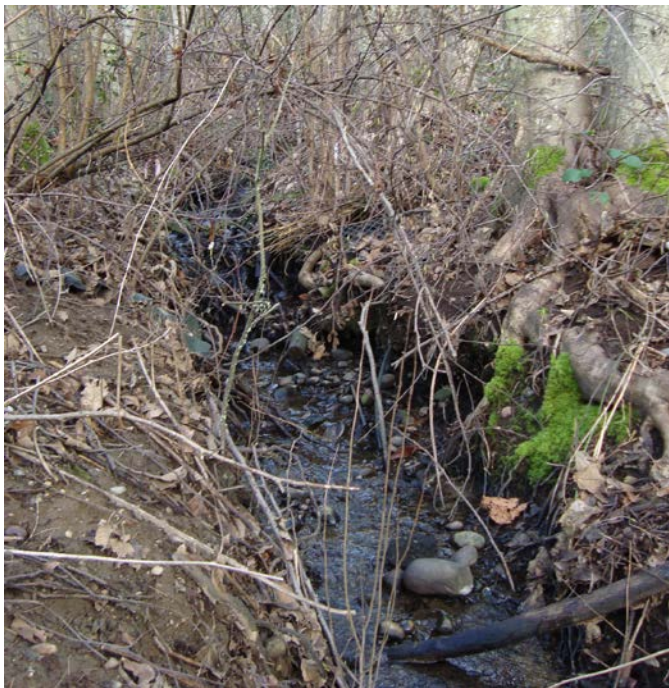
Photo #9. Champagne Creek upstream of Juanita Drive behind commercial businesses

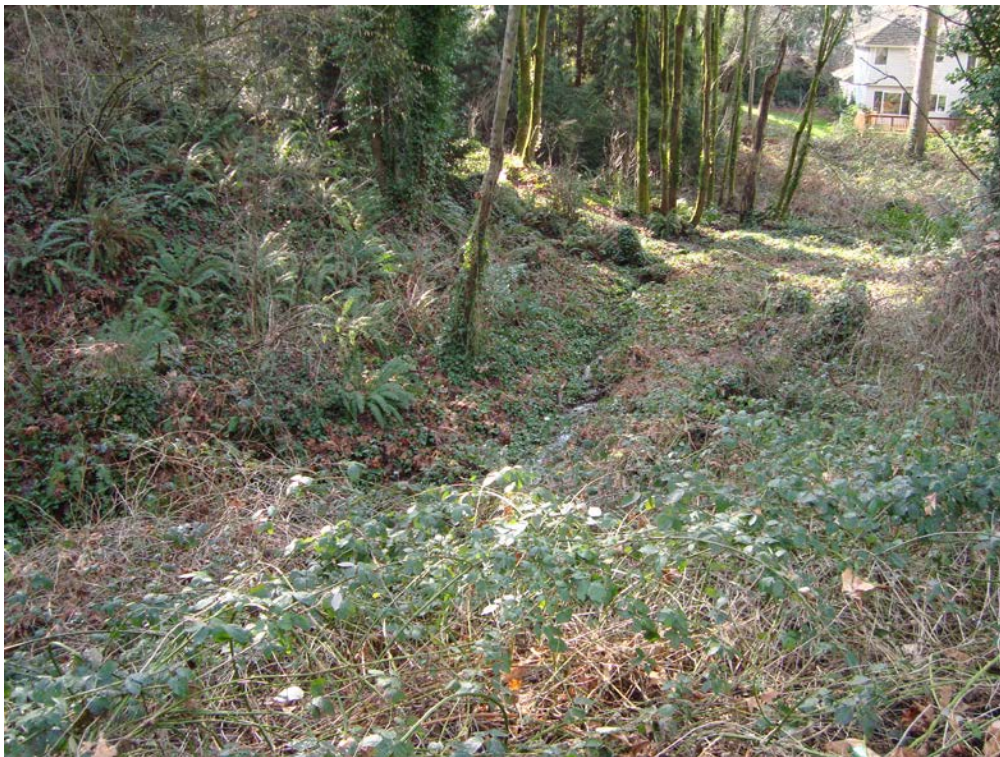
Photo #11. Champagne Creek adjacent to NE 123rd Street

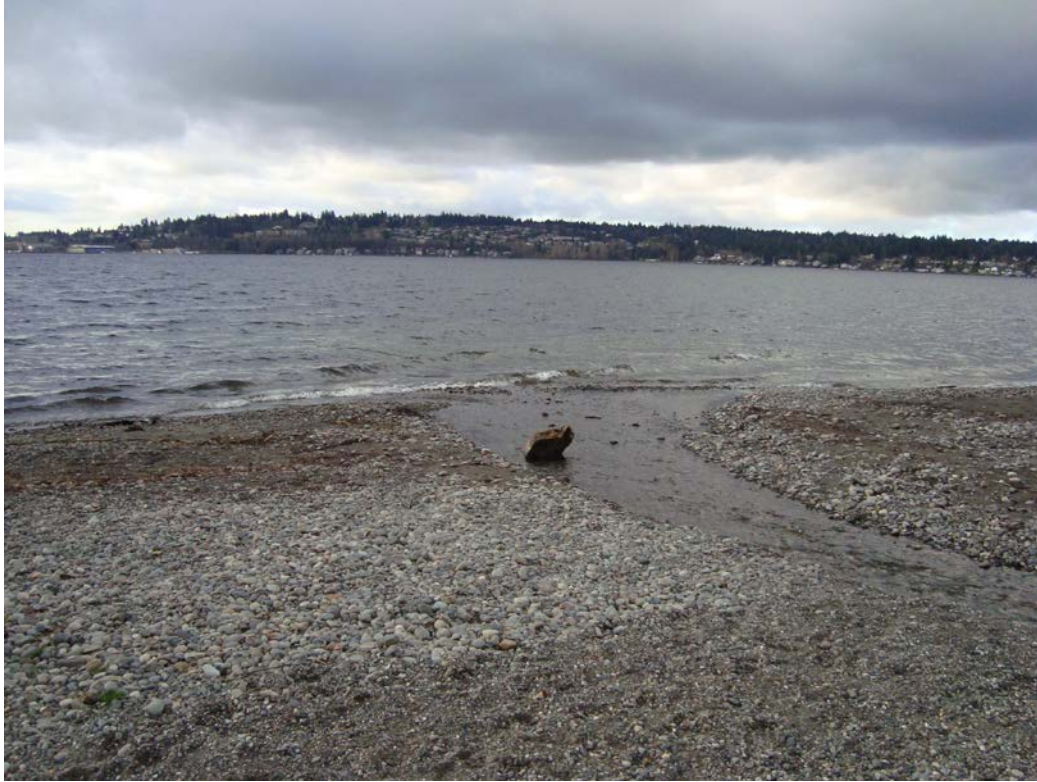
Photo #1. Denny Creek Alluvial Fan in Lake Washington

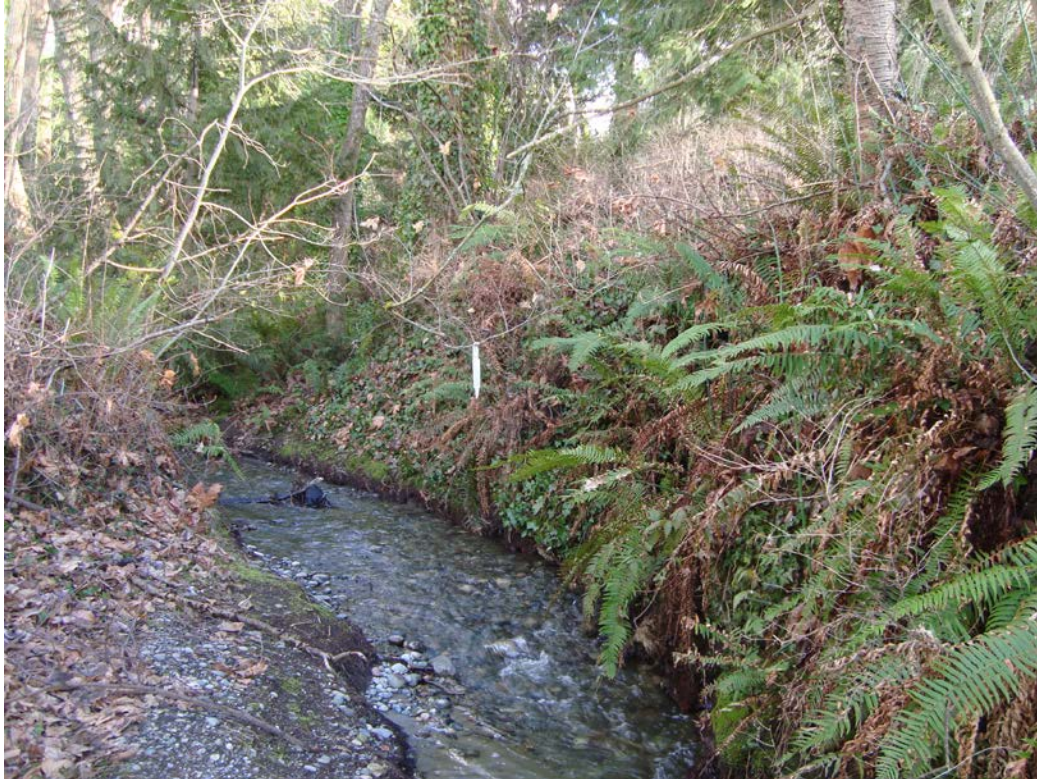
Photo #2. Denny Creek upstream of Lake Washington

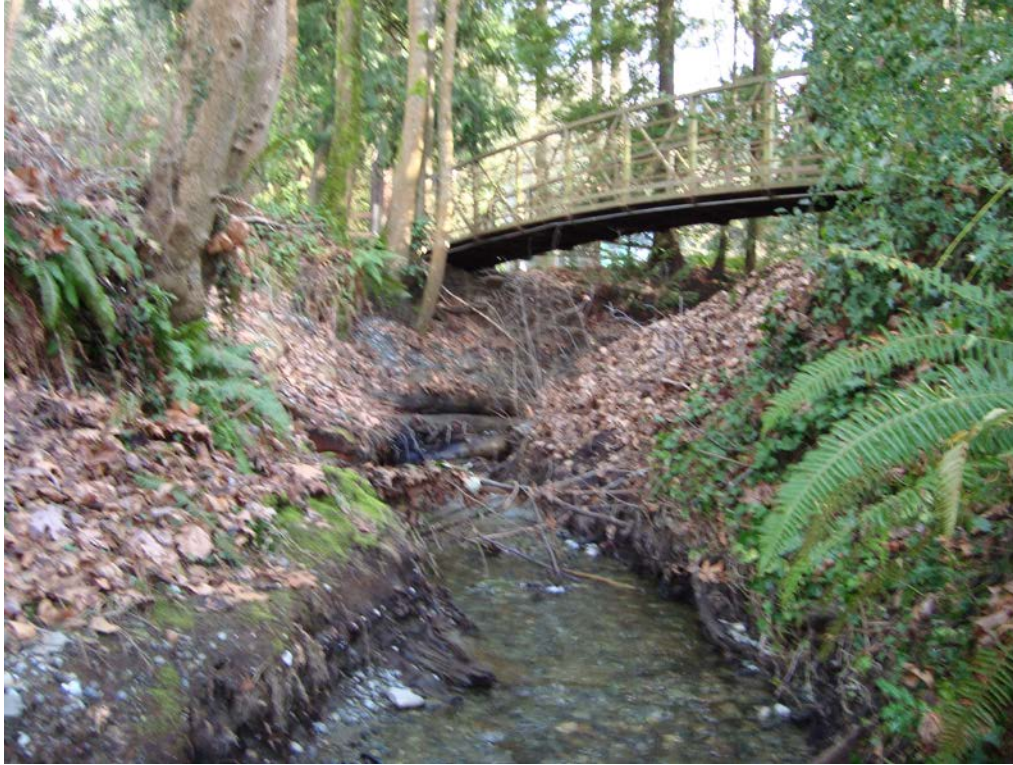
Photo #3. Pedestrian bridge over Denny Creek in O.O. Denny Park

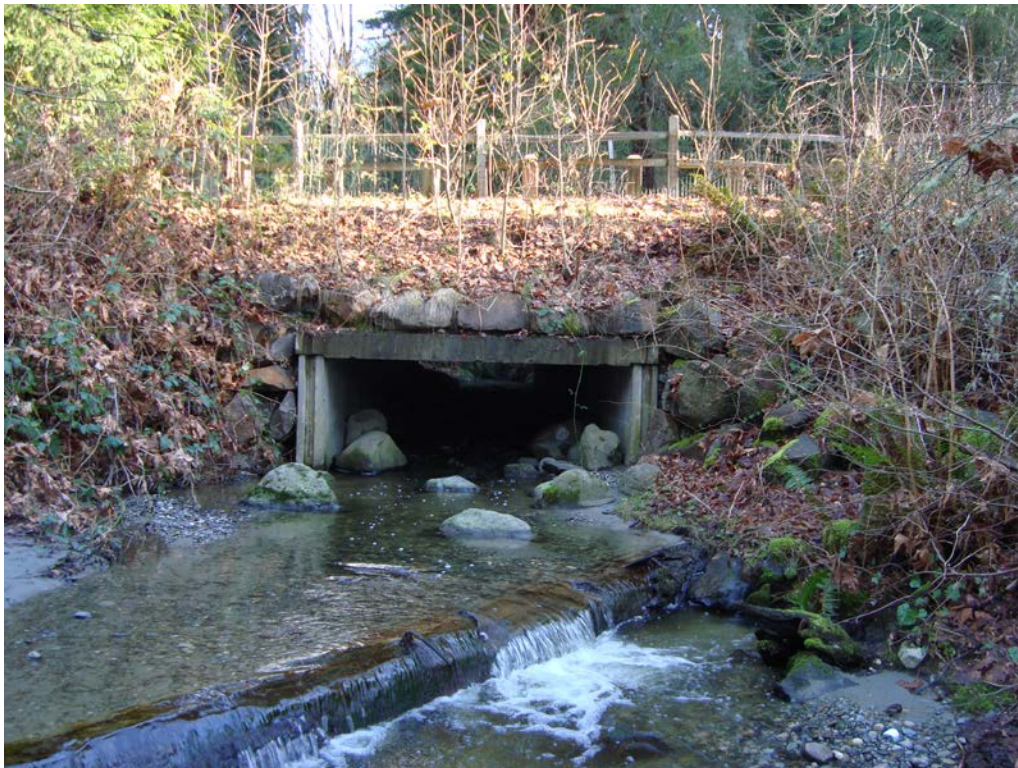
Photo #4. Holmes Point Drive 10-ft wide box culvert looking upstream

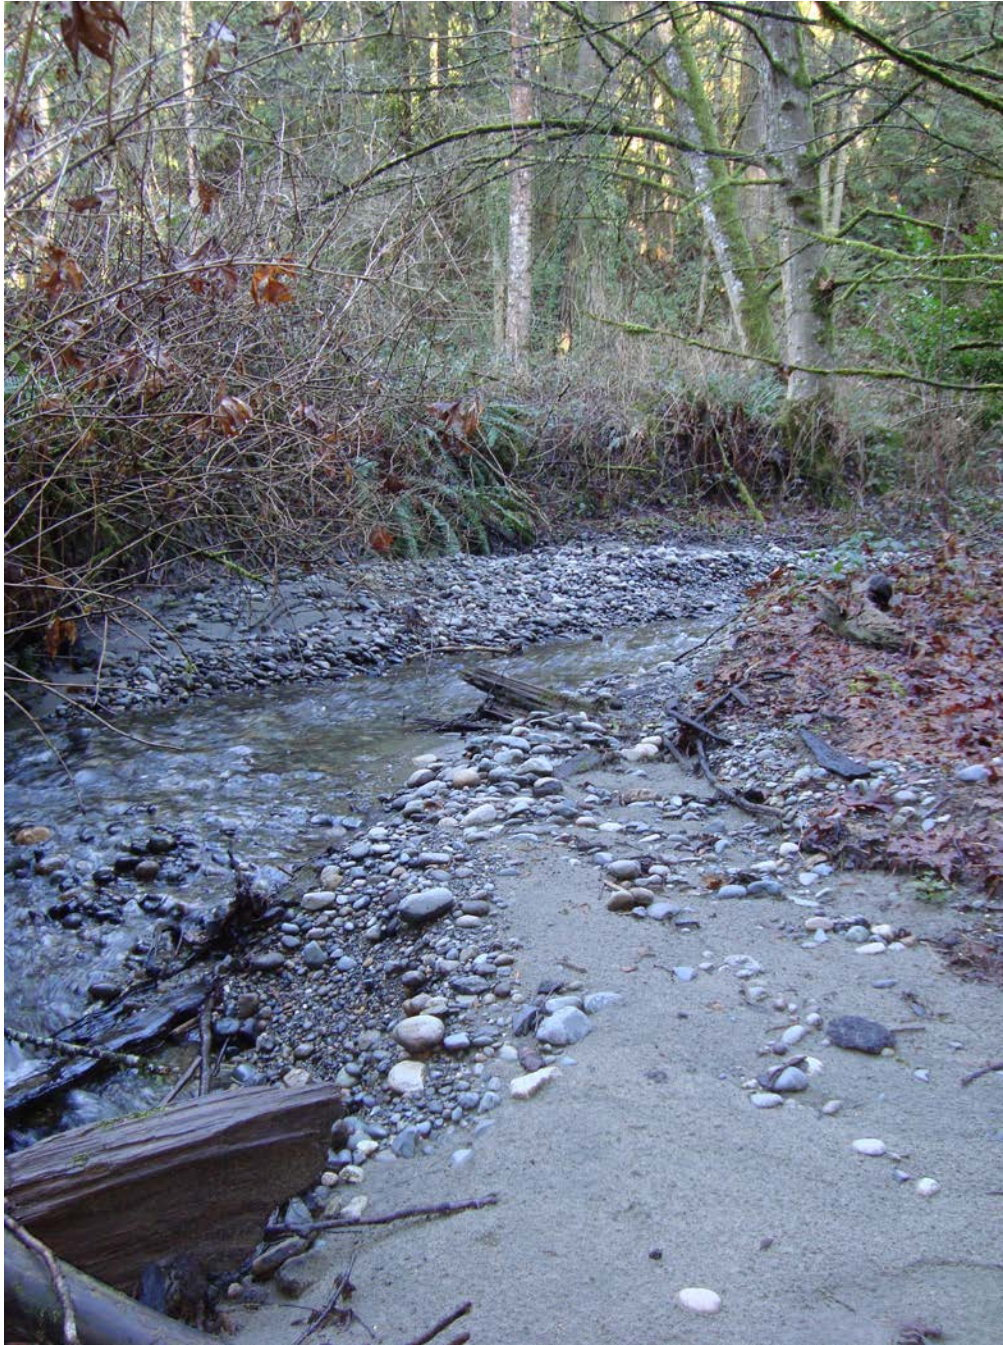
Photo #5. Denny Creek just upstream of Holmes Point Drive

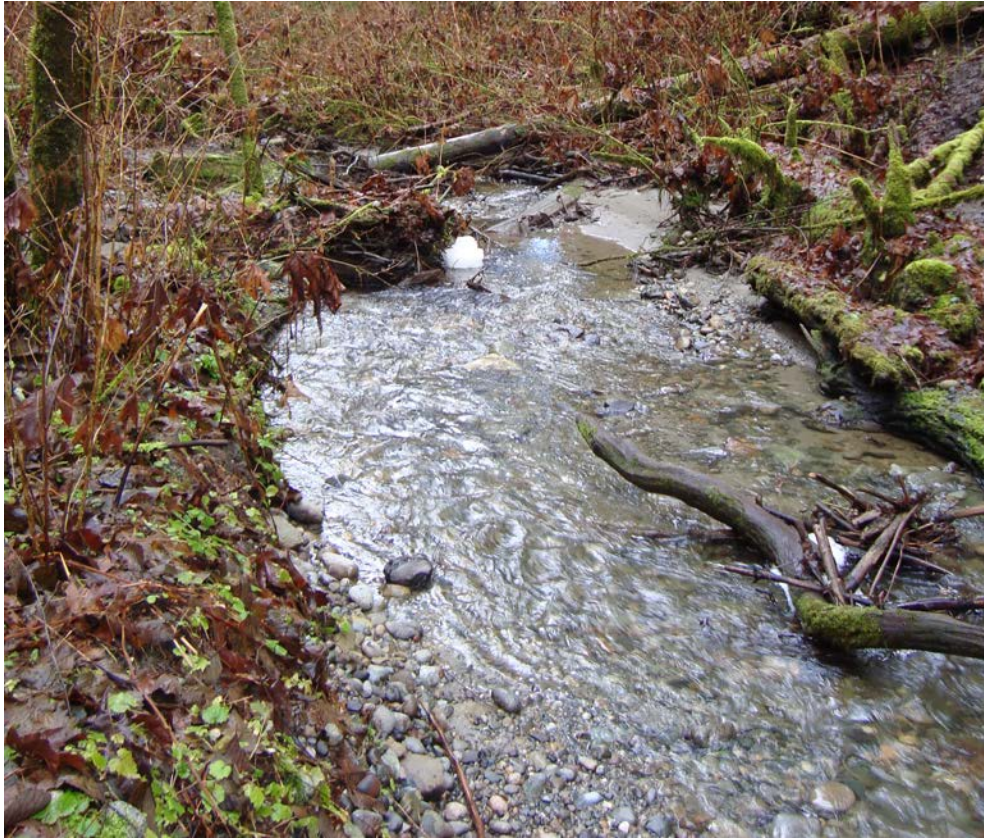
Photo #8. Denny Creek downstream of Stone Bridge

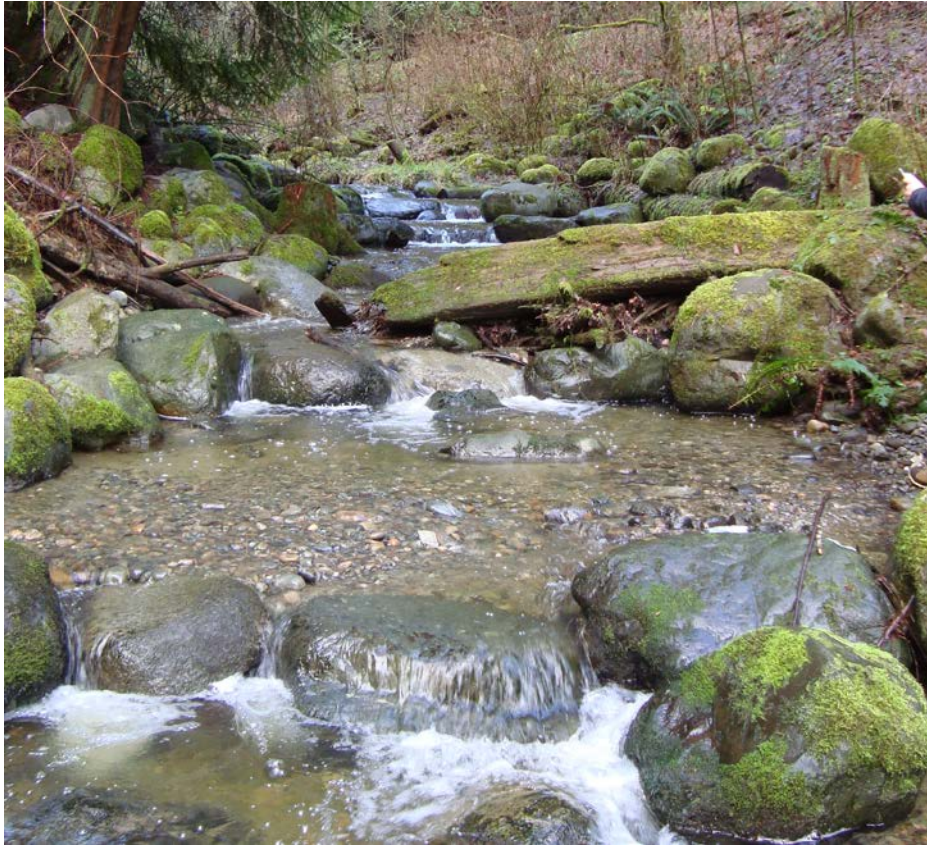
Photo #10. Stream restoration and fish ladder in vicinity of Stone Bridge

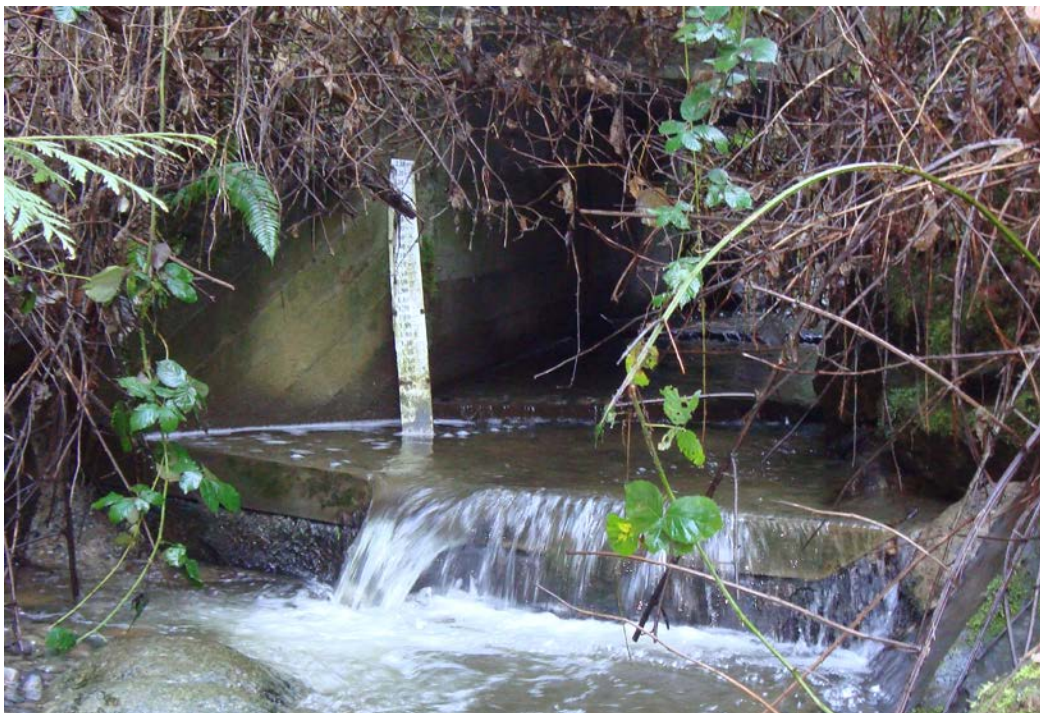
Photo #11 Box culvert at Stone Bridge

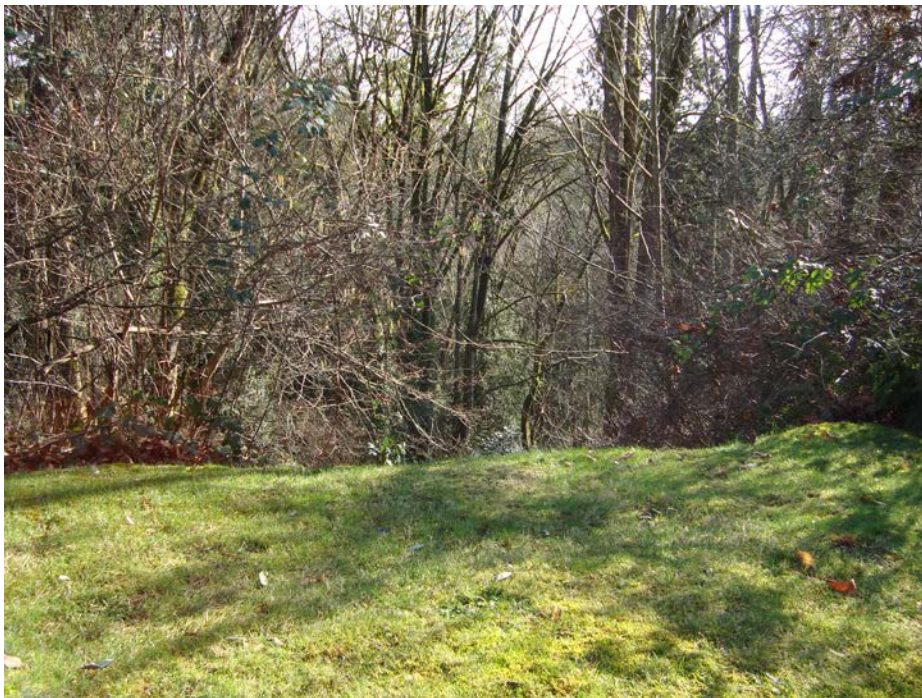
Photo #14. Yard at top of gully that begins at the edge of the lawn

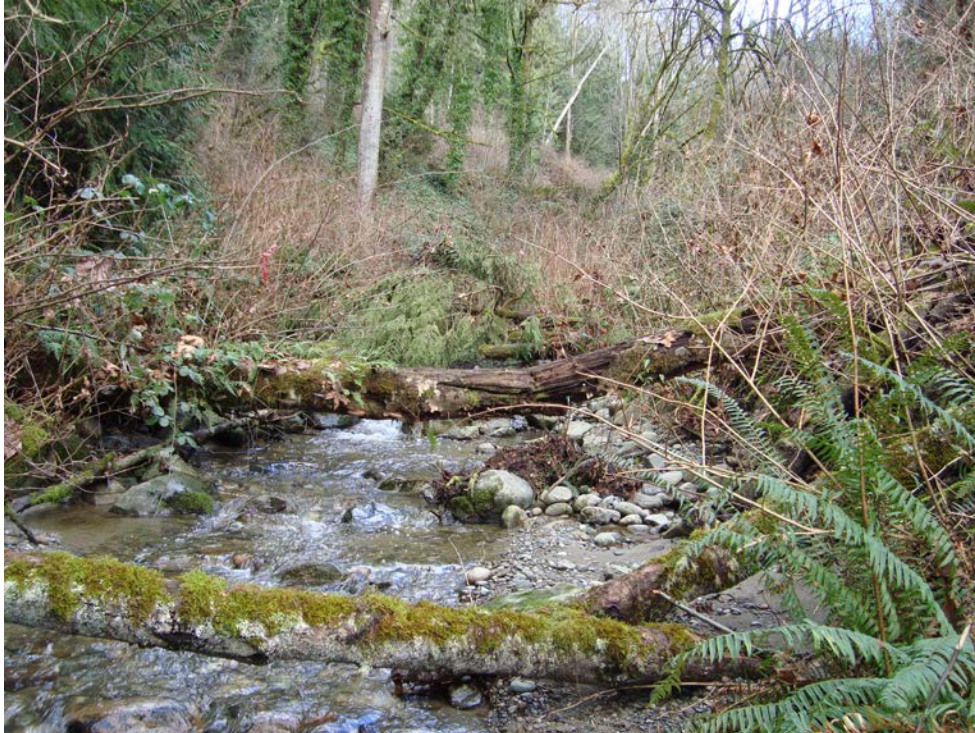
Photo #15. Typical stream conditions in upper ravine, just upstream of Stone Bridge

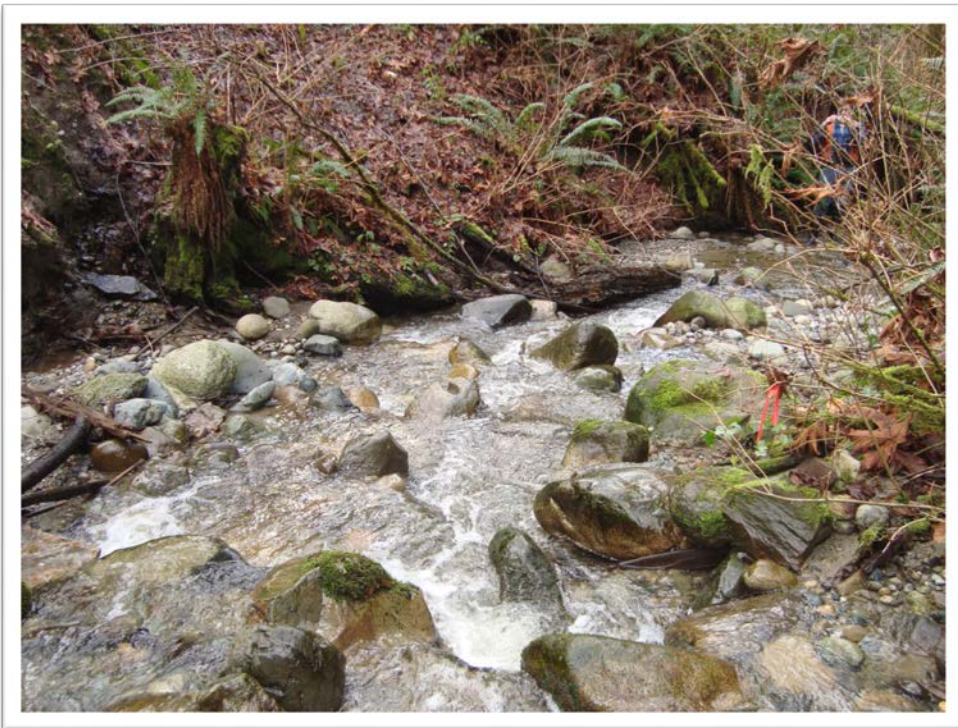
Photo #17. Example of steeper gradient and larger bed material in upper ravine reach

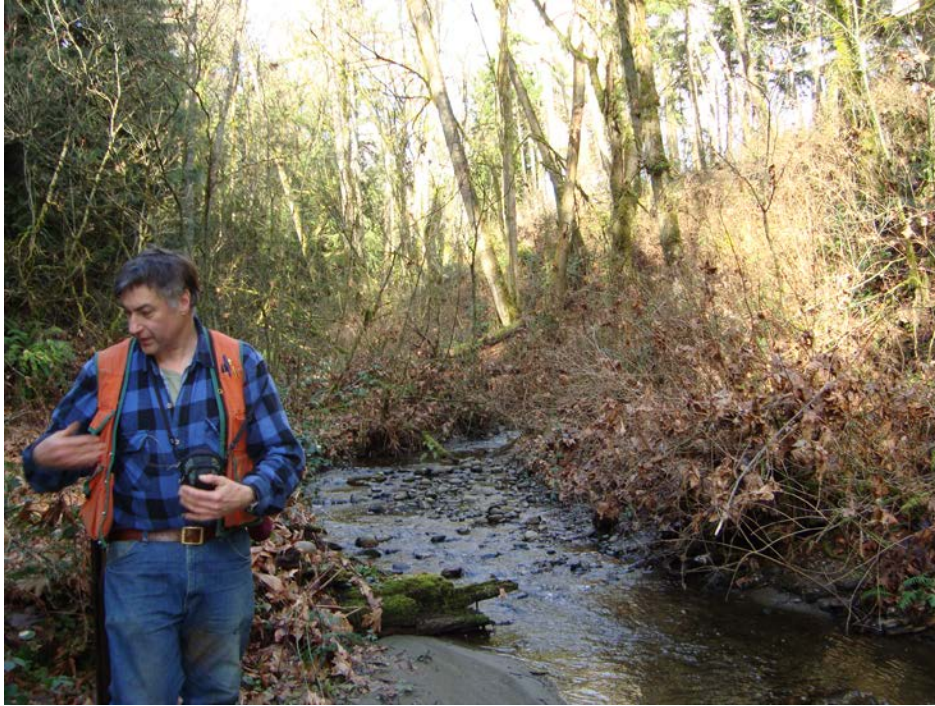
Photo #19. Just downstream of Juanita Drive in lower gradient reach.

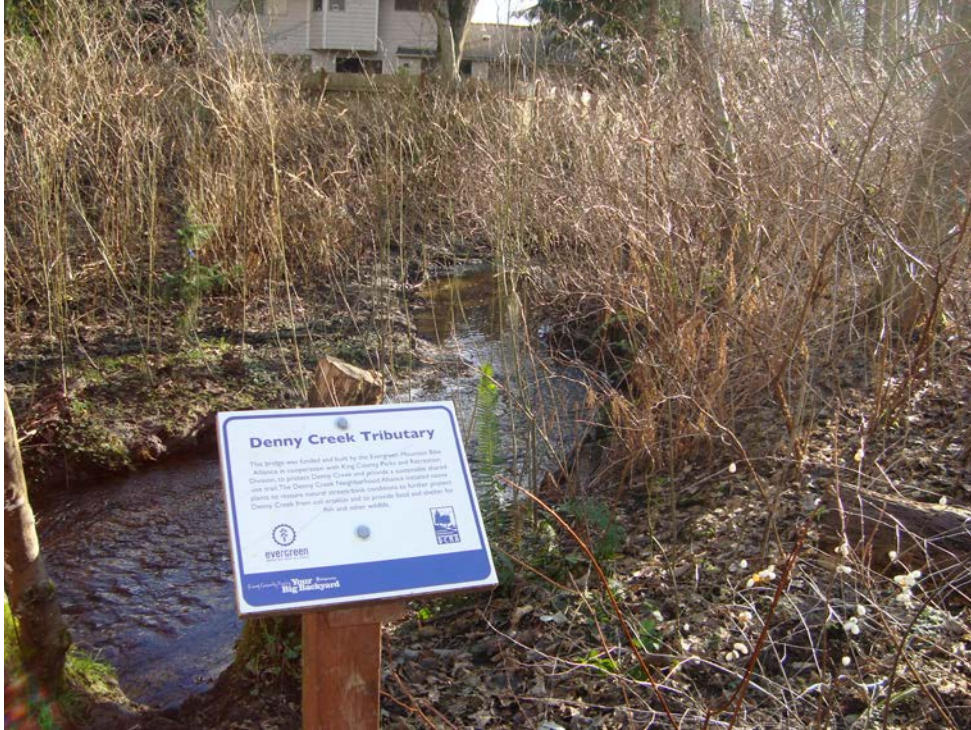
Photo #21. Near Finn Hill Junior High School

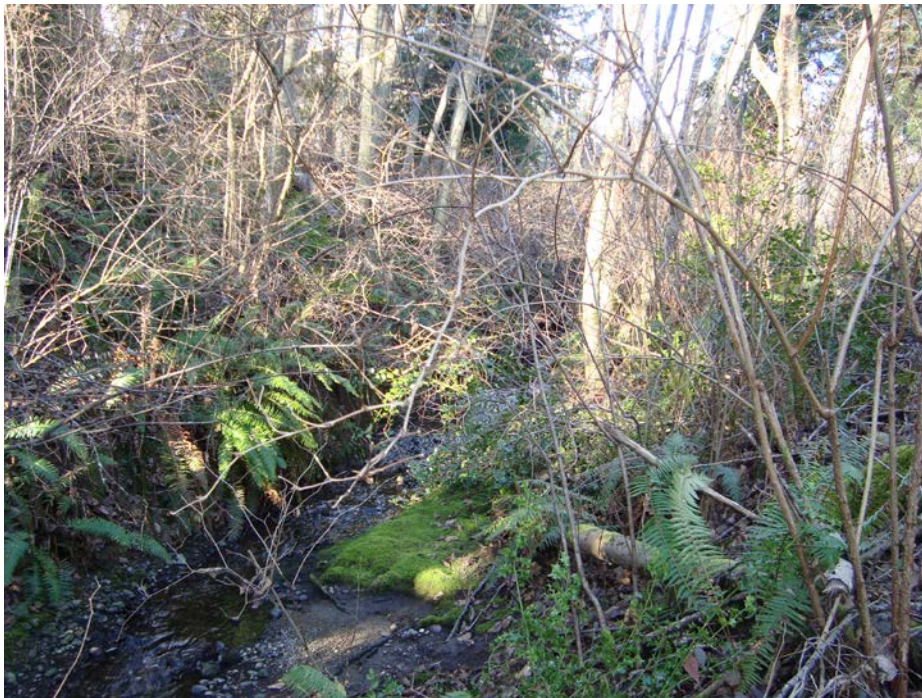
Photo #22. Wetlands and multiple Denny Creek tributary channels in Big Finn Hill Park

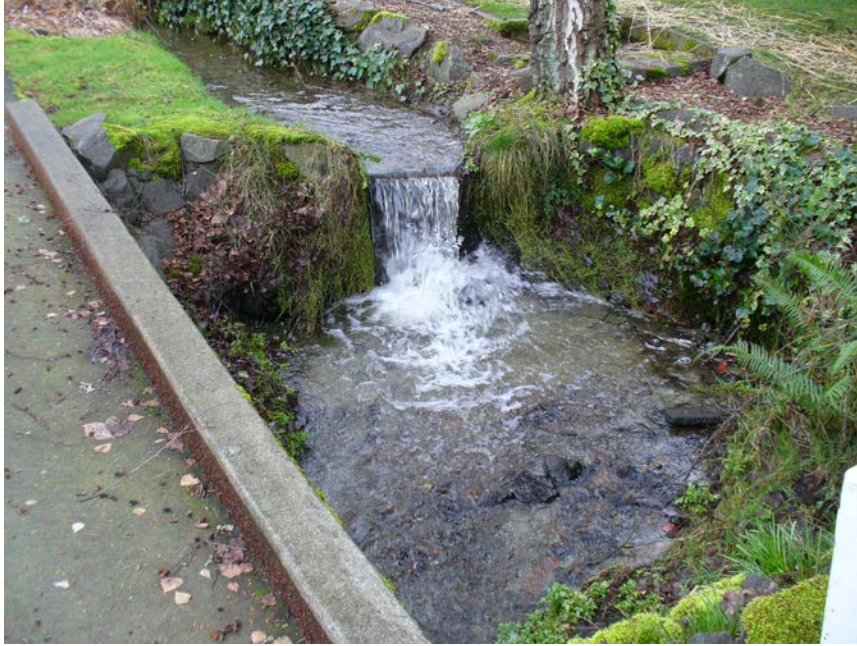
Photo #1. Lower Holmes Point Creek near Lake Washington

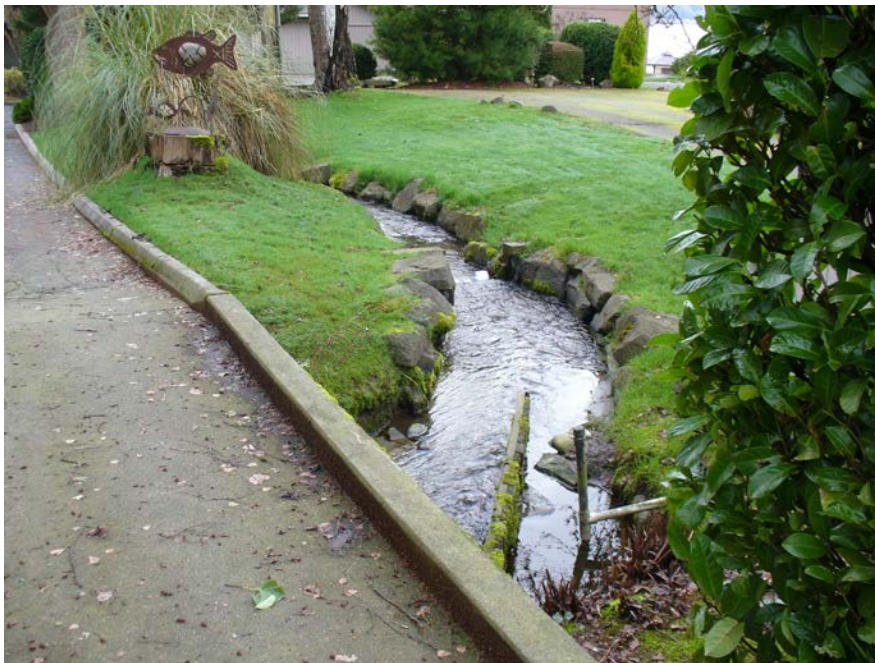
Photo #2. Holmes Point Creek confined to constructed channel

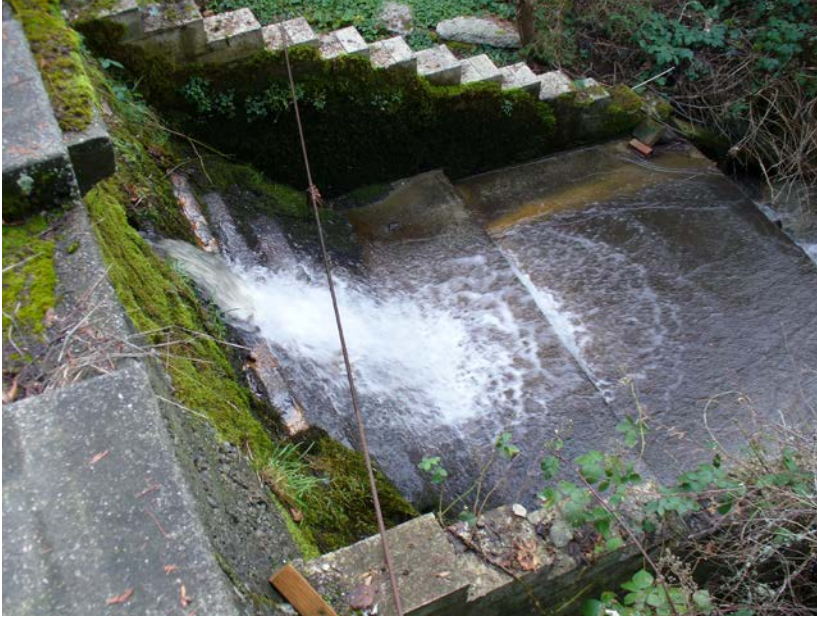
Photo #3. Downstream end of private dam in line with Holmes Point Creek

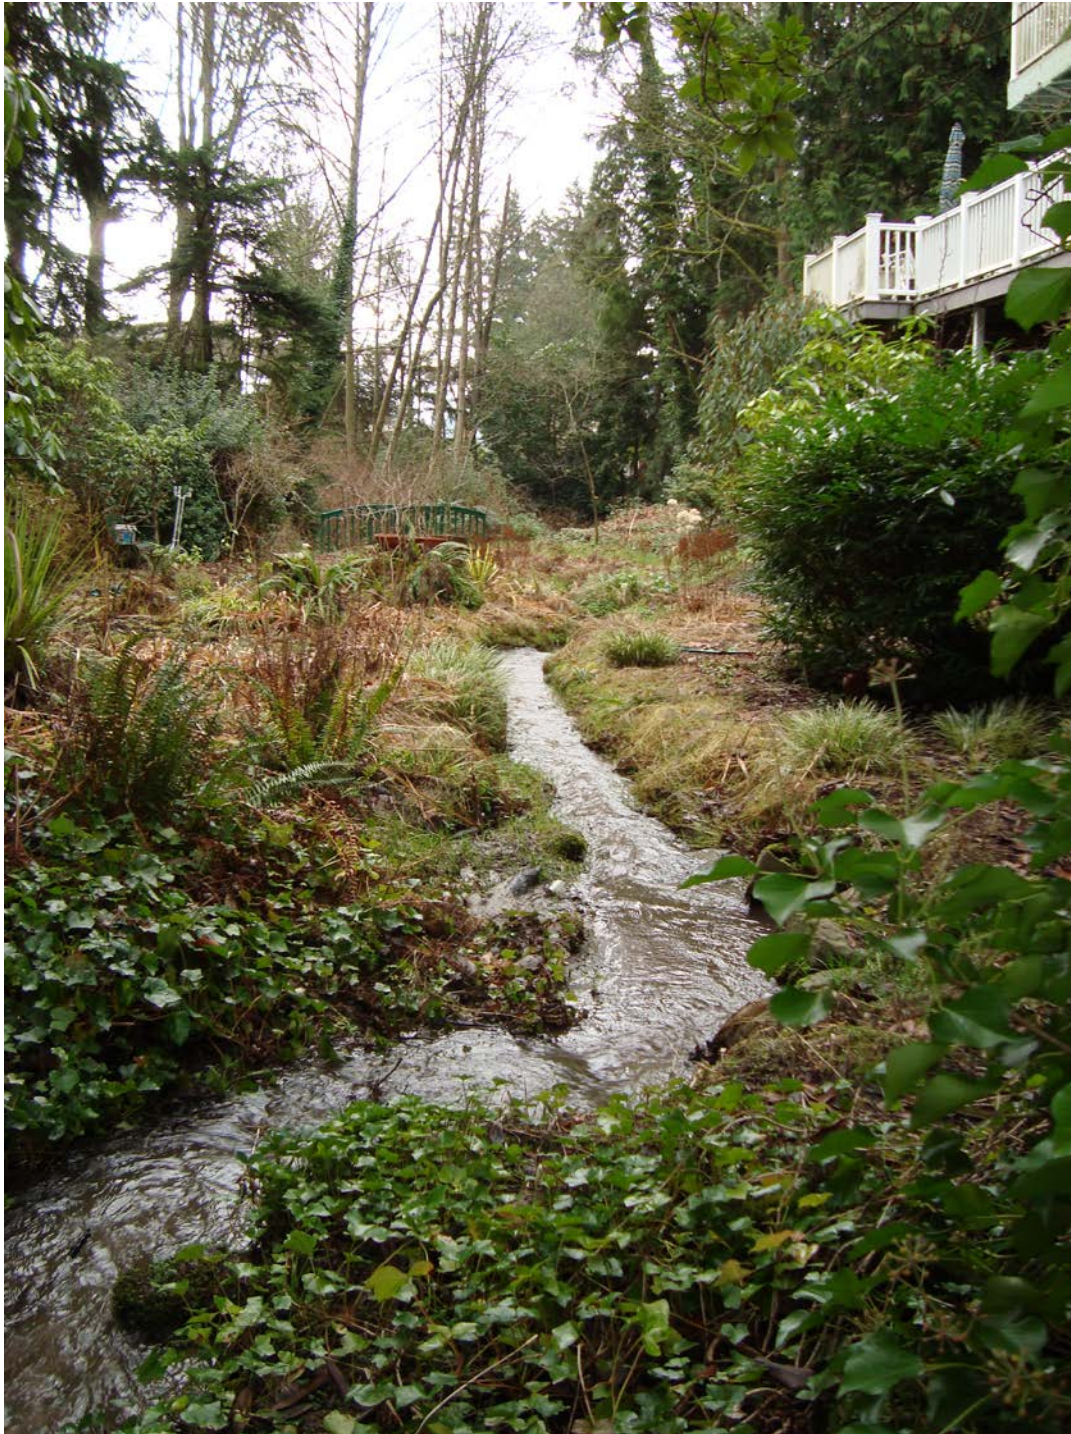
Photo #5. Holmes Point Creek upstream of 62nd Avenue NE

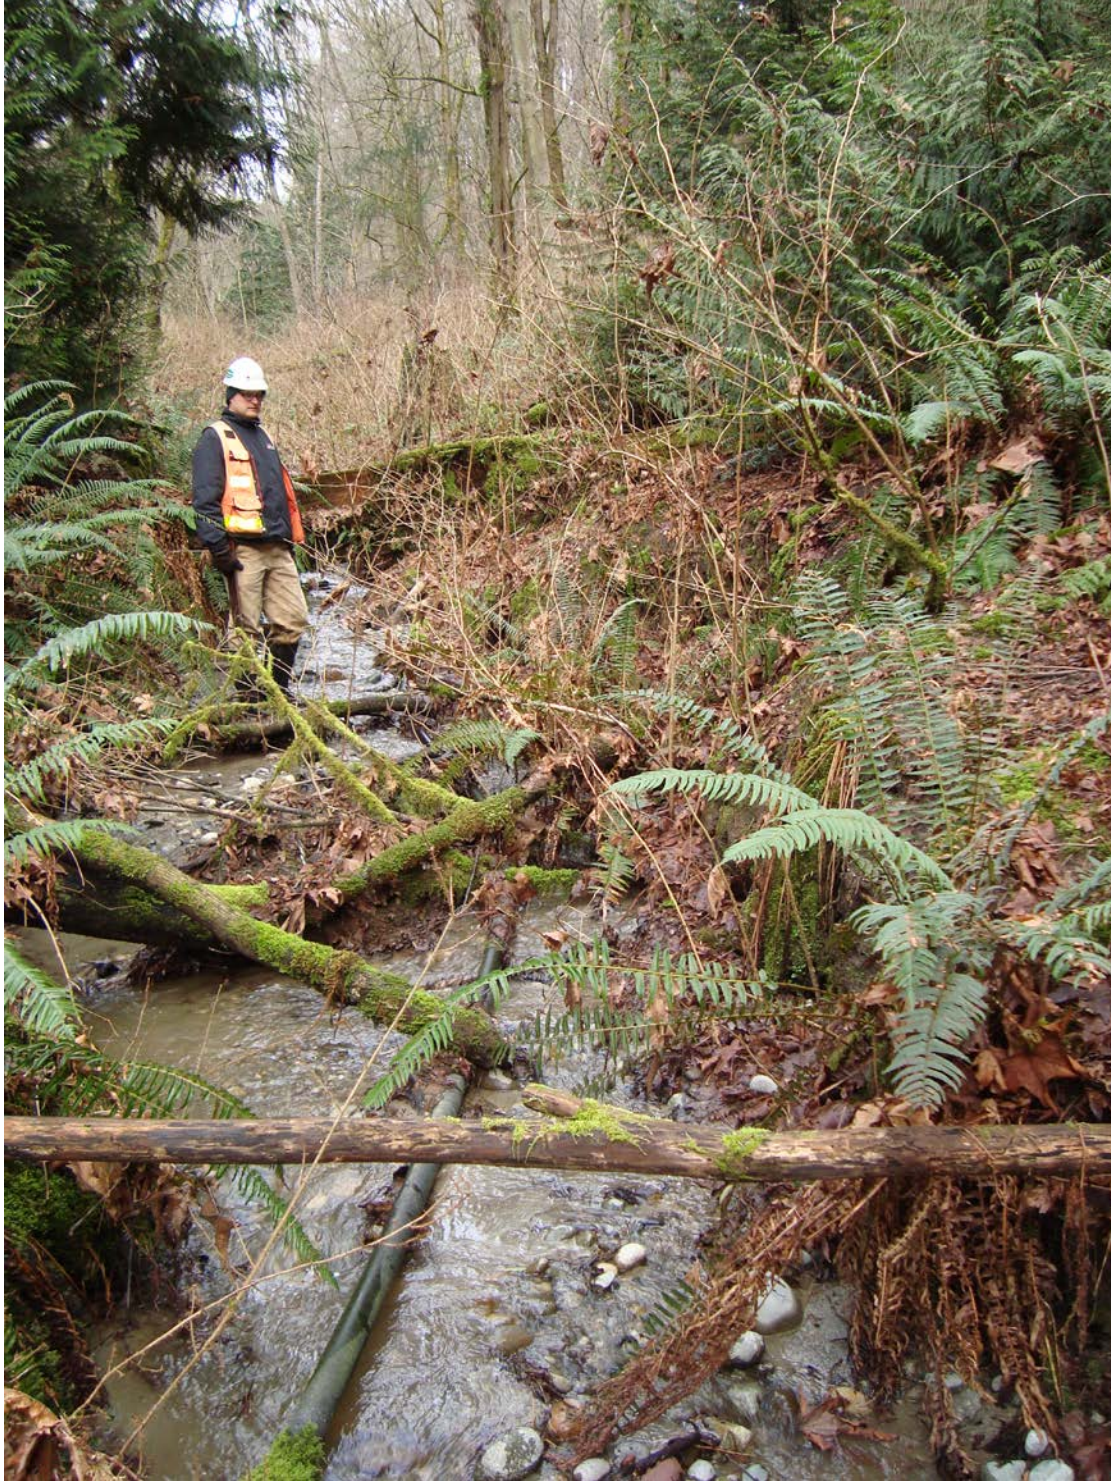
Photo #8. Typical stream section. Black pipe is in center of channel.

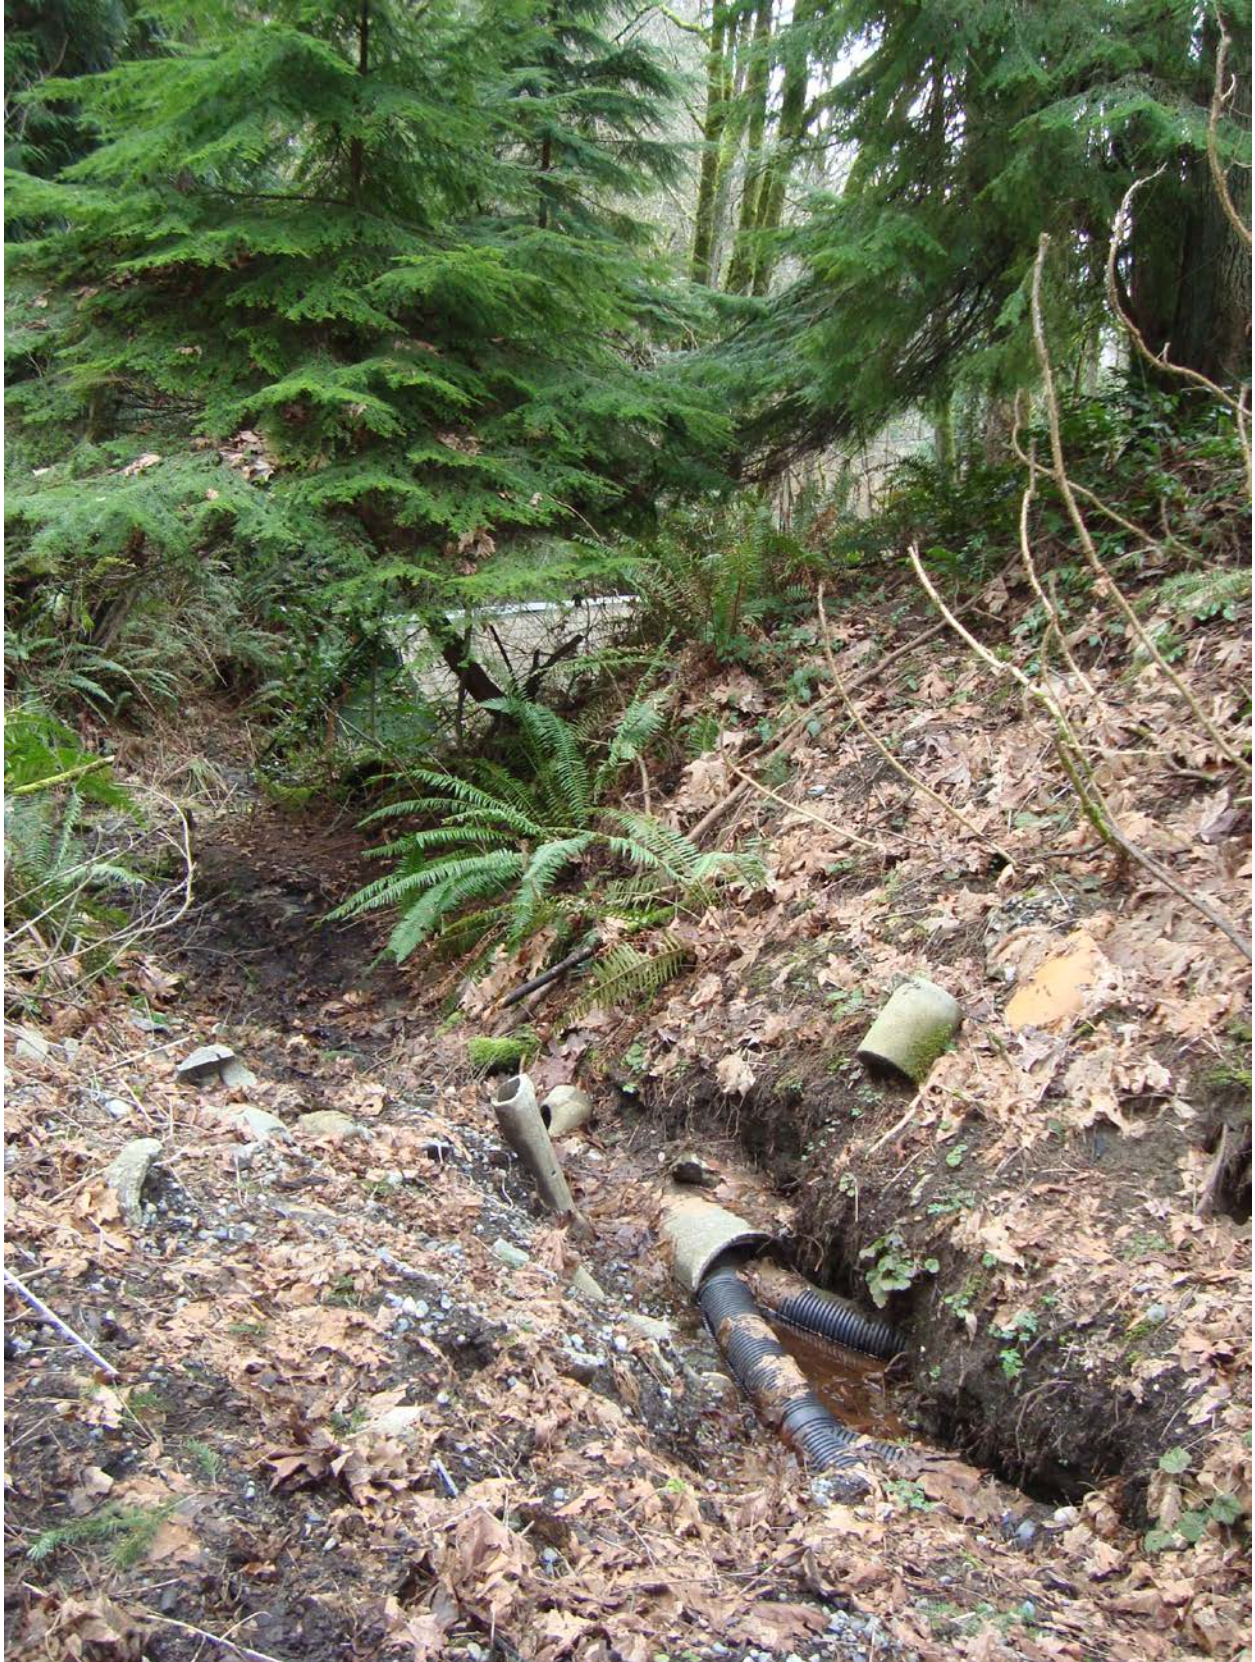
Photo #12 Upstream of pump house (roof visible in center of photo)

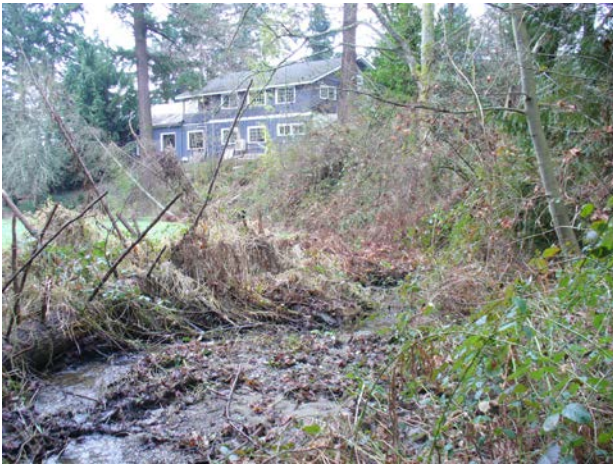
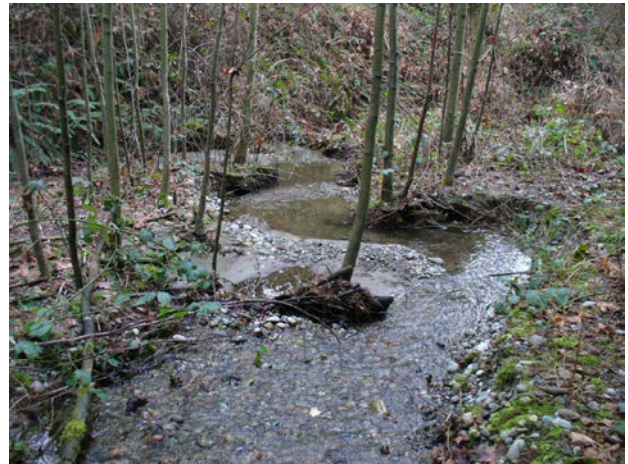
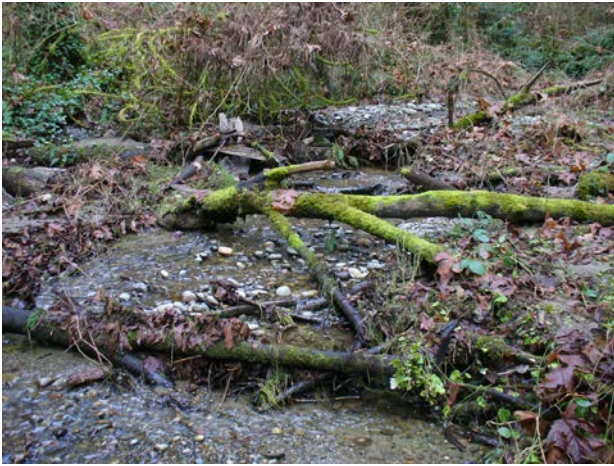
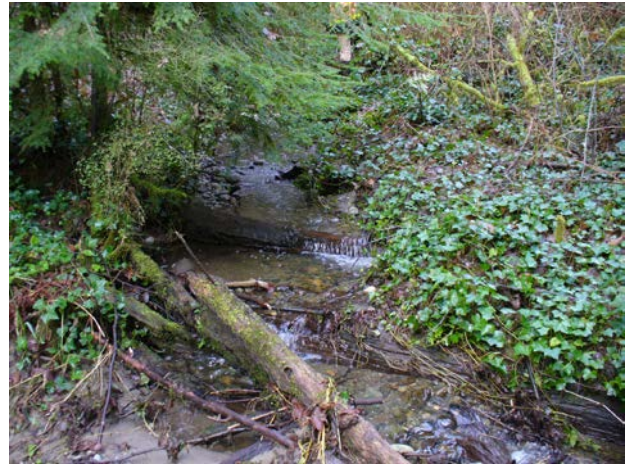
Description and Comments: Approaching the residences near its mouth, Champagne Creek flows through a depositional reach occupying the lower portions of its wooded ravine. Here, much of the sediment that is mobilized in the deeply incised reach just upstream (see below) is deposited. As a result of this excessive sediment loading, the channel in the lower reach is broad, ill-defined, and braided, migrating and depositing sediments across the entire flood plain along the ravine bottom, which is fairly broad in that section. Alder saplings have sediments deposited around them and/or find themselves in the middle of the channel as it migrates through or past them. Non-native vegetation is very prevalent including primarily English Ivy, Himalayan blackberry, and laurel. A project to remove such non-native vegetation would be in order. Wood is fairly abundant in the stream channel and the substrate consists of very sandy small-to-medium-sized gravel. Some pools are formed around logs, but remain fairly shallow due to the predisposition for deposition. Native plant species present include western red cedar, bigleaf maple, hemlock, alder, sword fern, and salmonberry. See Photos below:
