Appendix G

Summary of Annexation Area Stream Survey

Stream Walk Photo Logs

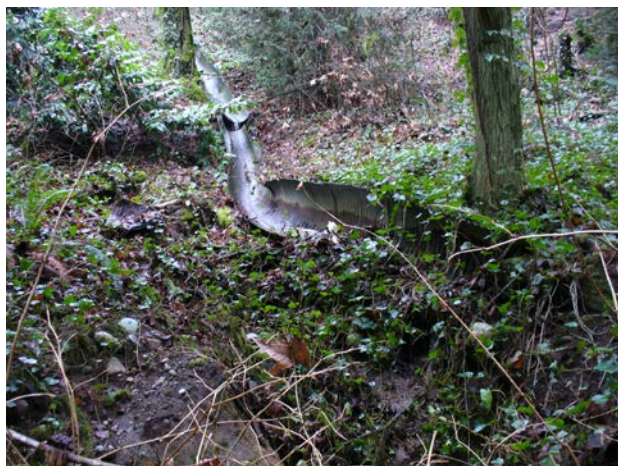
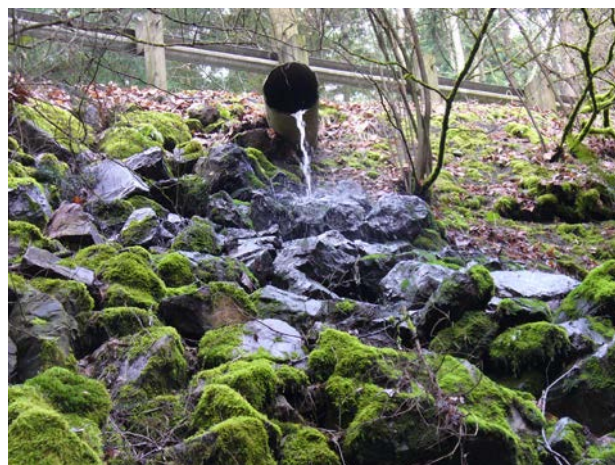
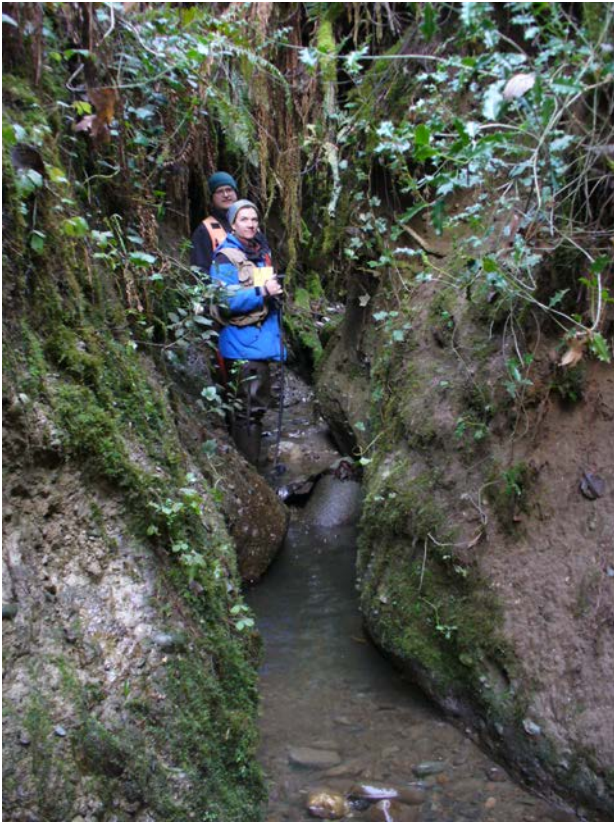
Number: 2

Description and Comments: The central portion of the Champagne Creek Ravine downstream of Juanita Drive NE is characterized by deep channel incision through glacial soils. The incision is commonly 8-10 feet in depth and more, and provides the sediment source for deposition farther downstream. Banks are vertical and lack vegetation, though the ravine sideslopes above the channel banks are well-vegetated. Few pools are present, and wood in the channel is sporadic. Non-native vegetation including primarily ivy is prevalent up the ravine sideslopes above the incised channel. Sources of storm drainage entering the creek through this reach have been armored to try to reduce erosion. See Photos below:

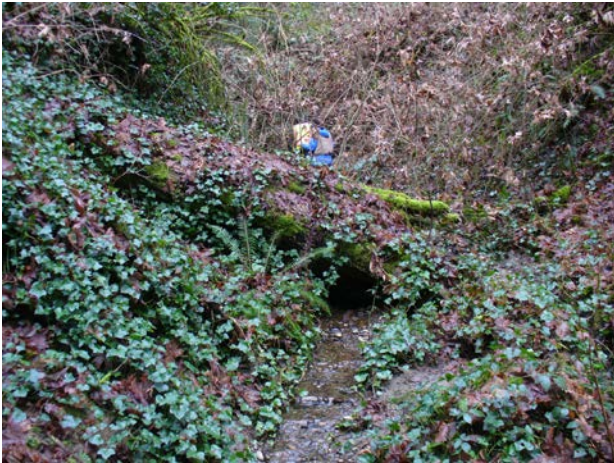
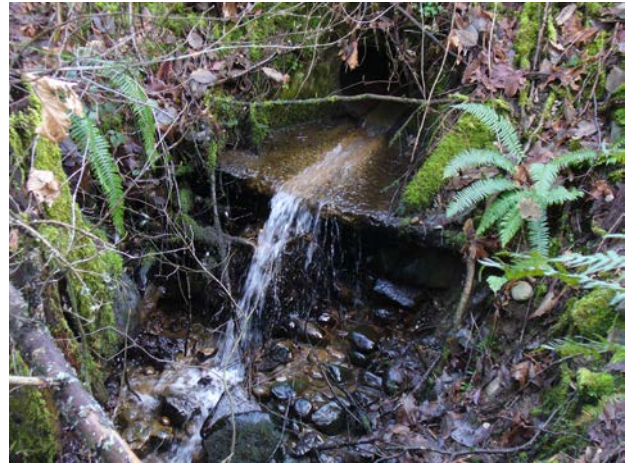
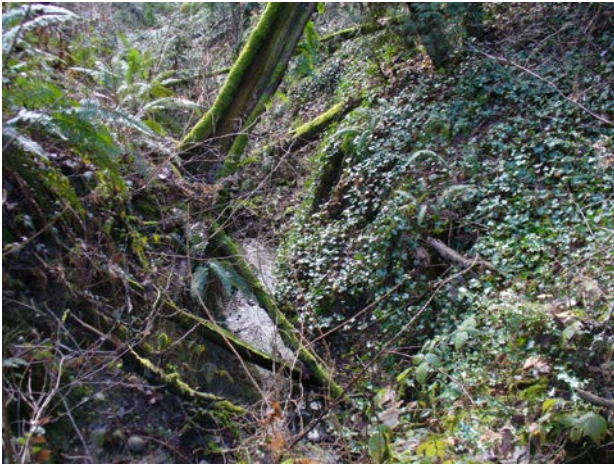
Number: 3

Description and Comments: The upper part of the Champagne Creek Ravine has diminishing incision proceeding upstream to the outfall of the culvert under Juanita Drive NE. There is a fair amount of wood in the stream and fairly good-quality gravel. English ivy remains pervasive, making a project aimed towards removing it worth suggesting. The culvert outfall from Juanita Drive NE is clearly a barrier to upstream fish migration, if fish were to make it that far upstream. See Photos below:

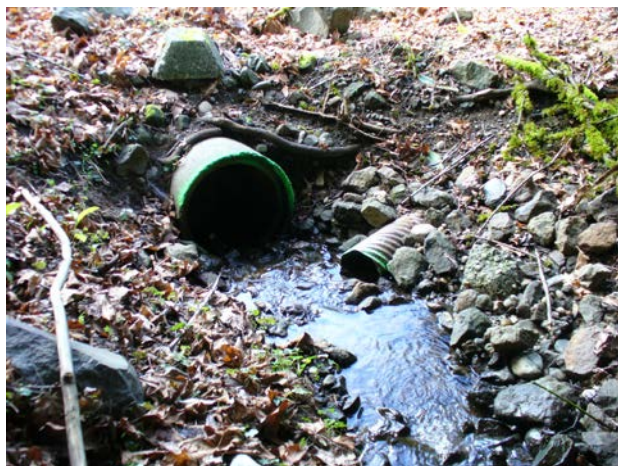
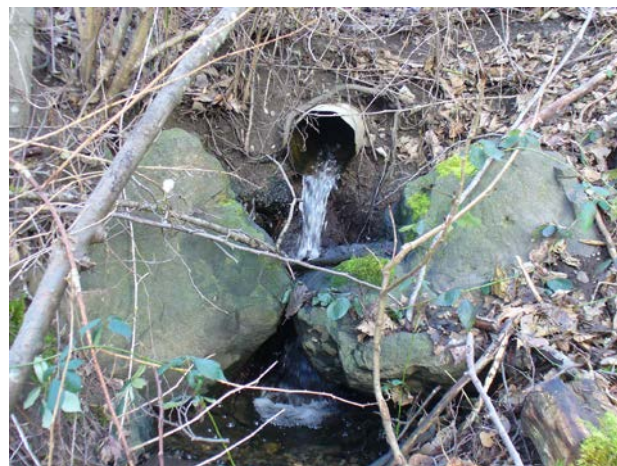
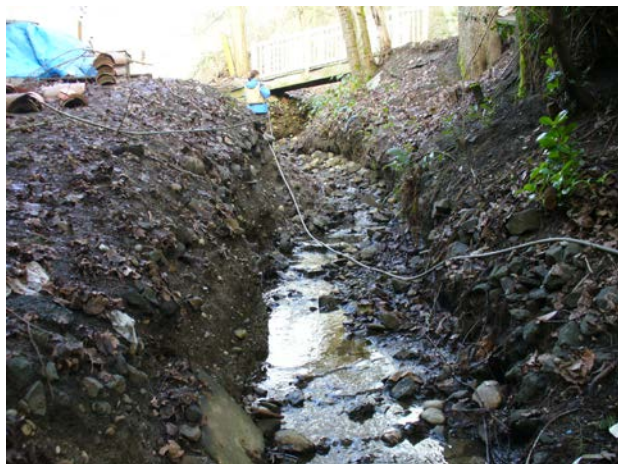
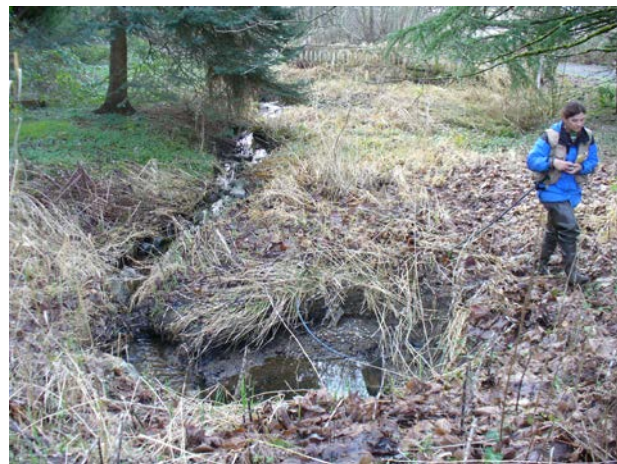
Headwater sources include swale-like channel sections paralleling NE122nd Pl. and NE 123rd St. See Photos below:

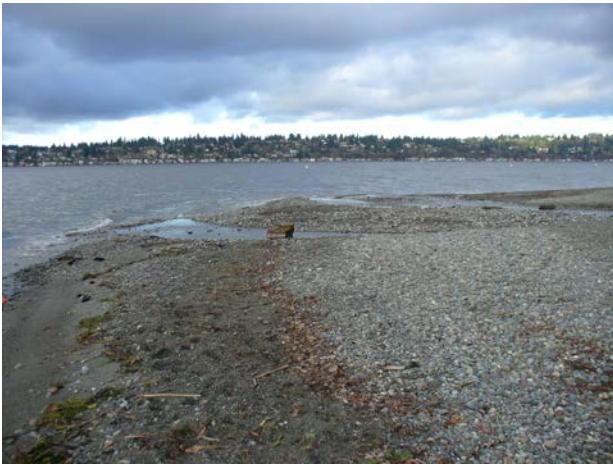
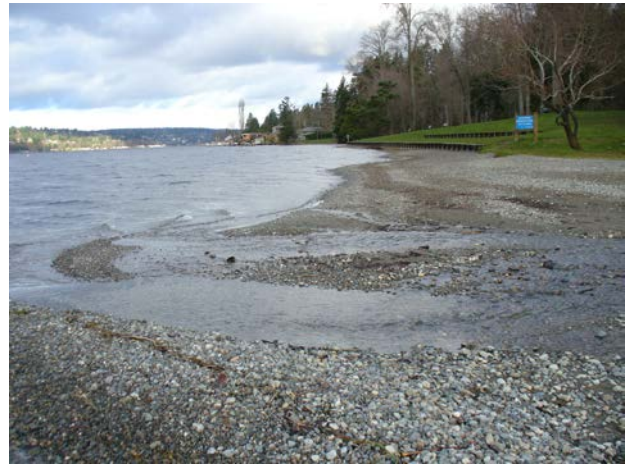
Number: 1

Description and Comments: Typical alluvial fan location at the mouth of Denny Creek at O. O. Denny Park. Sand and gravel deposition occurs as flow loses energy entering the lake, causing the shoreline to bulge outward at that location. Note that Lake Washington was lowered by approximately __ feet in 19__ meaning that the original alluvial fan was farther upstream, perhaps near the location of Holmes Point Dr. NE. Also of note, the Corps keeps the lake a foot and half lower in winter than summer, which is the opposite of a more natural lake hydroperiod. This has implications for fish passage out of the lake and into the creek, especially during the winter. Due to shallow flows across the fan, it can be harder for fish to enter during the winter and this could make it harder for adult coho to enter the creek in November or cutthroat trout throughout the winter or on their spawning migration Feb.-Mar. Corrective actions have been proposed and implemented at the mouths of other Lake Washington Streams, for Example Coal Creek, but is not proposed particularly here. See Photos below:

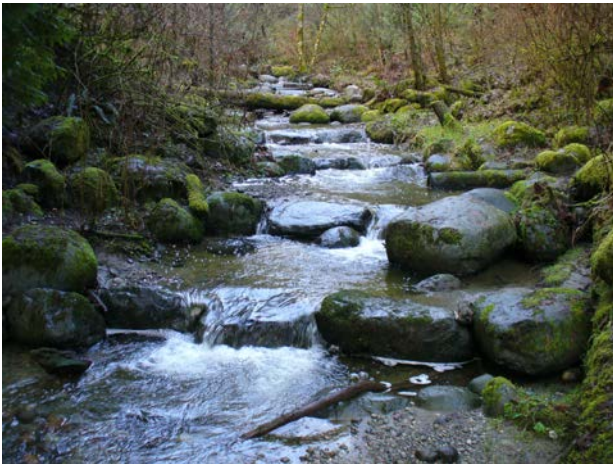
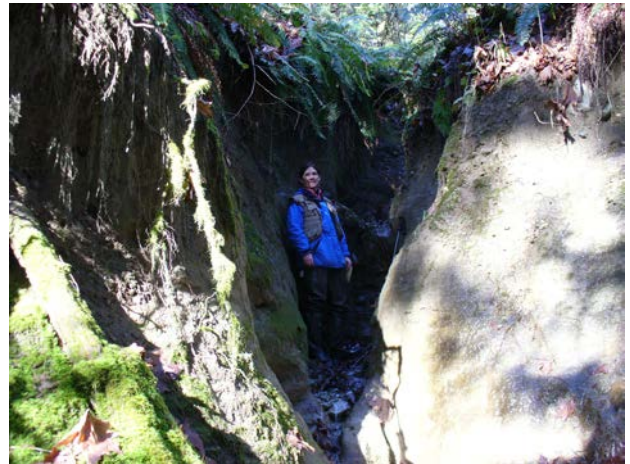
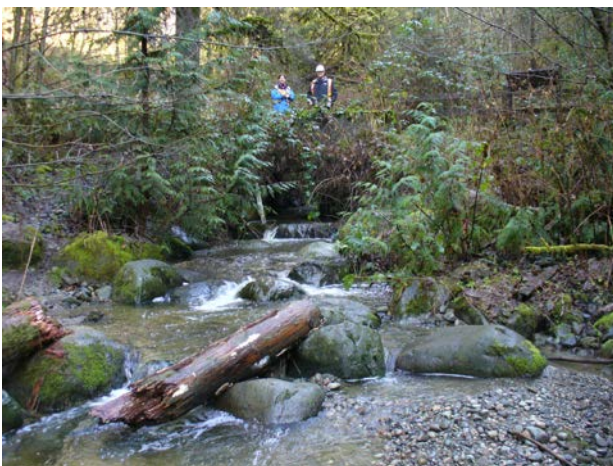
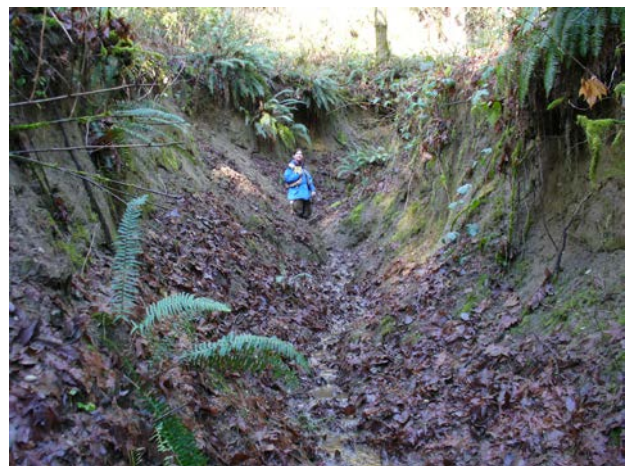
Number: 4

Description and Comments: Features in this reach include a multi-step rock weir structure built by King County in ____ providing fish passage at an old concrete bridge. Also a significant gully erosion feature originates apparently as a result of neighborhood runoff from the vicinity of 72nd Avenue NE. Boulders are more prominent in the streambed. Wide buffers of native vegetation as the stream flow through the large open space areas of Big Finn Hill Park. See Photos below:

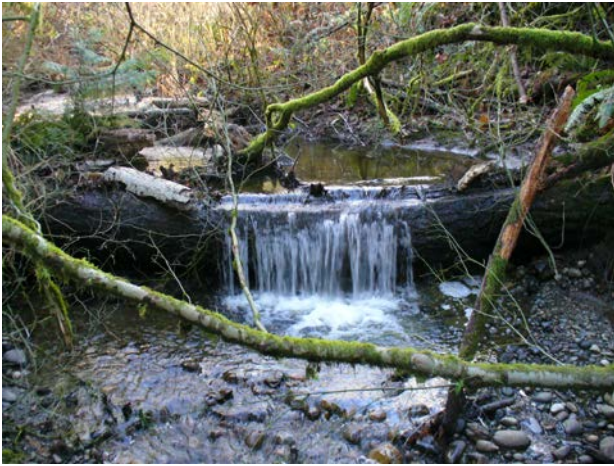
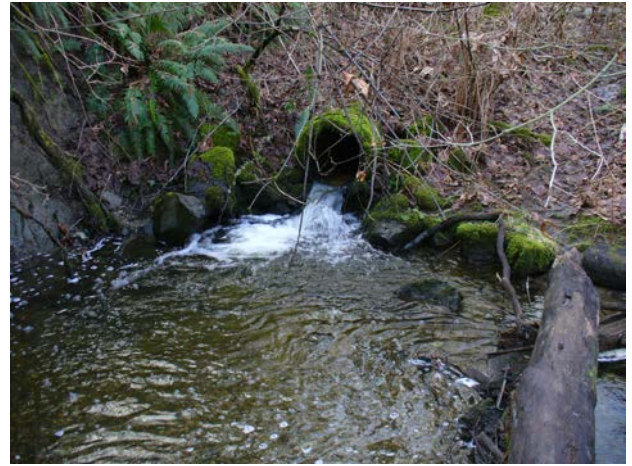
Number: 5

Description and Comments: Noteworthy characteristics of the upper ravine include a prevalence of boulders along much of the streambed length. Also, sections of ravine sideslope and streambank instability are common, resulting in large amounts of wood, as well as substrate materials, being supplied to the stream channel as trees fall and slide into the creek. A natural log weir barrier to fish passage was noted, though this is likely not a permanent feature and should correct itself on its own with time. A short distance farther upstream is the outfall of the culvert under Juanita Drive NE, a 2-foot-diameter concrete pipe which is likely a complete or near-complete fish passage barrier due to high velocities and a plunge at the outfall. See Photos below:

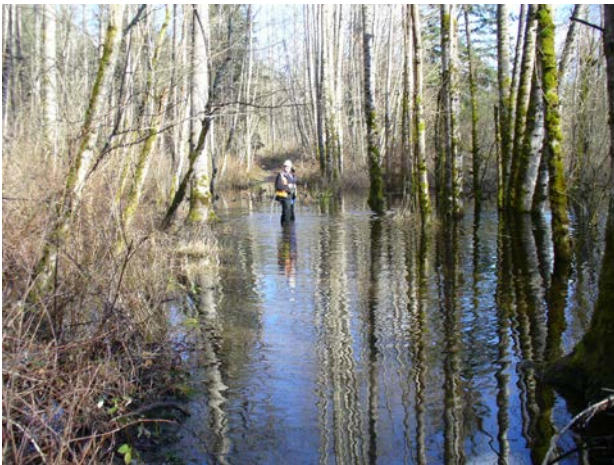
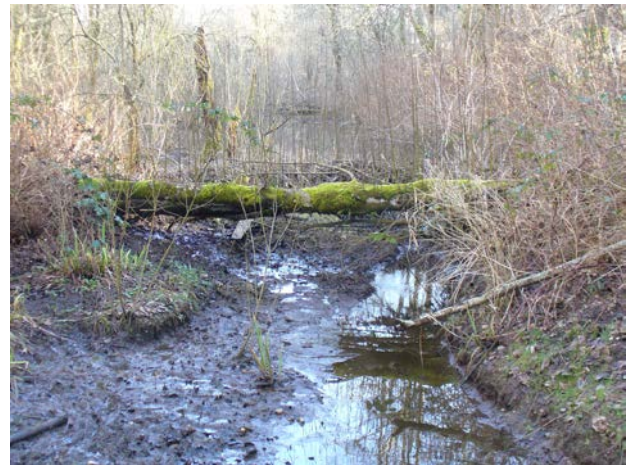
Number: 6

Description and Comments: Includes low-gradient stream sections through upper Big Finn Hill Park, with some areas inundated as a result of beaver activity. See Photos below:

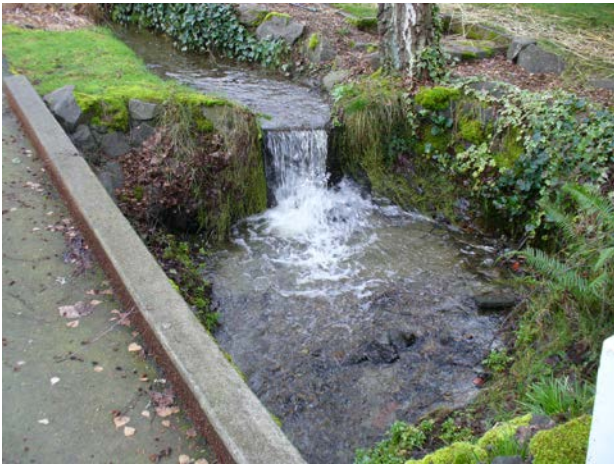
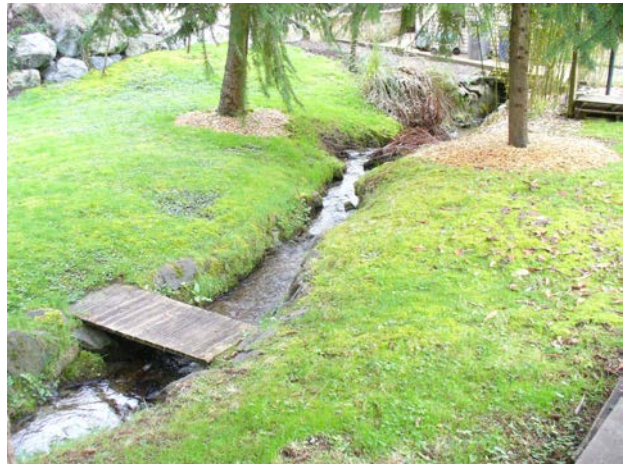
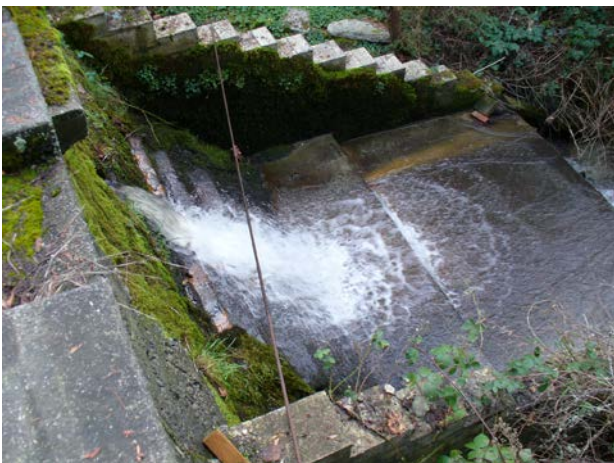
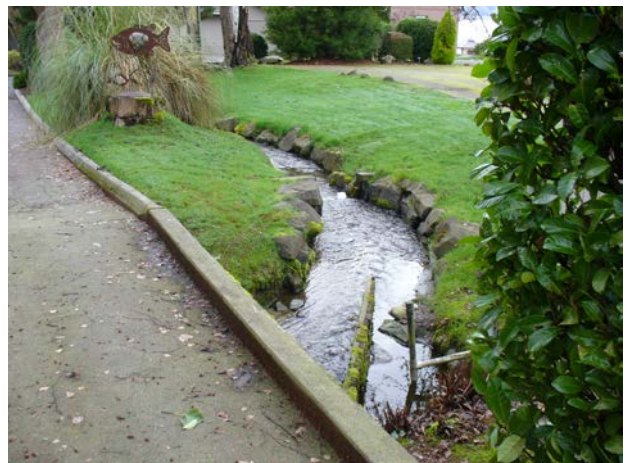
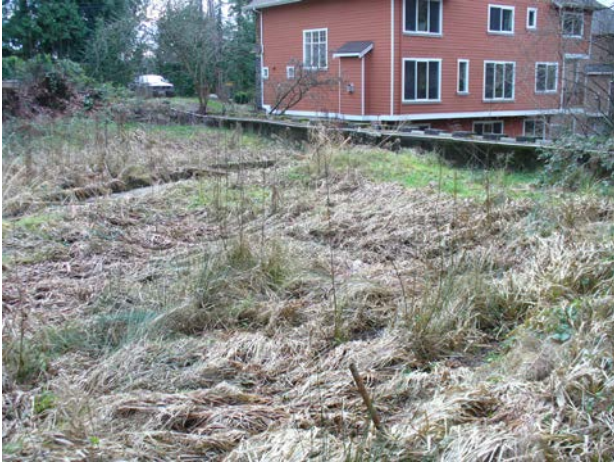
Number: 1

Description and Comments: Near its mouth, Holmes Point Creek Typical passes through the yards of a number of houses in a very narrow, armored channel with little tree or shrub vegetation along its banks. Lawns typically extend right up to the creek. Several plunges occur along the way which would block upstream fish movements, including a major barrier in the form of an 8 to 10 foot-high concrete dam with a vertical plunge at its spillway. The former pond above the dam is now completely filled up with sediment such that it is now meadow-like with a lumber-lined, constructed channel passing across it. See Photos below:

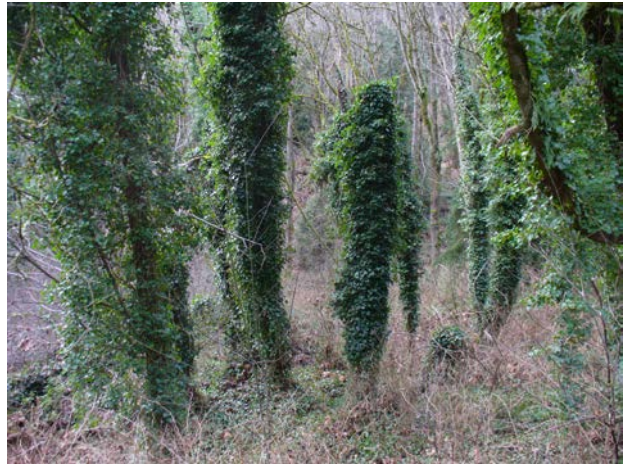
Number: 2

Description and Comments: Vegetation noted – Alder, Maple, cedar, salmonberry, sword fern, ivy. Strong potential for a project to remove ivy and other non-natives. The channel substrate is mostly silty, very sandy small gravel with some larger gravel. Braided sections, the filled-up reservoir in the lower section, and alluvial fan deposits at the mouth plus bank instability indicate that the stream carries a high sediment loading. Some wood is present, but pools formed tend to be shallow due to the sediment load. See Photos below:

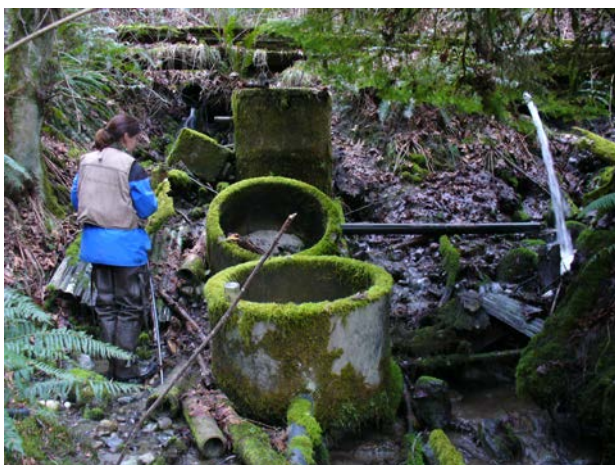
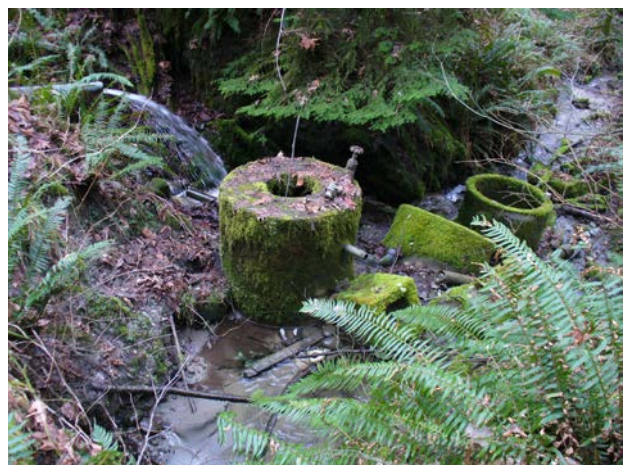
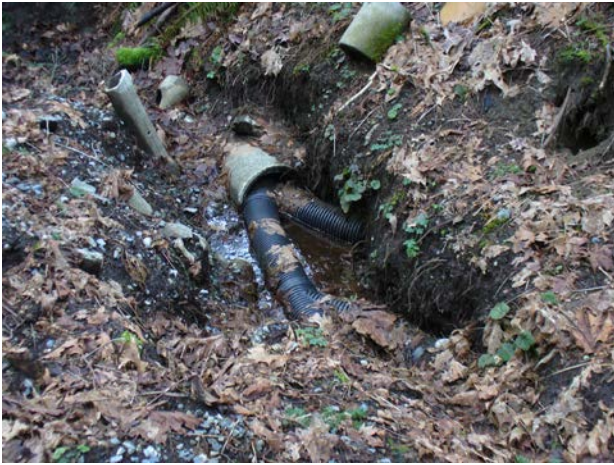
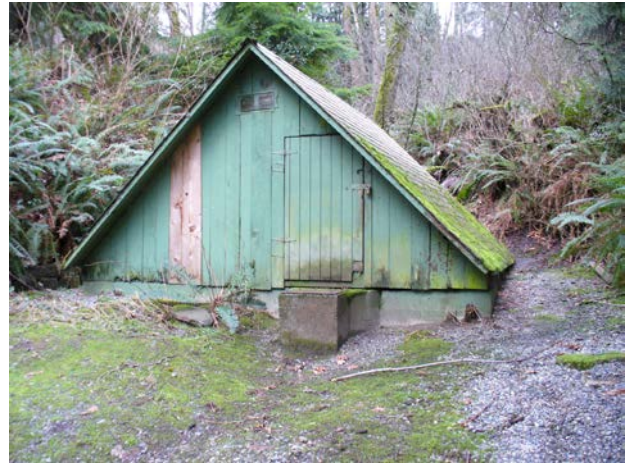
Number: 3

Description and Comments: A collection of flow diversion structures is in place apparently to collect water for and pump it to a water tower at Saint Edwards State Park. Some of the features are mossy and to appear to be old and out of use, but the overall feature appears to still be functioning. is present at the upstream end of box culvert. Streambanks near-vertical in places, up to 3-4 feet high. Gravel variable being very coarse but still sandy in places and mostly sand in others. Stream flows through wooded ravine with wide buffers. Vegetation includes alder, bigleaf maple, cottonwood, cedar, hemlock, salmonberry, sword fern and vine maple. One stand of non-native Japanese knotweed noted. Good amounts of moderately-sized large wood in the stream, resulting in good pool/riffle definition, but pools on the shallow side possibly due to high sand loading. Some areas of moderate bank instability recruiting silt and sand to the creek. See Photos below:

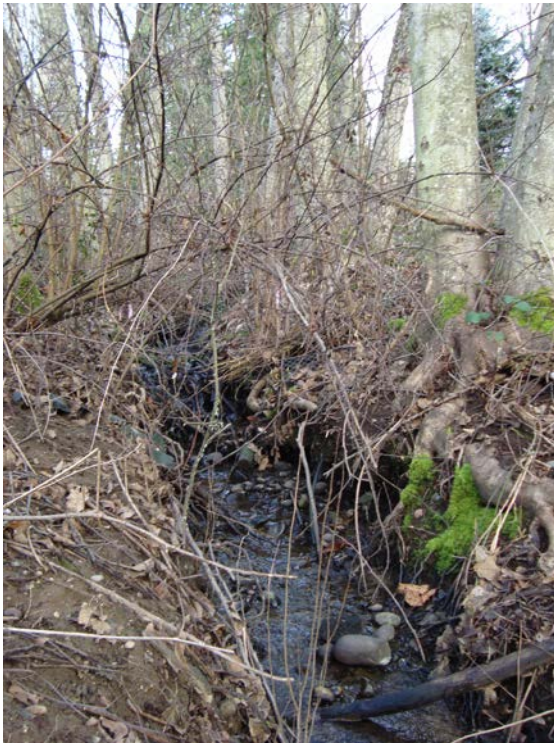
Typical stream section above Juanita Drive

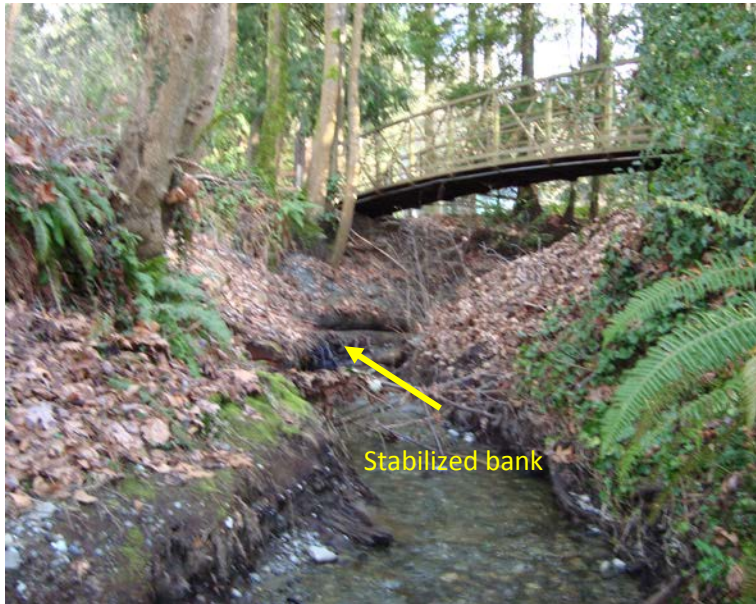
Denny Creek through O.O. Denny Park. Stream restoration was completed in this reach as part of sewer line project.

Non-native vegetation, potential fish migration issues during certain times of the year.

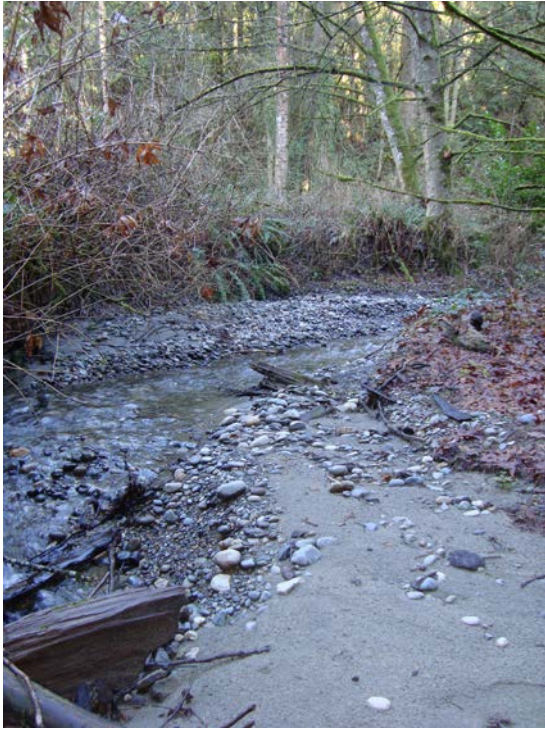
Denny Creek upstream of Holmes Pt. Drive

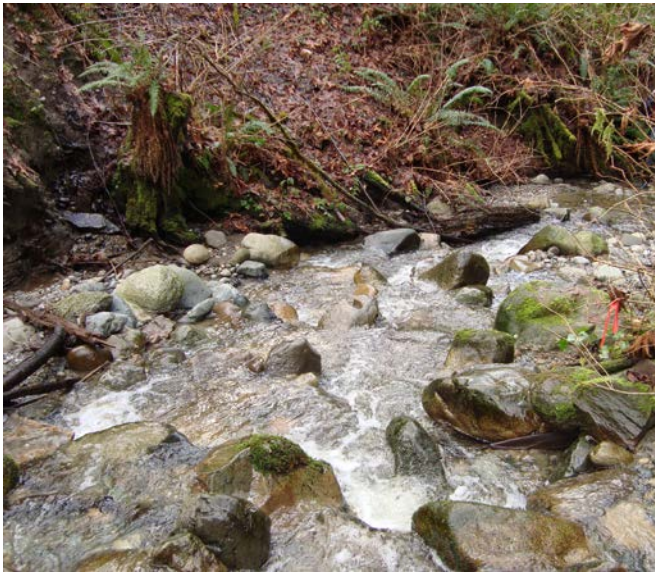
Denny Creek downstream of Juanita Drive.

Much steeper gradient and coarser substrate in this reach.

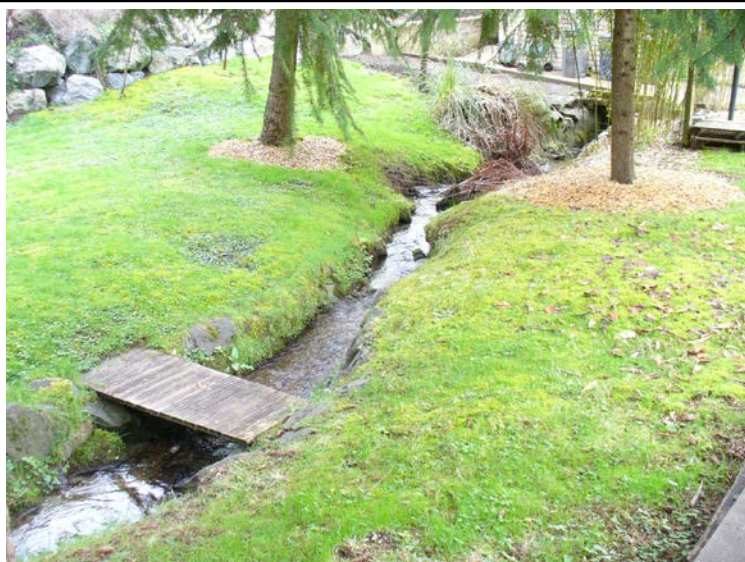
Holmes Point Creek near mouth in Lake Washington

Large private dam.

No native riparian vegetation.

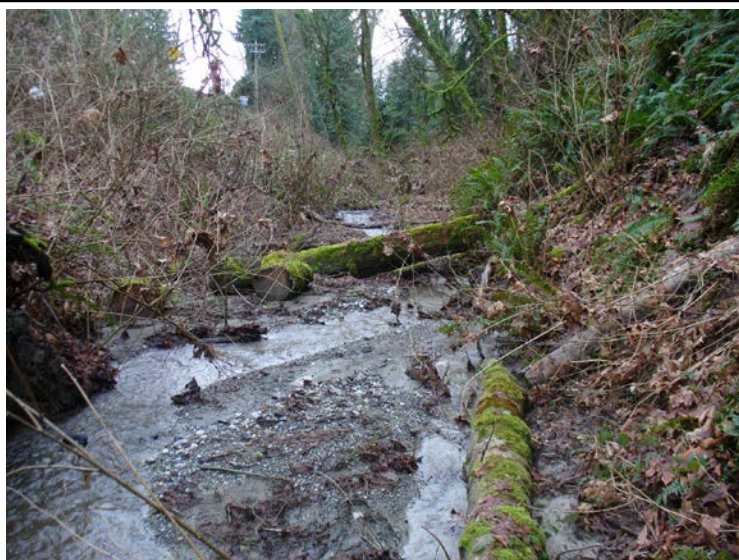
Holmes Point Creek near upstream of 62nd Avenue NE

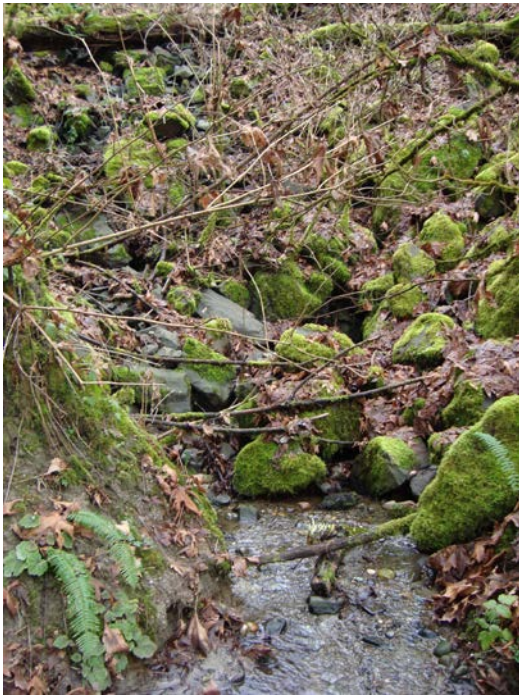
Holmes Point Creek downstream of St. Edwards Park.
